Technical Service Bulletin

94 Taillight warning appears in instrument cluster

94 17 88 2039584/3 June 15, 2017. Supersedes Technical Service Bulletin Group 94 number 15-71 dated August 3, 2015 for reasons listed below.

Model(s)	Year	VIN Range	Vehicle-Specific Equipment
A6	2012 - 2015	All	Not Applicable

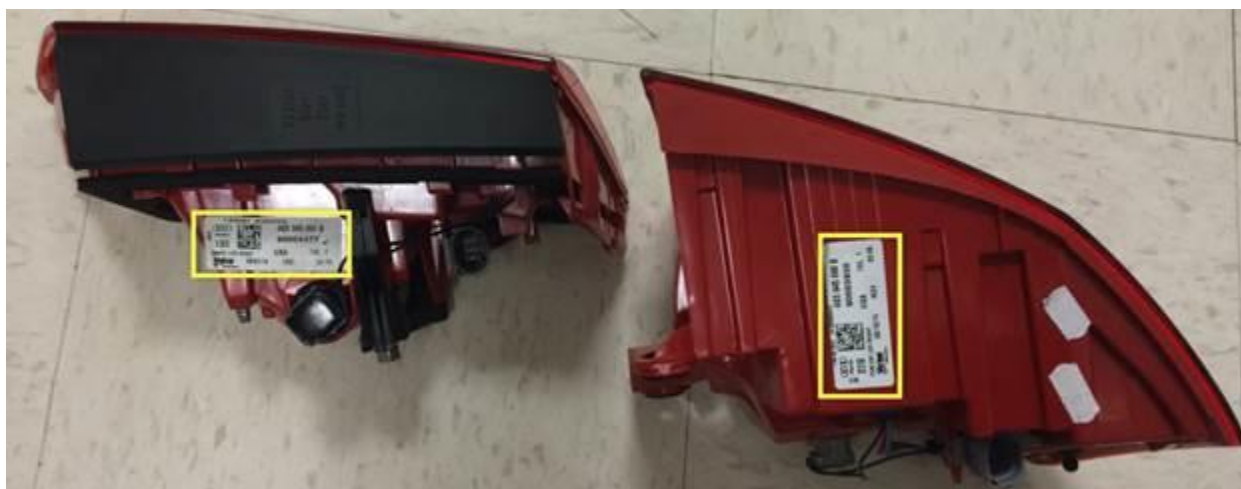
Replace any taillights with logged DTC entries. Ensure that the updated taillights with the optimized transistor are used. The updated taillights have production date August 11, 2014 or newer, written as 11/08/2014 (DD/MM/YYYY) (Figure 1, Figure 2, and Figure 3).

Figure 1. Location of date information.

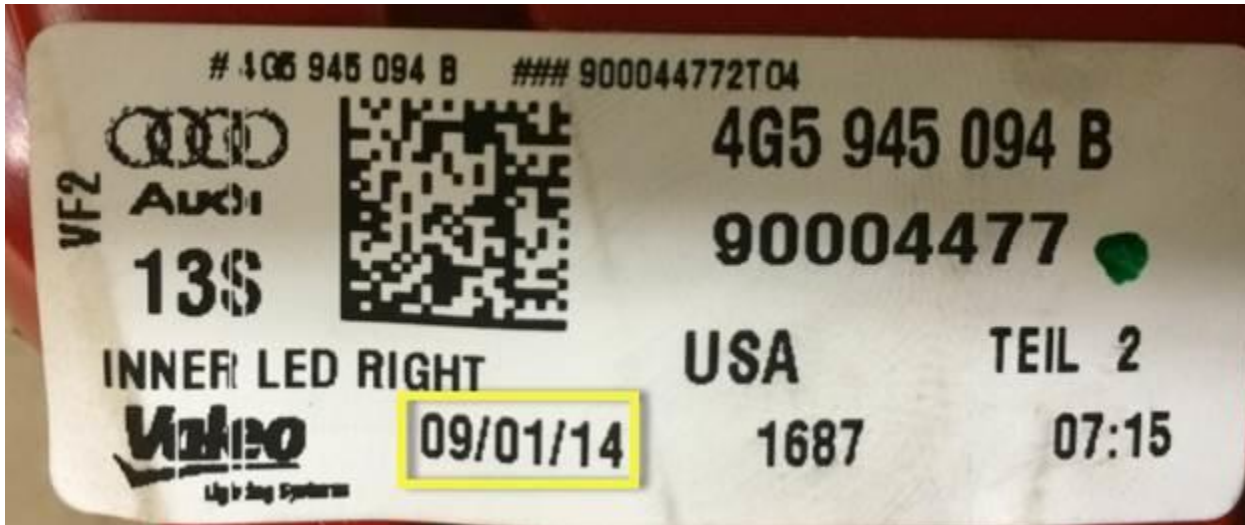
Figure 2. Location of production date, shown as DD/MM/YYYY. The production date of this taillight is January 9, 2014.

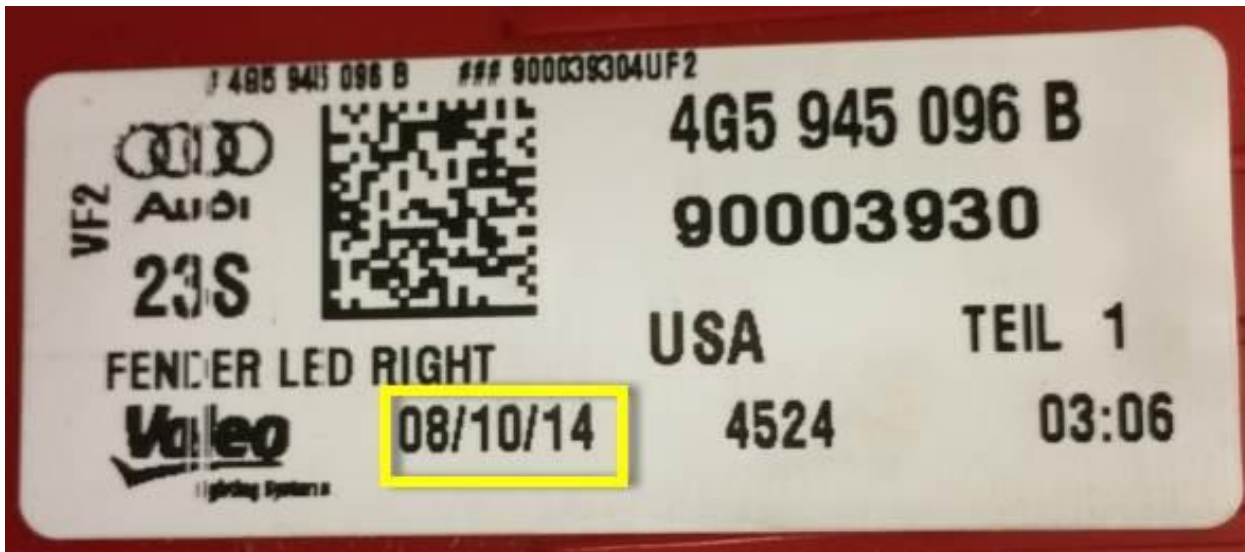
Figure 3. Location of production date, shown as DD/MM/YYYY. The production date of this taillight is October 8, 2014.

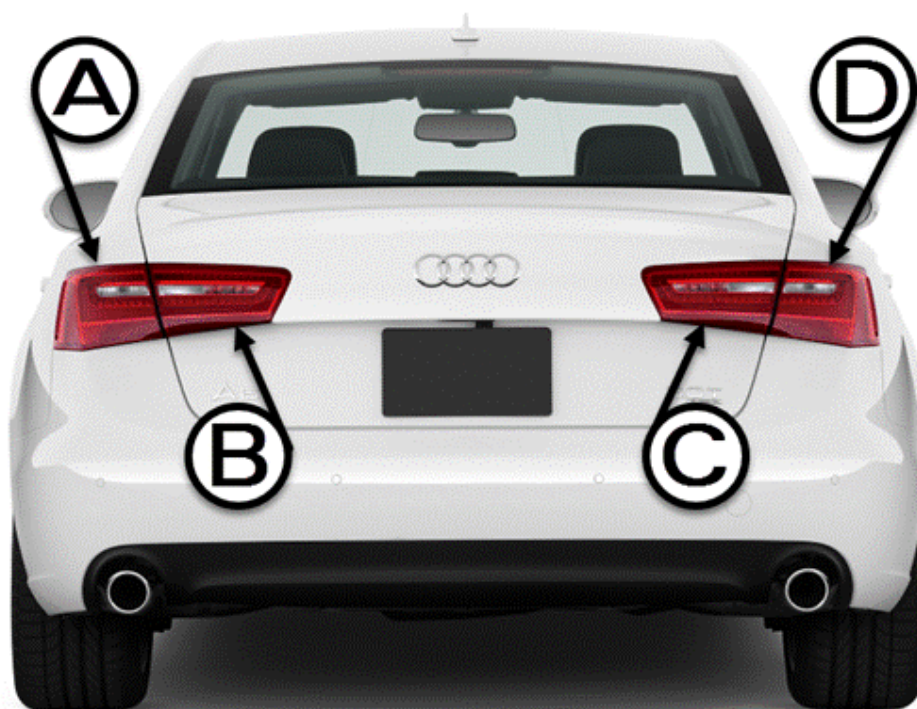
Figure 4. DTC To Brake Lamp Photo Reference:

Fault Number	Lamp Position	Photo Reference Figure 4
DTC 02771	Trunk Lid (Inner) Left	B
DTC 02772	Trunk Lid (Inner) Right	C
DTC 02901	Outer Left	A
DTC 02902	Outer Right	D

A:	DTC 02901: Left brake lamp/turn signal/tail lamp bulb 2 - M72, electric fault in circuit
B:	DTC 02771: Left brake lamp/turn signal/tail lamp bulb - M69, electric fault in circuit
C:	DTC 02772: Right brake lamp/turn signal/tail lamp bulb - M70, electric fault in circuit
D:	DTC 02902: Right brake lamp/turn signal/tail lamp bulb 2 - M73, electric fault in circuit
