# Service Action

## Code: 21F2

<b>Subject</b>	ECM Software and/or Coolant Line Seals
<b>Release Date</b>	June 07, 2017
<b>Revision Summary</b>	<b>Required tool added and work instructions updated.</b>
<b>Affected Vehicles</b>	<b>U.S.A. &amp; CANADA: Certain 2013-2015 MY Audi vehicles with 4.0L TFSI Engine</b> <ul style="list-style-type: none"><li>• 2013-2015 MY Audi A6/A7, S6/S7</li><li>• 2013-2014 MY Audi A8/S8</li><li>• 2014-2015 MY Audi RS7</li></ul> <p><i>Check Campaigns/Actions screen in Elsa on the day of repair to verify that a VIN qualifies for repair under this action. Elsa is the <u>only</u> valid campaign inquiry &amp; verification source.</i></p> <ul style="list-style-type: none"><li>✓ Campaign status must show "open."</li><li>✓ If Elsa shows other open action(s), inform your customer so that the work can also be completed at the same time the vehicle is in the workshop for this campaign.</li></ul>
<b>Problem Description</b>	On Audi vehicles with 4.0L TFSI engines manufactured within a specific period, the O-rings in the coolant lines for the turbocharger may be damaged. This can result in leaks between the coolant lines and the turbocharger.

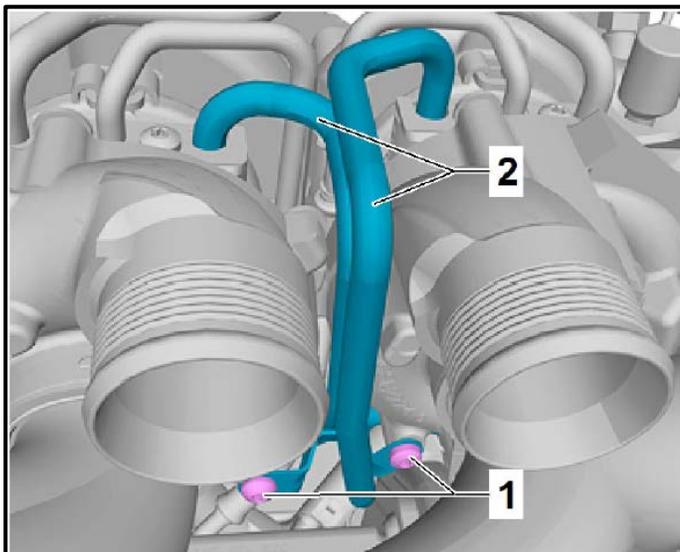
- Remove bolts <1> from coolant supply lines <2>.

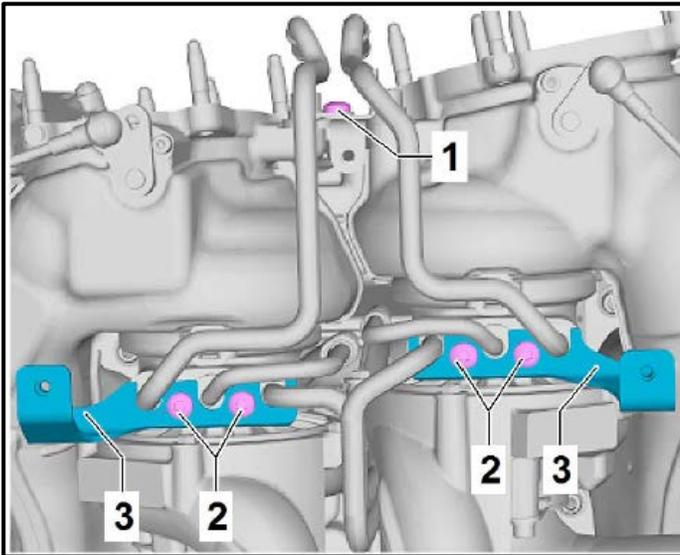
- Remove bolt <1> from coolant return lines.
- Remove bolts <2> and remove retaining plate brackets and retaining plates <3>.

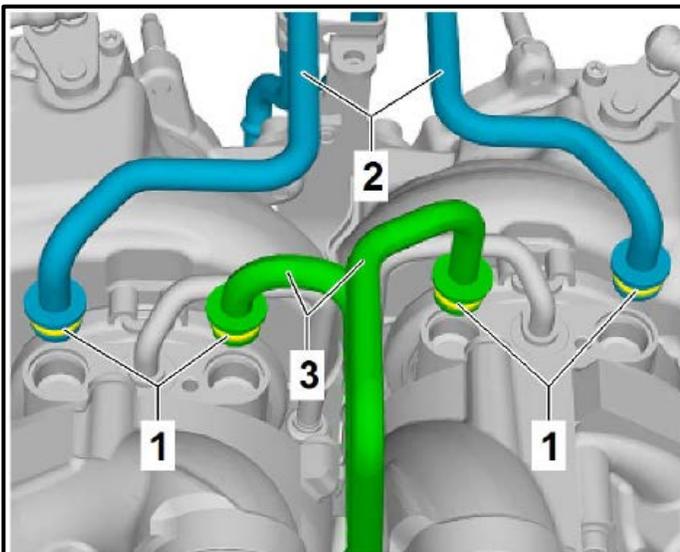
- Disconnect coolant supply lines <3> and coolant return lines <2> from turbocharger.
- Replace O-rings <1>.
- The original coolant pipes had a 2.5 mm O-ring groove which require the 2.0 mm (blue) O-rings. Replacement coolant pipes had a larger 3.5 mm groove which require the 2.8 mm (black) O-rings.
  - Measure the thickness of the O-ring groove using the Gap adjustment gauge -3371- to determine the O-ring groove thickness.
  - If groove measures 2.5 mm, install part # WHT006335A (blue).
  - If groove measures 3.5 mm, install part # WHT006537 (black).

If the coolant lines had been previously replaced, they will require the black 2.8 mm O-ring. The O-rings must be replaced with the same size O-ring. Failure to do so will cause a coolant leak.

- Lubricate new O-rings with clean coolant before installing.

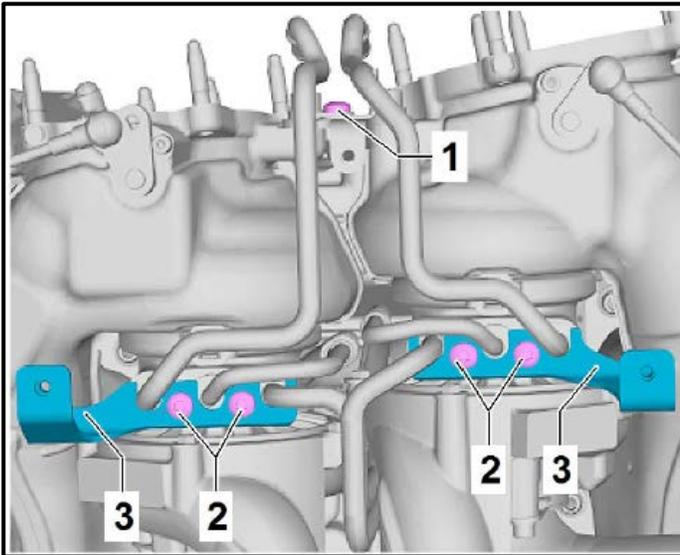
- Install retaining plates and retaining plate brackets <3>.
- Install bolts <1 and 2> and torque to 9 Nm.

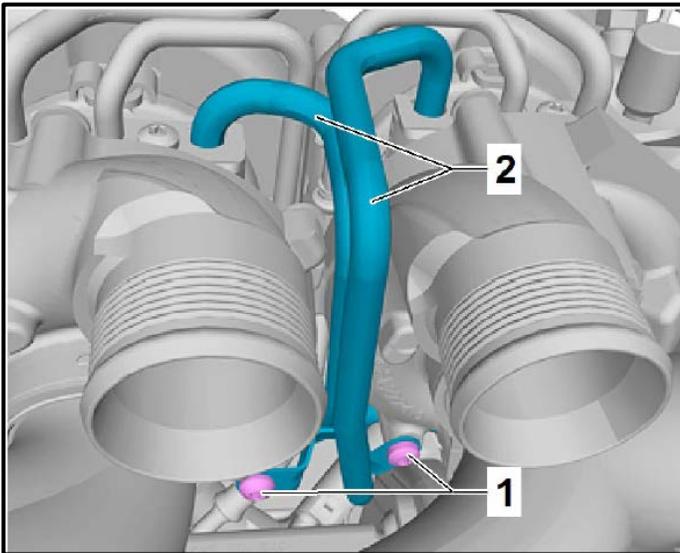
- Install bolts <1> and torque to 9 Nm.
