Technical Service Bulletin

91 Audi connect GEN2: Vehicle Code Entry Fails for Key User with message "Query user list manually"

91 17 34 2045540/4 July 18, 2017. Supersedes Technical Service Bulletin Group 91 number 17-14 dated March 14, 2017 for reasons listed below.

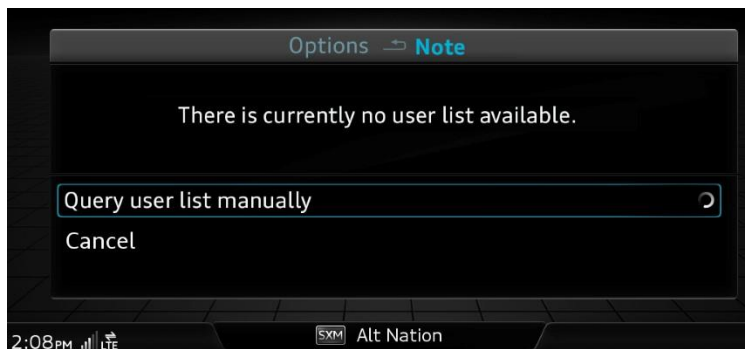
The customer sees the warning message "There is currently no user list available" (Figure 1) when accessing the Audi connect user management screen in the MMI and cannot enter the vehicle code to become key user.

Figure 1. Warning message.

The connected gateway software will need to be updated and in some cases the hardware may need to be replaced. The customer's vehicle code and myAudi user name will need to be used to setup the Key User if the customer is not already Key User. Only replacing the connected data bus on board diagnostic interface, J533 (address word 0019) will not resolve the condition (see repair steps below).

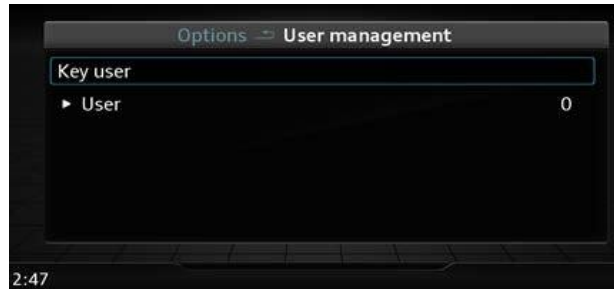
Figure 2. User management menu.

7. Select "Key user" (Figure 2). If the customer's user name is already entered in the MMI then step 7-10 can be skipped. Proceed to step 11.

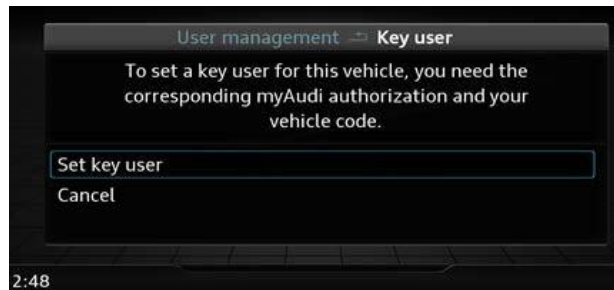
Figure 3. Set key user.

8. Select "Set key user" (Figure 3).

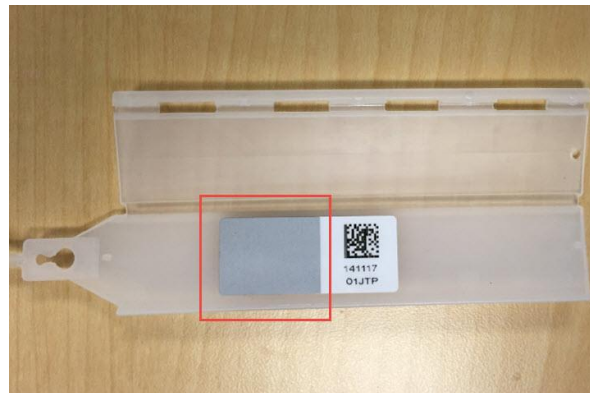
Figure 4. Vehicle code (F-PIN).

9. Enter the customer's vehicle code (Figure 4) and myAudi user name (email address) and select "Log in" (Figure 5). The vehicle code is hidden behind the grey scratch off area. The number listed below the QR Code is the serial number and is only used when contacting Audi connect support. This is not used by the customer.

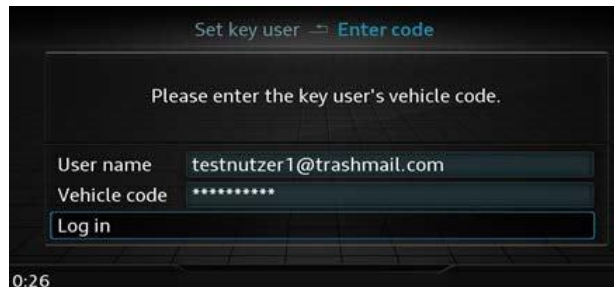
Figure 5. Log in.
