Technical Bulletin

24 17 07 July 18, 2017 2047363 Supersedes Technical Bulletin 24-17-06 (V241706) dated July 14, 2017 to adjust metadata.

Installation Instructions for Fresh Air Line During CCTA-CBFA Intake Manifold Replacement

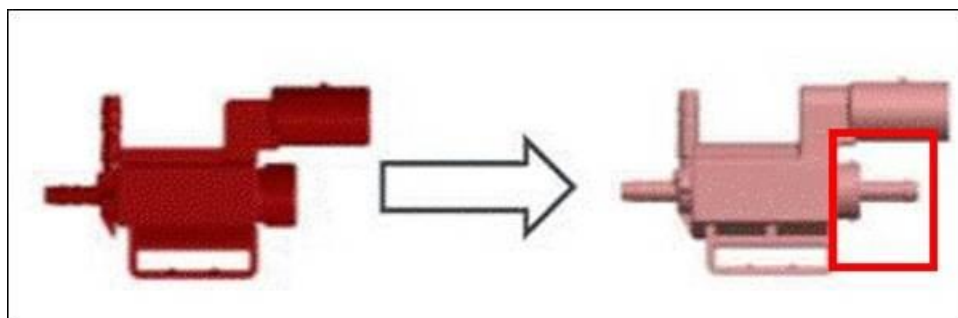
Figure 1.

Replacement intake manifolds for CCTA/CBFA engines have an improved intake manifold flap valve -**N316**. The new -**N316**- valve has 3 hose ports rather than 2 (See Figure 1), requiring a fresh air line be installed during intake manifold replacement. This fresh air line will prevent dirt and debris from contaminating the -**N316**- solenoid.

- Connect the fresh air line to the port below the electrical connector end of the solenoid (rear facing port) (See Figure 1.).
