# Technical Service Bulletin

## 91 Parking assistance provides false warnings

91 17 36 2024323/5 July 26, 2017. Supersedes Technical Service Bulletin Group 91 number 14-72 dated December 19, 2014 for reasons listed below.

Model(s)	Year	VIN Range	Vehicle-Specific Equipment
All	2005 - 2019	All	Not Applicable

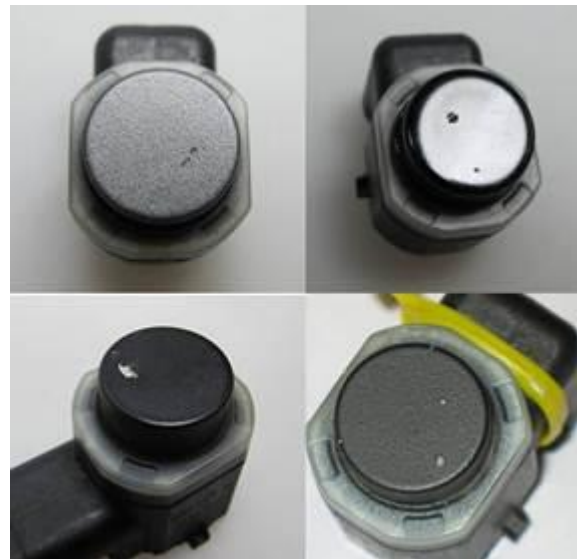
3. Check parking sensors (Figure 3) for obvious issues:

- Mechanical damage (stone chips, scratches).
- Dirt, ice, foreign bodies, foil adhered to sensor.
- Damage to the bumpers that may indicate an accident (or paint indicating a previous incident).

**Figure 3.** Stone chips causing sensor failure.

**Tip:** Exterior damage to the vehicle, including stone chips and scratches, is not covered by Audi Warranty. When painting sensors, the special painting instructions for parking sensors in the paint repair manual must be observed.

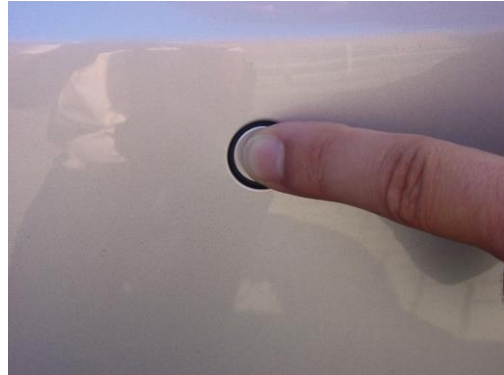
**Figure 4.** A pressure check on a parking aid sensor.

- Bent corners. Any bent-open corners may cause false readings.
  - Correct fit. Oversized license plate holders or frames can obstruct parking aid sensors.
6. Pressure check for a tight fit and correct attachment of the parking sensors (Figure 4). If the sensor is not snug or feels loose, remove the bumper and reinstall the sensor.

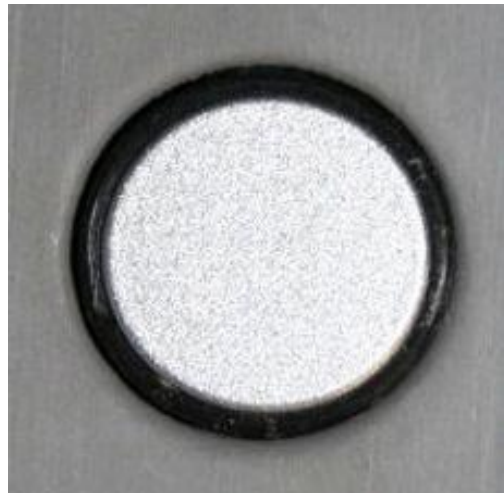
**Figure 5.** A correctly seated decoupling ring.

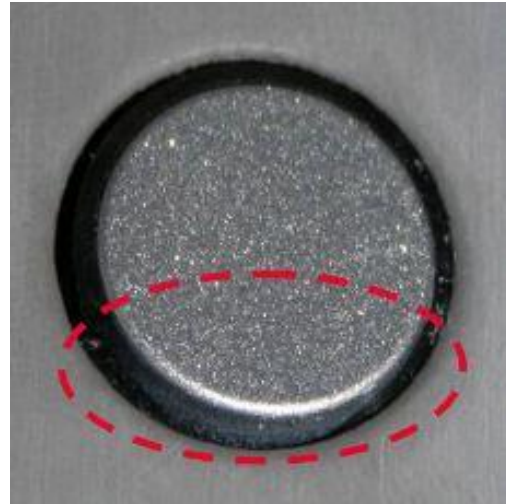
**Figure 6.** An incorrectly seated decoupling ring (bulging).

7. Check that the decoupling ring is correctly seated (Figure 5, Figure 6, and Figure 7). If the ring is folded or bulging, remove the bumper and reinstall the sensor.

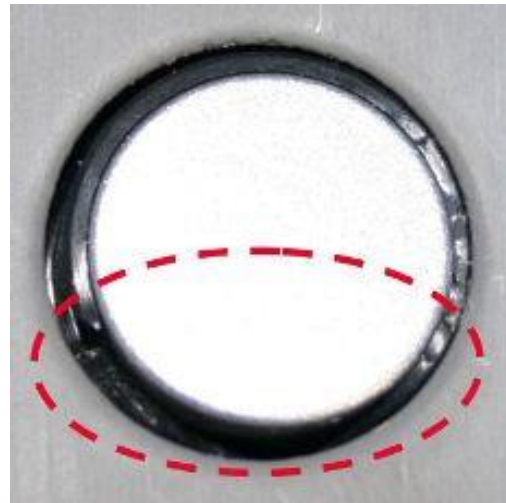
**Figure 7.** An incorrectly seated decoupling ring (folded).

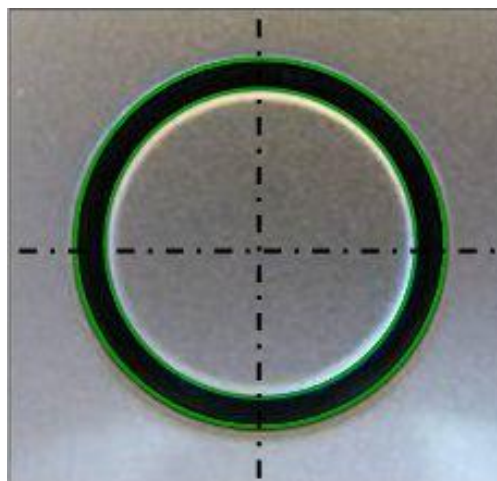
**Figure 8.** A correctly centered parking aid sensor.

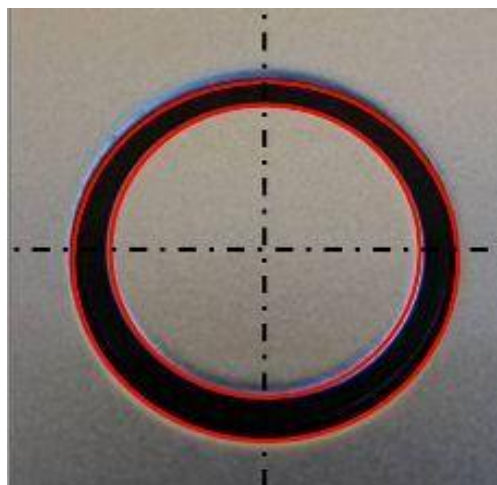
**Figure 9.** An off-center parking aid sensor.

8. Verify that the sensor is centered inside of the mounting hole (Figure 8 and Figure 9). If the sensor is mounted off-center, remove the bumper and reinstall the sensor.

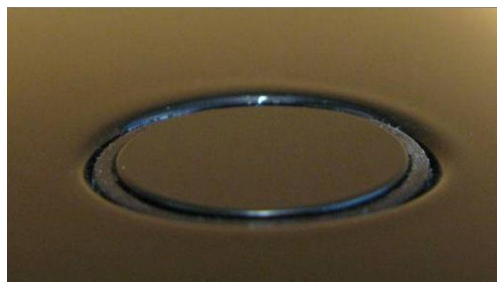
**Figure 10.** A correctly installed parking aid sensor.

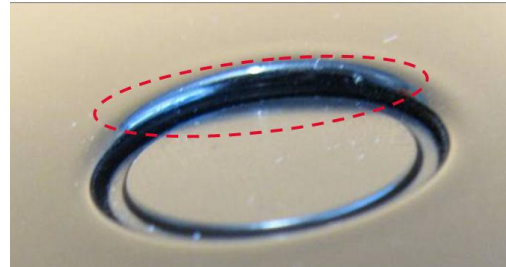
**Figure 11.** A recessed parking aid sensor.

9. Ensure the sensor sits flush with the bumper (Figure 10 and Figure 11). If the sensor is recessed or bulging, remove the bumper and reinstall the sensor.

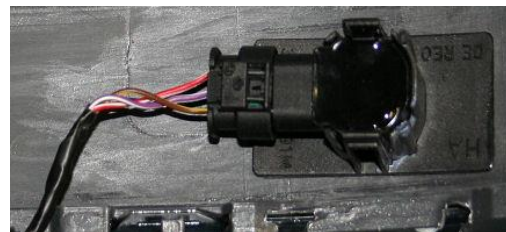
**Figure 12.** A correctly installed cable with sufficient length.

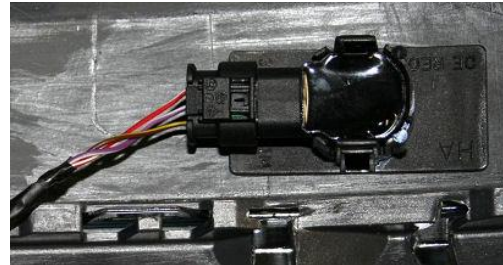
**Figure 13.** A sensor cable with insufficient length.

12. Check the cables in the bumper for damage and sufficient length (Figure 12 and Figure 13). Cables that are too short can cause damage to the harness.
  - If the cable is damaged, repair the cable using VAS Repair Kit 1978.
  - If the cable is too tight, correct the routing by moving the support clip so the cable is no longer under tension.

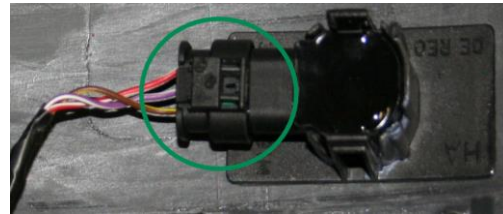
**Figure 14.** A correctly installed parking aid sensor connector.

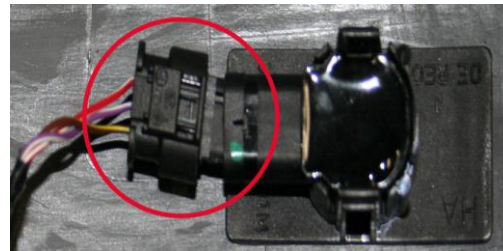
**Figure 15.** A parking aid sensor connector that is not seated correctly.

13. Check the connectors on the parking sensors and the socket box for correct installation (Figure 14 and Figure 15). If the connectors are not installed properly, reinstall.
