# Technical Service Bulletin

## 91 MIB2 Software Update Instructions

91 17 37 2047576/1 July 27, 2017.

Model(s)	Year	VIN Range	Vehicle-Specific Equipment
All	2016 - 2020	All	MIB2 with Navigation plus

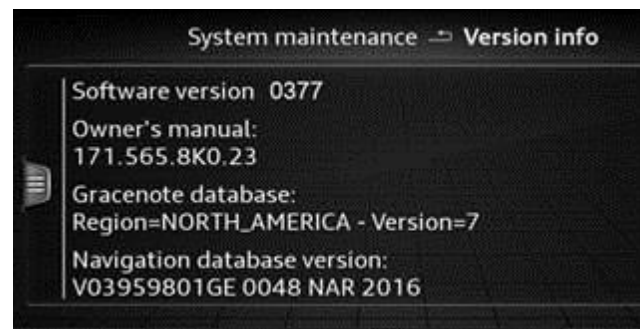
**Figure 1.** MIB2 Software Version in MMI with new UI.

1. To save time, always verify the customer's MMI requires the software update before proceeding. In the MMI, go to *Menu >> Settings >> Left drawer option >> Version Information* (Figure 1). This applies to models using the new MIB2 user interface. The C7 PA uses the old user interface similar to MMI3G+ along with the newer MIB2 hardware. The software version for the older user interface is found under *Menu >> Setup MMI >> Version Information*.
