Technical Service Bulletin

91 Audi connect myAudi pin not saved for stored online destinations

91 17 38 2047433/2 July 27, 2017. Supersedes Technical Service Bulletin Group 91 number 17-23 dated April 11, 2017 for reasons listed below.

Model(s)	Year	VIN Range	Vehicle-Specific Equipment
A6, A7	2016 – 2017	All	MIB2 High Navigation

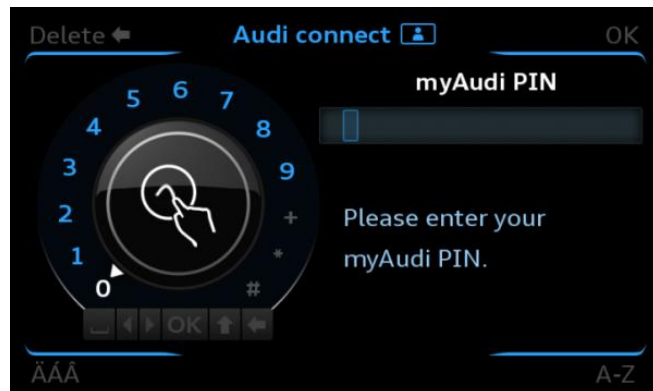
The vehicle is a MY2016 or MY2017 A6, A7, S6, S7, or RS 7 and the customer states that when retrieving the stored myAudi online destinations, the myAudi PIN (Figure 1) is not saved and must be entered each time after the vehicle has been switched off for a long period of time. Additionally, the customer's vehicle is equipped with MMI Navigation plus (MIB2 High Nav; PR code "7UG").

Figure 1. myAudi Pin entry screen.

The condition is the result of an MMI software bug and can be fixed by updating the MMI software. The software bug only prevents the myAudi PIN from being stored in the navigation area of the MMI menu. The myAudi pin is saved in the Audi connect menu for accessing custom news feeds.

The service solution is to update the MMI software to SW1062 for MY16 and SW0924 for MY17 to fix the myAudi PIN issue.

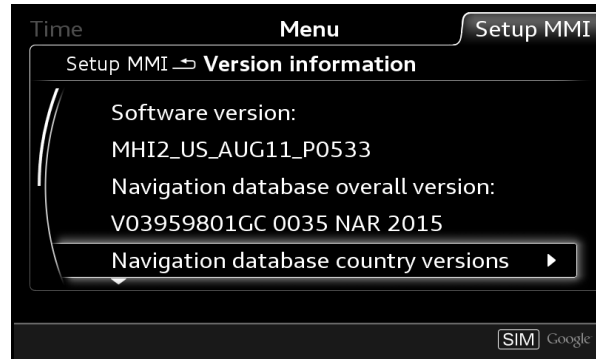
Figure 2. MMI Version Information.

1. Verify the customer's MMI requires the software update by going to the *Main Menu >> Setup MMI >> Version Information* (Figure 2).
