Technical Service Bulletin

17 Increased oil consumption or sporadic blue smoke, R8 with S tronic transmission

17 17 87 2048564/1 August 8, 2017.

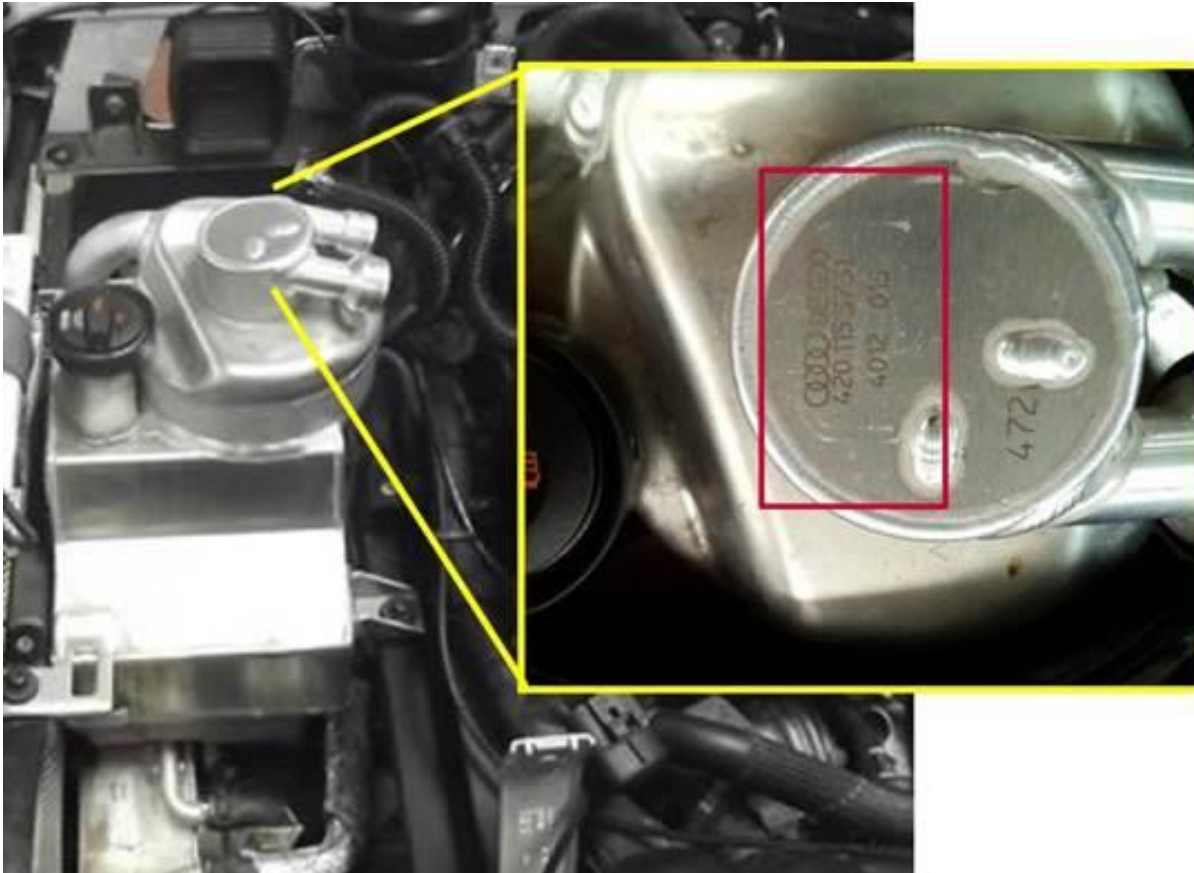
A quality-deviation of internal coarse oil separator in the engine oil reservoir can cause an internal oil leak in to the crankcase ventilation system.

1. Check the part number of the engine oil reservoir, the affected part number is 420 115 373 L with version 01S.

Figure 1. Part number 420 115 373 L with version 01S.

2. If the customer concern is confirmed and the affected part number is fitted, replace the engine oil reservoir after opening a TAC contact and attaching the GFF log and video of the smoking on cold start.
3. Follow instructions in Elsa to complete the repair at Repair Manual, *Engine >> Engine Mechanical, Fuel Injection and Ignition >> 17 Lubrication >> Oil Check Valves and Spray Nozzle Valve, Oil Filter Housing, Oil Cooler >> Oil Reservoir, Removing and Installing >> Oil Reservoir, Removing and Installing, Vehicles with S tronic Transmission 0BZ.*
