Technical Service Bulletin

96E6 UPDATE – Q7 Update Package Traffic Sign, Unable to Start and Service Msg (NVLW)

August 22, 2017

Model(s)	Year	VIN Range	Vehicle-Specific Equipment
Audi Q7	2017	See Elsa	None

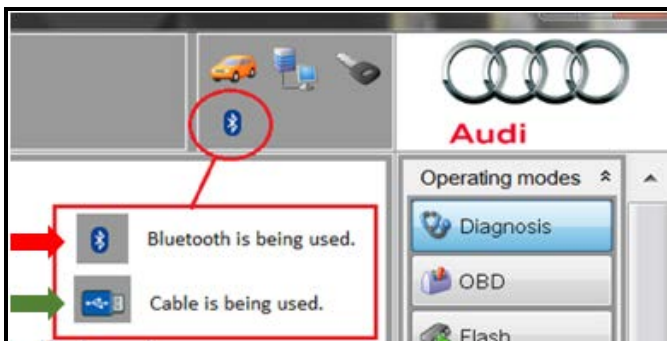
1. Follow all instructions in TSB 2011732: *00 Software Version Management (SVM), operating instructions* and TSB 2047812: *SD Creator: How to setup and use the SD Creator for obtaining vehicle software updates via the MirrorServer.*
2. Attach an appropriate battery charger to the vehicle.
3. Attach the scan tool to the vehicle using an USB cable.
4. Confirm that the scan tool is communicating with the diagnostic head by USB <Green Arrow>. If the Bluetooth symbol is shown <Red Arrow> then disconnect the diagnostic head from the vehicle and then reattach the USB cable to the diagnostic head and then reattach to the vehicle.

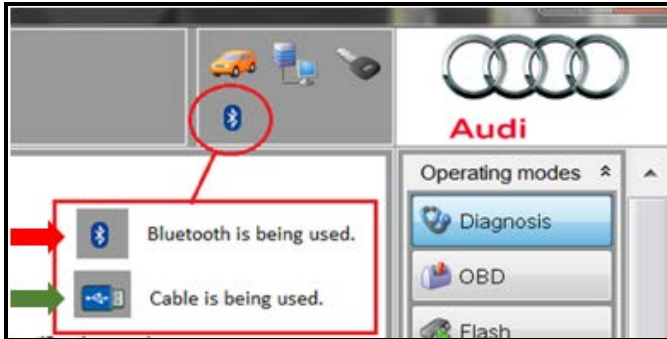
4. Confirm that the scan tool is communicating with the diagnostic head by USB <Green Arrow>. If the Bluetooth symbol is shown <Red Arrow> then disconnect the diagnostic head from the vehicle and then reattach the USB cable to the diagnostic head and then reattach to the vehicle.
