Technical Service Bulletin

9106 UPDATE – Q7 Update Package MMI, Steering Column and Sunroof (NVLW)

August 22, 2017

Model(s)	Year	VIN Range	Vehicle-Specific Equipment
Audi Q7	2017	See Campaign/Action screen in Elsa	None

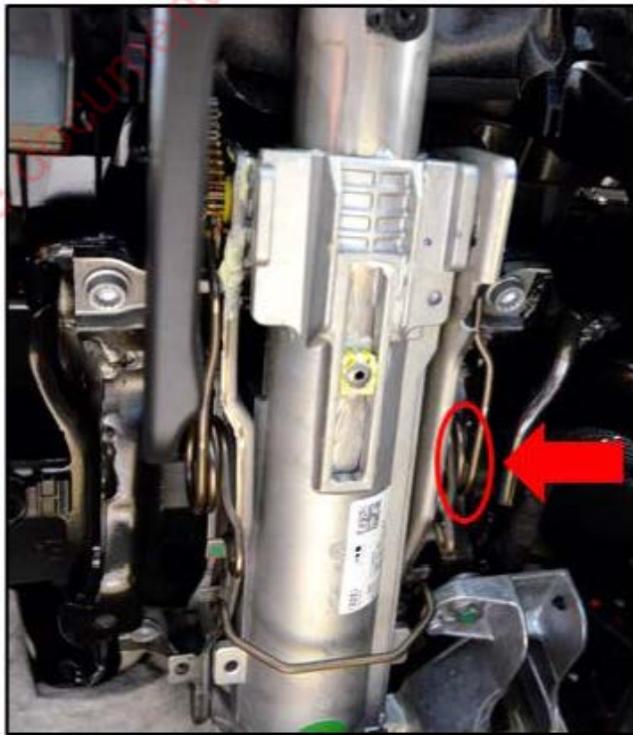
The securing cable is attached to the weight balancing springs on the right side of the steering column <arrow>.

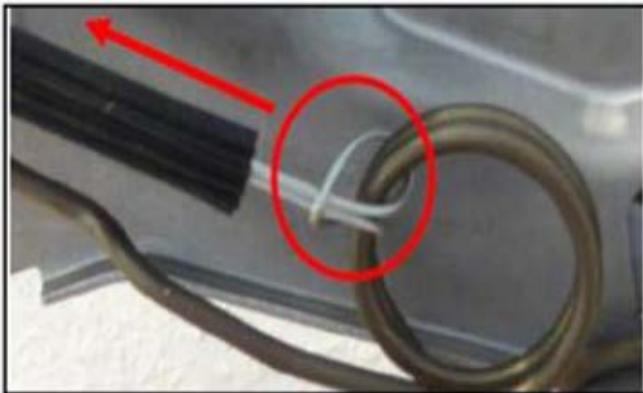
Securing cable loop on coil of weight balancing spring must face towards steering wheel.

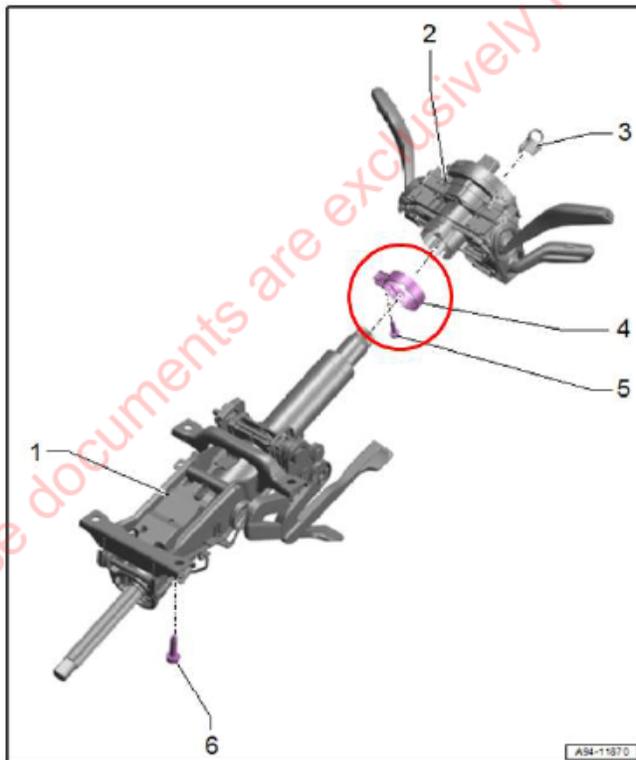
The adjustment range of the steering wheel may be reduced if the securing cable is too loose.

8. Feed the free loop around thread of securing bolt on steering column switch module <5> and secure hand tight using hexagon nut from repair kit 4M0 498 085 to prevent it from sliding down.

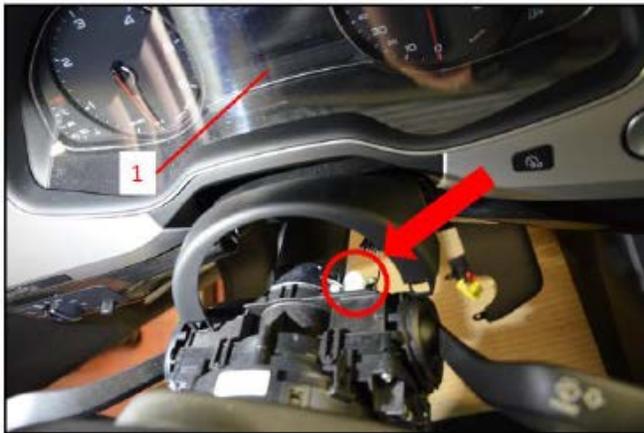
Bolt is located at position marked by <arrow> adjacent to instrument cluster <1>.

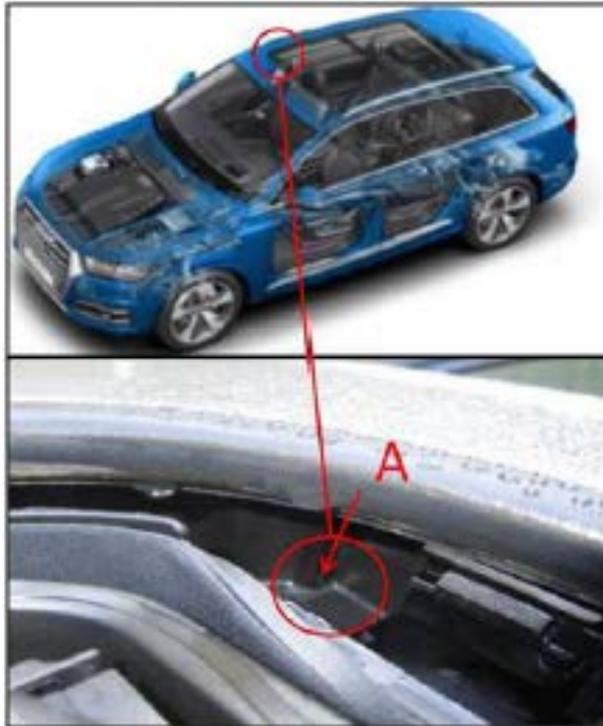
1. Check water drain channel at position <A> (Front right only) for cracking.

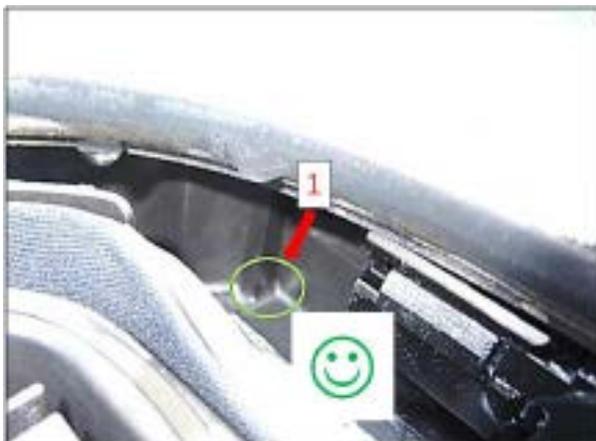
2. Press wind deflector downwards and check for cracks.
 - a. If no cracks are present no further steps required.
 - b. If cracks are present perform the following steps.
