# Technical Service Bulletin

## 50D2 UPDATE – Repairing suspension turret (NVLW)

August 29, 2017

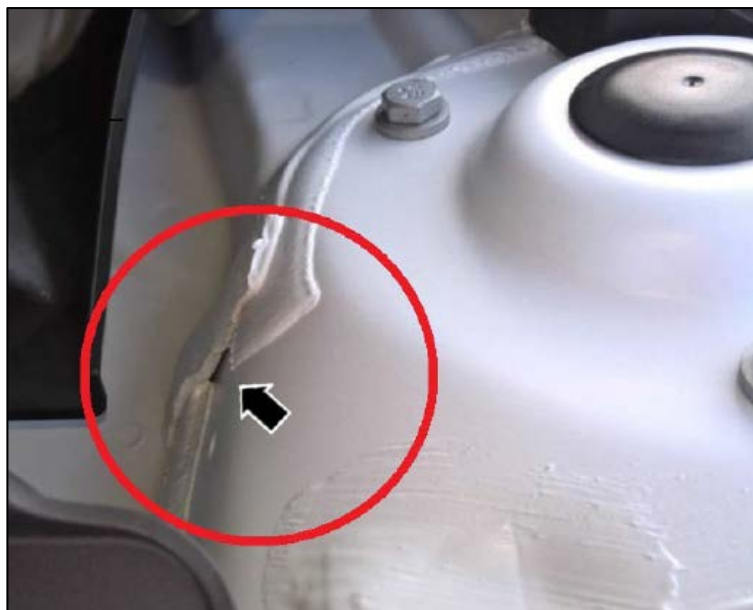
On Audi A3 vehicles manufactured within a specific period, a sealing seam was positioned incorrectly during production. This may result in corrosion damage on the right suspension turret.

- Check sealing seam <arrow> on suspension turret (right-side).
- The seam must be re-worked if it is not fully sealed.
