# Technical Service Bulletin

## 28H3 UPDATE – Quality Package (NVLW)

August 29, 2017

Quality improvement measures must be performed on Audi A4 vehicles manufactured within a specific period.

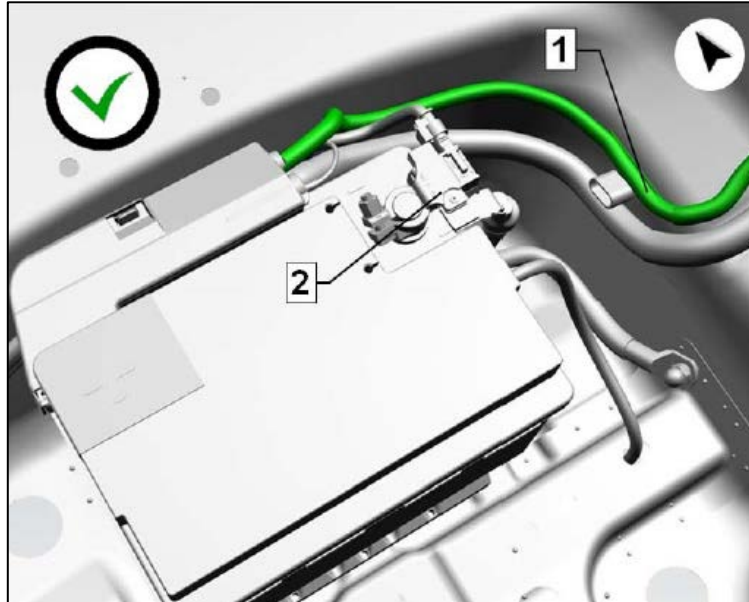
- Switch off the ignition.
- Lift the luggage compartment floor cover.
- If equipped, remove the spare tire and vehicle tool kit mount.
- Check that Electromechanical Power Steering (EPS) cable <1> is routed correctly and examine it for damage.
  - Battery terminal clamp <2> must face to right.
- If the cable is routed correctly, no further work is required.

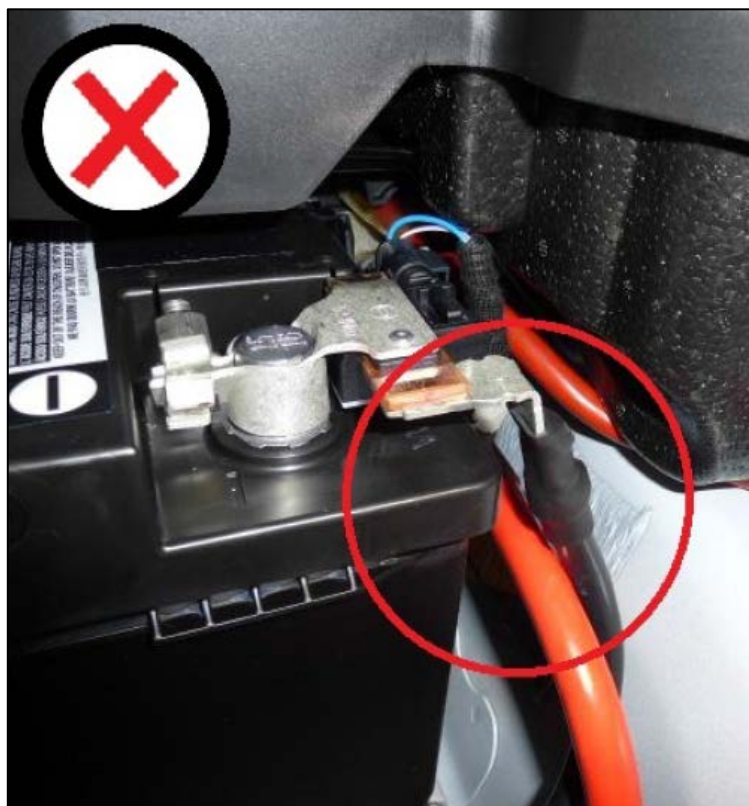
- The cable routing shown is not correct.
  - Positive cables must not be routed between the earth cable and the battery.
  - The battery terminal clamp must not face the front.
- If the cable is not routed correctly, continue with **Modifying wiring harness**.

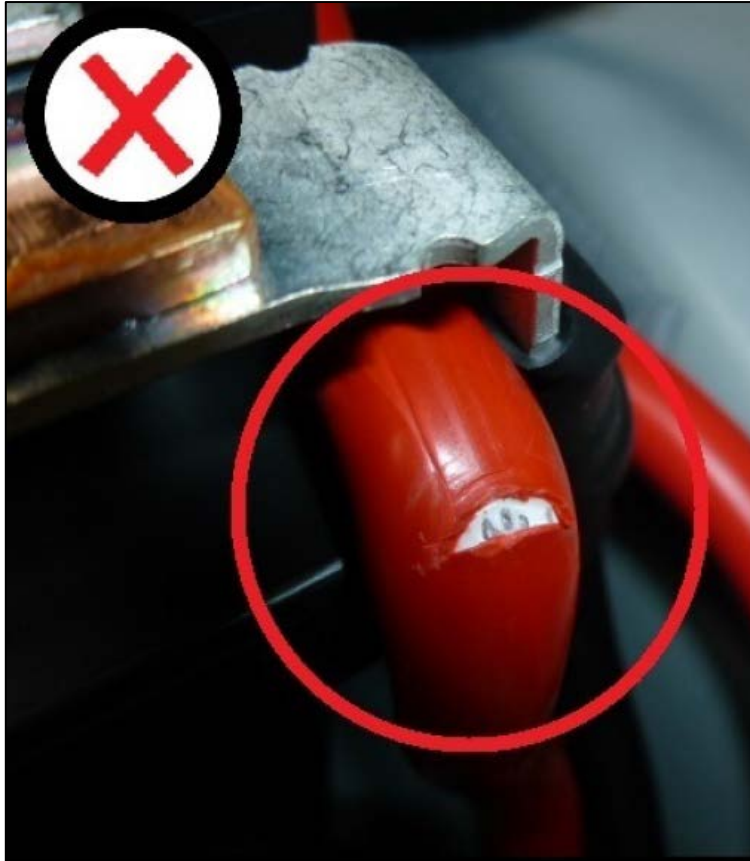
- The cable condition shown is not correct.
  - The insulation of the EPS cable must be repaired if it is damaged.
- 
- If the EPS cable is damaged, continue with **Repairing wiring harness**.

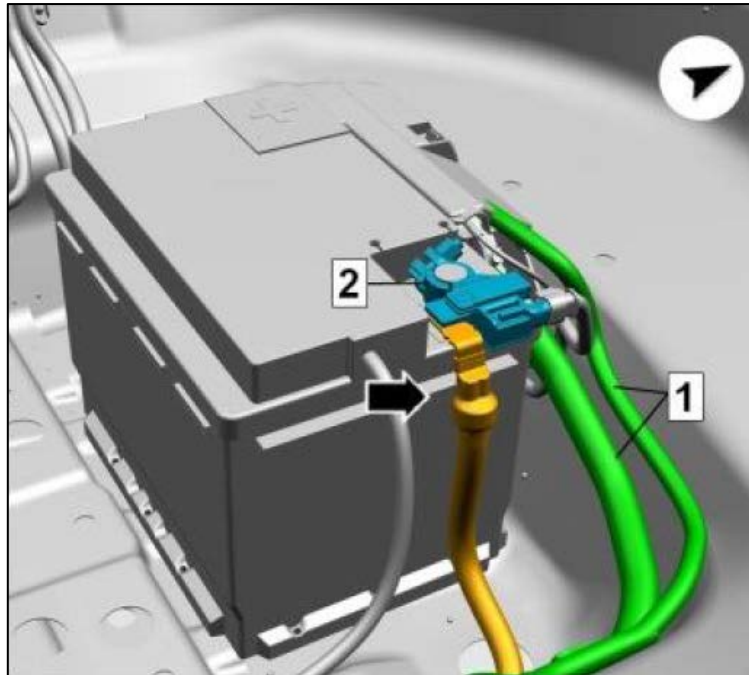
- The positive cables <1> must not be routed between the earth cable and the battery <arrow>.
- Electrical wiring <1> must not be trapped under battery terminal clamp <2>.
- Battery terminal clamp <2> must face to right.

If the EPS cable is damaged, continue with **Repairing wiring harness**.

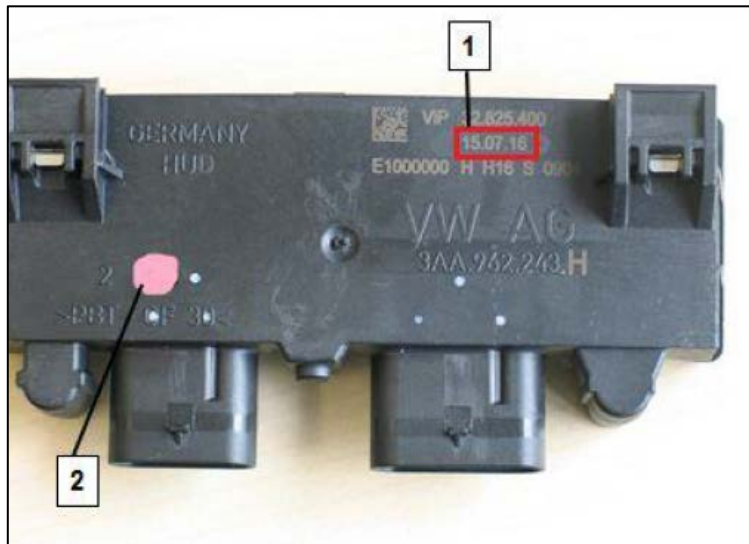
- The control unit <1> must be replaced if it was manufactured within the following period:  
**11.08.2016 to 22.09.2016.**

Control units that have already been modified are marked with a colored dot <2>.
