96 Lane Change Assist inop, Audi pre sense warning in instrument cluster

96 17 18 2048470/1 August 4, 2017.

Model(s)	Year	VIN Range	Vehicle-Specific Equipment
Q5	2018	All	With Audi pre sense

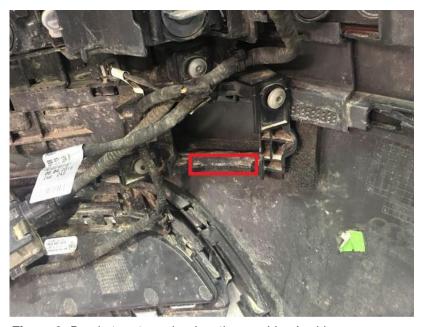
Figure 2. Bracket part number location on driver's side.

Before removing the bumper, check the bracket part numbers (Figure 2 and 3). If they are not part numbers 80A 907 908 B and 80A 907 907 B then proceed with the instructions below.

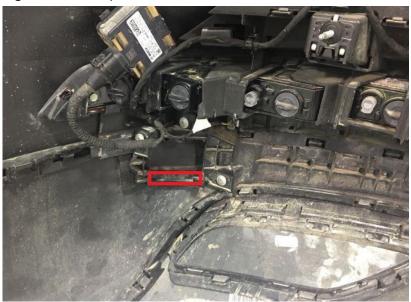
Figure 3. Bracket part number location on passenger's side.

2. Unclip the modules and remove the brackets. In order to access to the passenger side bracket the bumper needs to be partially detached on the right side. See Elsa for bumper removal steps, only follow for right side.

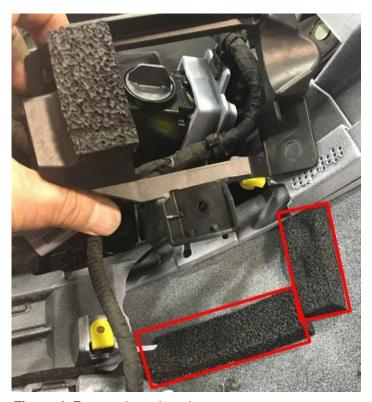
The fault most likely was caused by the improper installation of foam which interferes with the sensor's field of view.

Figure 4. Foam to be stripped out.

3. Strip out any foam that is glued to the bumper (Figure 4) marked in the red areas (Figure 5).

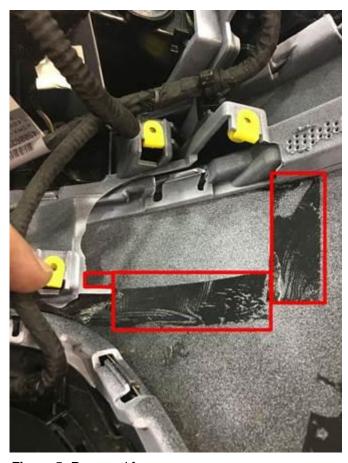
Figure 5. Removed foam.

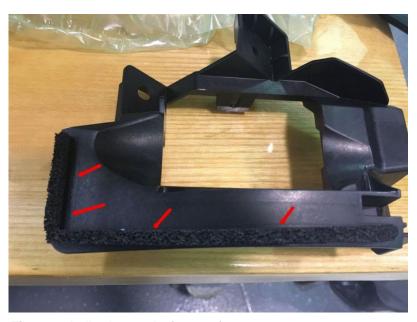
Figure 6. Indication marks for new foam.

Prepare the new brackets 80A 907 908 B and 80A 907 907 B by applying the foam strips 80A 807 549.

The brackets have indication marks to help positioning the foam (Figure 6).
