Technical Service Bulletin

91 MMI connect smartphone app warning messages do not refresh information or remote lock and unlock fails

91 17 47 2044853/3 August 31, 2017. Supersedes Technical Service Bulletin Group 91 number 17-15 dated March 14, 2017 for reasons listed below.

Model(s)	Year	VIN Range	Vehicle-Specific Equipment
A4, Q7	2017 - 2019	All	With Audi connect
A5, Q5	2018 - 2019	All	With Audi connect

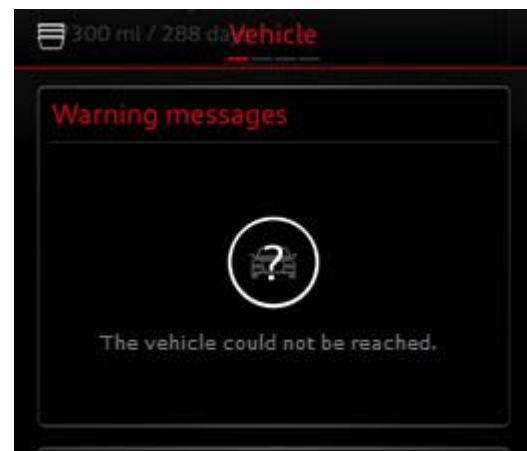
- The function "Warning messages" does not provide new data when the user manually attempts to refresh the data. An error message stating "The vehicle cannot be reached" can be seen in the app and the myAudi web site (Figure 1).
- The vehicle cannot be locked or unlocked with the app, and an error message stating "A technical error occurred" is displayed (Figure 2).

Figure 1. Warning messages cannot be refreshed.

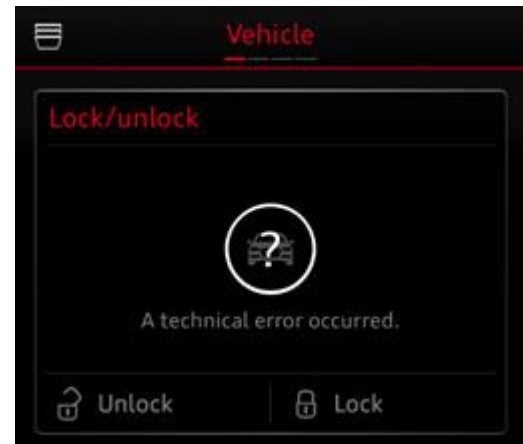
Figure 2. Lock/unlock error.

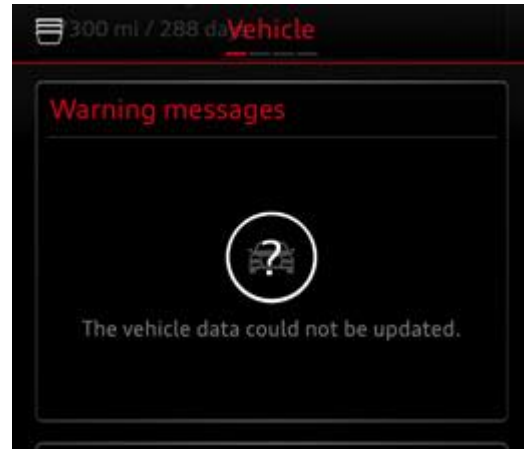
Tip: Not all errors in the MMI connect app indicate a problem. For example, the message “The vehicle data could not be updated” is displayed when the engine is on or when the vehicle is being driven, as data is not refreshed under these conditions (Figure 3).

Figure 3. Normal condition warning message.

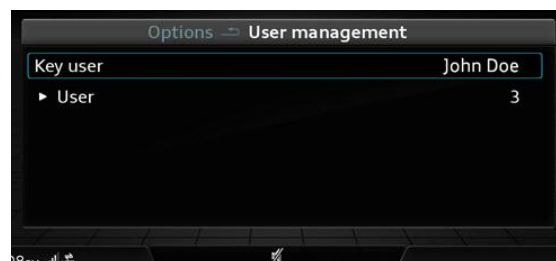
- Ensure that the plastic key tag, with the vehicle code scratched off, is available (check the glovebox).
1. Verify the customer’s name is showing as an active Key User of the vehicle. In the MMI, navigate to *MENU >> Audi connect*, then the right option and choose *Audi connect user management*. If the customer is a Key User, his or her myAudi registered name will be listed (Figure 4).

Figure 4. Key User assigned with three secondary users.
