Technical Service Bulletin

91 Audi connect not working with service list missing services after PDI for MY2018

91 17 46 2048436/2 August 31, 2017. Supersedes Technical Service Bulletin Group 91 number 17-35 dated July 24, 2017 for reasons listed below.

Model(s)	Year	VIN Range	Vehicle-Specific Equipment
A3, A4, S4, A5, S5 Cabriolet, Q5, and Q7	2018	All	With MMI Navigation plus

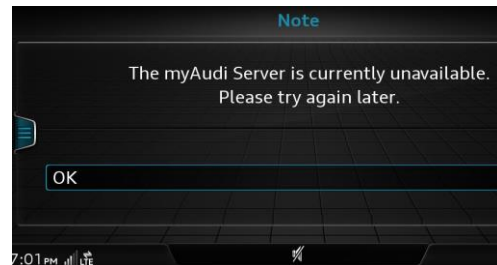
After PDI is performed, the customer states that the Audi connect services are not functioning. There is an error of “The myAudi Server is currently unavailable. Please try again later” along with an active LTE connection including data bars over the “LTE” symbol (Figure 1).

Figure 1. Audi connect error in MMI.

However, there is a known MMI software concern that prevents the MMI from being able to reach the Audi connect backend server after the car is taken out of transport mode. A work around is available to fully re-enable the Audi connect services (service section).

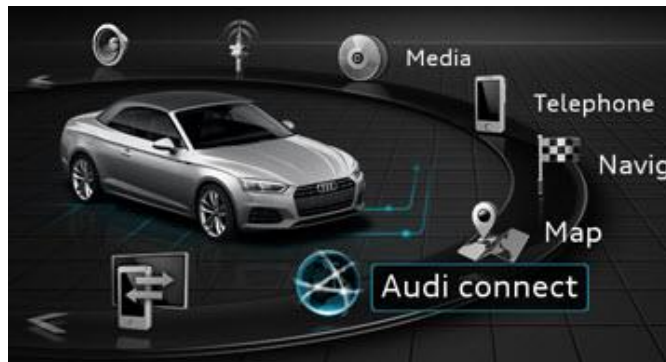
Figure 2. Audi connect in main menu.

1. Check the MMI in the glovebox, and if a removable SIM card is inserted then remove it. The USA market does not use removable SIM cards for MIB2 with embedded SIM. If a removable SIM card is inserted it can prevent the MMI from being able to use Audi connect services.
2. Press the **"MENU"** button and select **"Audi connect"** from the main MMI Menu (Figure 2).

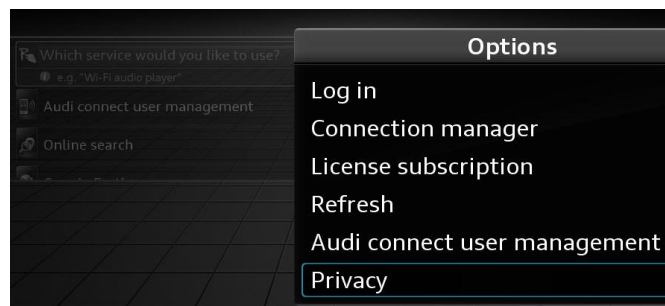
Figure 3. Right sub-men option, "Privacy".

3. Use the Right Drawer Sub-menu (Move the Main MMI Knob to the right) and select **"Privacy"** (Figure 3).

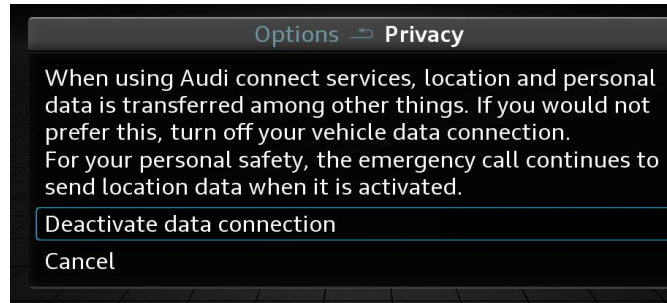
Figure 4. Deactivate data connection.

- Next select **"Deactivate data connection"** (Figure 4).

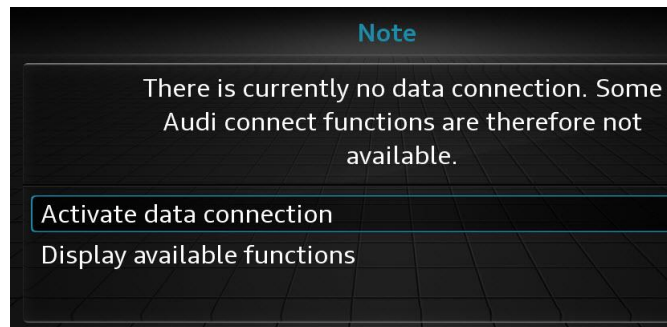
Figure 5. Activate data connection.

- The MMI will now show a message of **"The data connection was restricted"** and the MMI should automatically revert back to the main menu.
- Next select **"Audi connect"**, then select **"Activate data connection"** (Figure 5).

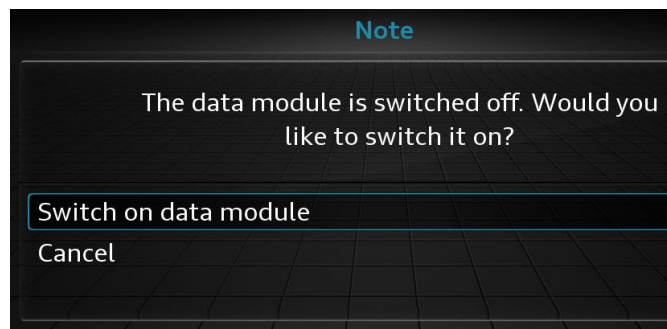
Figure 6. Switch on data module.

- Next select **"Switch on data module"**. This will turn on the LTE data module (Figure 6).
