Technical Service Bulletin

87 Faint noise heard in cabin from air conditioning circuit

87 17 81 2044717/4 August 16, 2017. Supersedes Technical Service Bulletin Group 87 number 17-80 dated January 26, 2017 for reasons listed below.

Model(s)	Year	VIN Range	Vehicle-Specific Equipment
A6, A7	2012 - 2015	All	2.0L or 3.0L gas engine

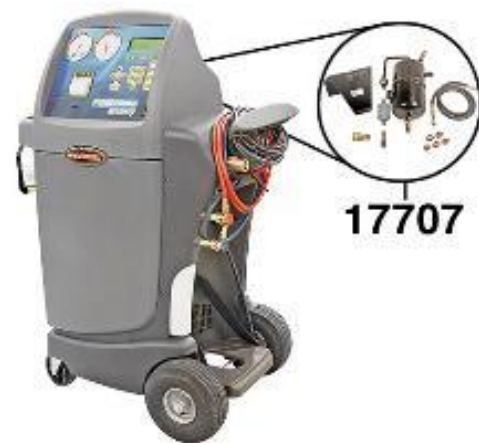
Figure 1. A/C flushing unit.

1. Perform a complete recovery and flush of the air conditioning refrigerant circuit (Figure 1 and Figure 2).

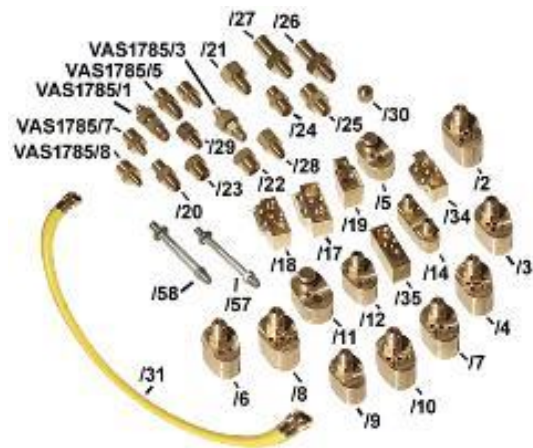
Figure 2. Flushing fitting set.

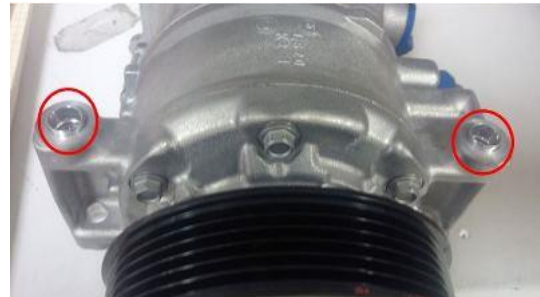
It is imperative that the compressor mounting bolt centering sleeves be reinstalled with the compressor (Figure 3). Failure to reinstall these sleeves will result in compressor failure (as well as possible engine and/or ancillary component damage) in a short period of time. If any sleeves were misplaced during the removal and reinstallation process, new sleeves should be ordered and installed on the compressor housing before reassembly. Compressor or consequential component damage resulting from a failure to install the centering sleeves will not be accepted under warranty.

Figure 3. Mounting bolt centering sleeves on the air conditioning compressor housing.

2. Remove the air conditioning compressor, empty the compressor of the PAG oil completely, then reinstall it to the vehicle. The compressor does not need to be replaced.

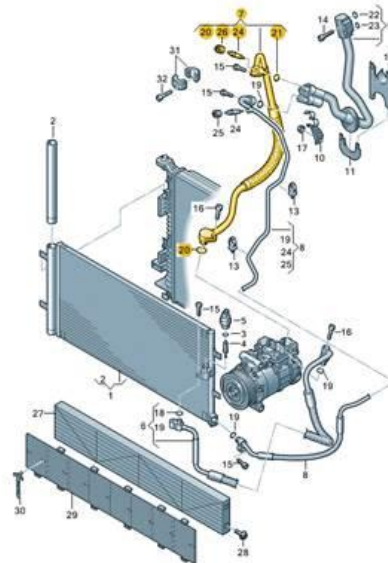
Figure 4. Low side line to be replaced.

3. Replace the low side refrigerant line that connects the air conditioning compressor suction port to the hybrid refrigerant line to the expansion valve (Figure 4). Be certain to use new O-rings at these and all refrigerant circuit joints that are disconnected.

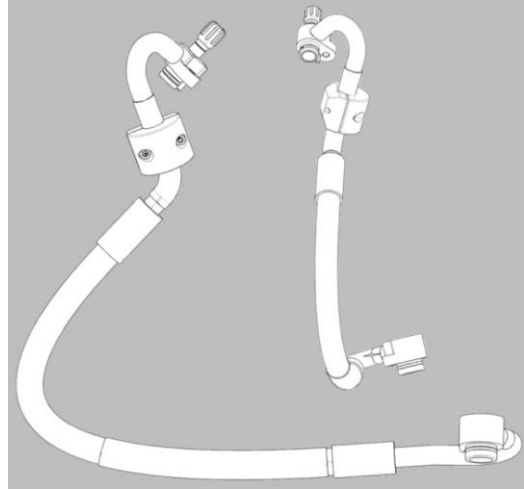
Figure 5. Balance weight position on low side line.

4. Install the balance weight (part number 4G0513621A) to the line in the position shown in the illustration (Figure 5).
