# Technical Service Bulletin

## 66 Servicing rear spoiler drive unit

66 17 62 2038477/3 August 17, 2017. Supersedes Technical Service Bulletin Group 66 number 16-56 dated August 2, 2016 for reasons listed below.

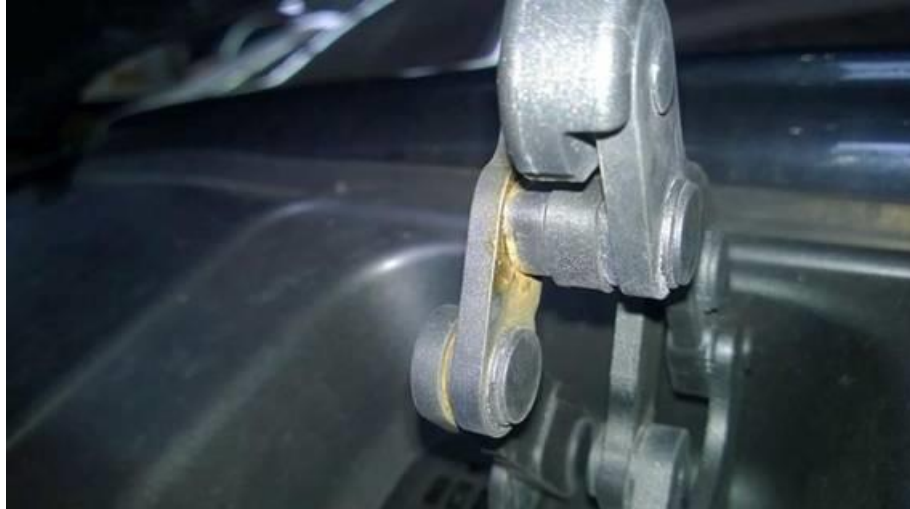
The rear spoiler operation can be restricted due to corrosion in the spoiler drive unit. As a result, the rear spoiler becomes stiff and does not reach its end points. This may cause a rear spoiler error light to be illuminated.

1. Check for corrosion on the spoiler drive unit hinge (Figure 1).

**Figure 1.** Corrosion on the spoiler drive unit hinge.

2. If corrosion in the drive unit hinge is found to be the cause of the function restriction, the hinges can be lubricated using special lubricant G 052172A1 (Figure 2).

Move the spoiler mechanism outward to expose the hinges and apply the special lubricant. Run the spoiler in and out several times to distribute the lubricant thoroughly into all of the hinge components.
