Technical Service Bulletin

91 MMI 3G+ MMI inop; blank screen at startup; various technical issues (K0942 ZUG update; supersedes K0814 update)

91 17 45 2030465/11 August 22, 2017. Supersedes Technical Service Bulletin Group 91 number 16-67 dated August 18, 2016 for reasons listed below.

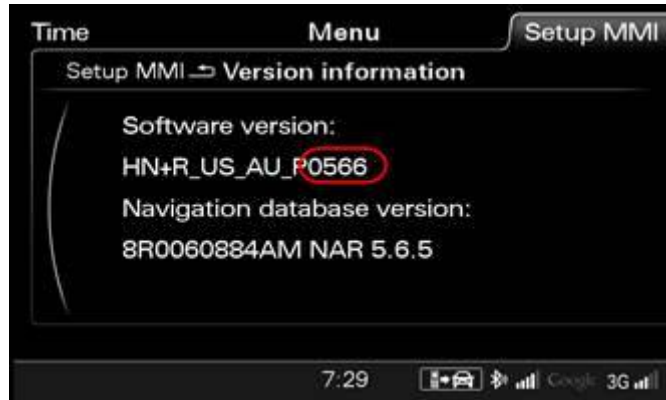
Tip: The MMI software version can be found under *Menu >> Setup MMI >> Version Information*. The software version will show the 4-digit software version number with a “P” or “K” prefix (“P” for Production and “K” for Service”) (Figure 1).

Figure 1. Example showing MMI software version (0566).

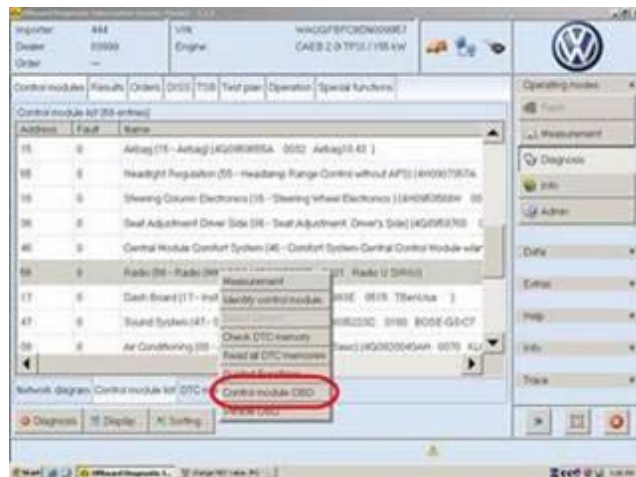
Figure 2. Radio self-diagnosis.

2. Using ODIS, right-click on 56 – *Radio* in the Control module list, and select *Control Module OBD* (Figure 2).

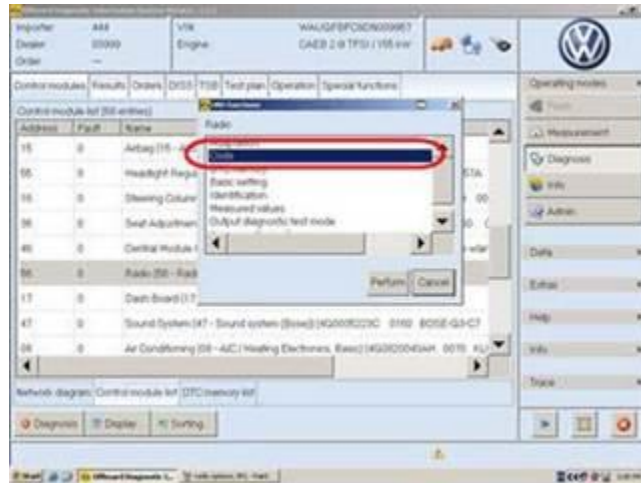
Figure 3. Code radio option.

3. Select Code (Figure 3).

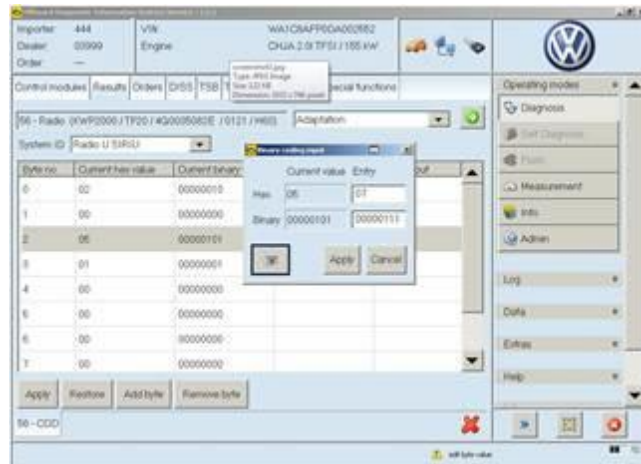
Figure 4. Changed radio coding.

4. Verify the coding in byte 2 is HEX 07.

- If it is not HEX 07, change the coding to HEX 07. Apply changes (Figure 4).

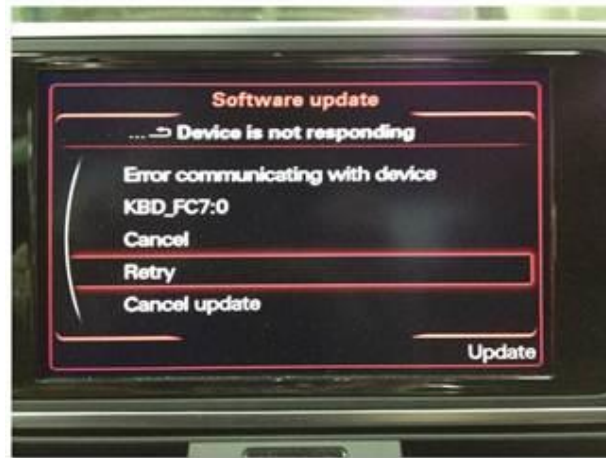
Figure 6. A device requiring a 'Cancel' selection.

Some earlier model year 2012 vehicles, or vehicles equipped with Bose® sound systems may experience certain modules that will not update properly during Step 16 of TSB 2028141. If this should occur, either choose 'Cancel' (Figure 6), or 'Skip device' (Figure 7), depending on the type of error. Do *not* choose 'Cancel update', as this may cause the software update to fail entirely. After the update is finished and the summary page is shown, select 'Retry' at the bottom of the list if it is available to attempt to update the modules again. If 'Retry' is greyed out, then the software update was successful. Select 'Continue' to proceed. In some cases 'Retry' may have to be repeated two or three times to get all modules to update successfully.

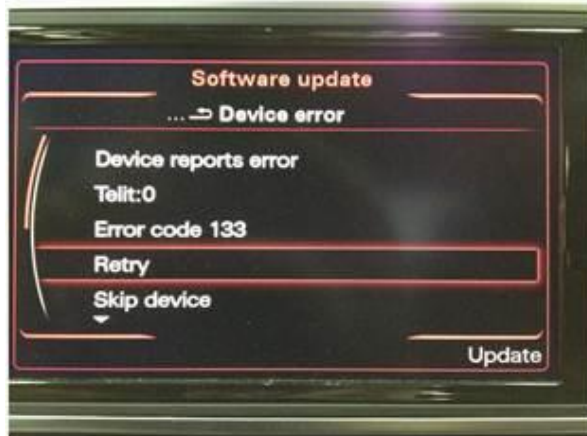
Figure 7. A device requiring a 'Skip device' selection.

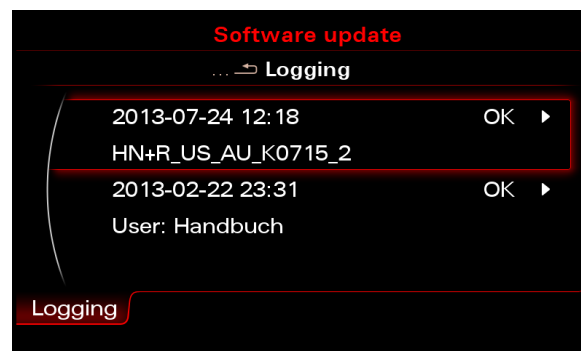
Figure 8. Software update log showing a successful software installation.

- Verify that the software update has been completed successfully by accessing the logging page (Figure 8). To access this screen, proceed to step 8 in TSB 2028141 and press the lower left softkey. A successful update will show the date the update was performed and the software that was installed (HN+R_US_AU_K0715_X), with 'OK' listed on the right (example 0715 installation). The 'X' may be one of several different numbers. If K0715_X does not have any rows with 'OK', the update must be retried

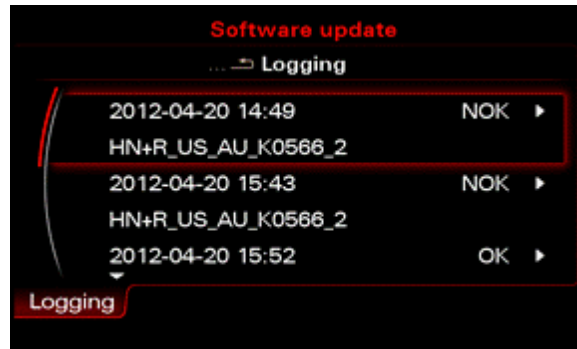
Figure 9. Software update log showing 2 failed attempts before a successful installation.

Tip: If the update must be performed two or more times due to modules not updating correctly, a screenshot of the software update log is required (Figure 9). This should be kept on-hand for warranty auditing purposes. To take a screenshot, insert an SD Card into slot 1. For A6/A7/A8/Q7, press and hold the left and right arrow keys at the same time. For A4/A5/Q5, press and hold the bottom two softkeys at the same time. All 4 softkeys will flash when the screenshot is taken. A screenshot should be taken of each page in the logging display.
