60 17 01 February 6, 2017 **2045403** Supersedes Technical Bulletin V601608 dated December 6, 2016 to updated title with applicable model clarification. Clarify definition of a Panoramic Sunroof, updated VIN range and update application of additional foil patches.

Water leak from the Sunroof (Panoramic Roof) on Golf and GTI models

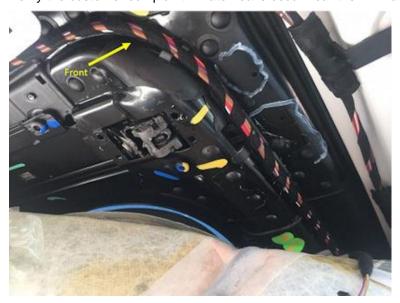
Verify the customer complaint. Water leaks occur near the A-Pillars in the corners of the sunroof water channel.

Figure 1 (Water leaking through corner of water channel)

Some of the plastic rivets/buttons may be missing from the steel reinforcement plate as illustrated by the white outline in Figure 1. This will not affect the structure of the water channel. <u>DO NOT</u> attempt to repair or seal the openings caused by the missing rivets.

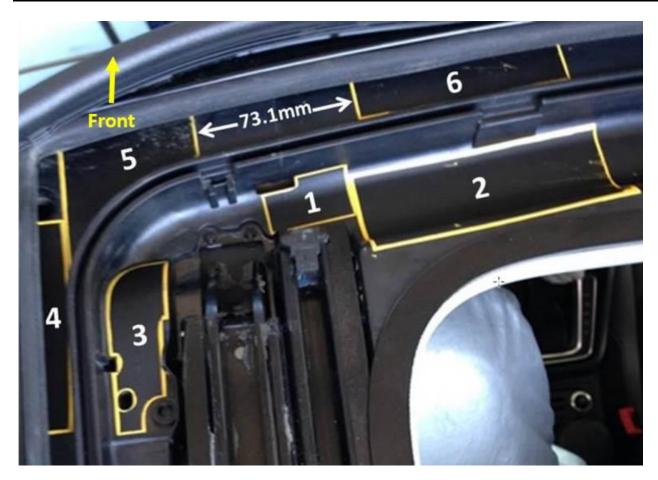
Inspect the sunroof water channel for stress cracks (see figure 2). There are a total of 12 areas to inspect for cracks which are outlined in Figure 3 below. (More than 1 crack may be found).

Figure 3 (Inspections zones for stress cracks / application zones and sequence for foil application)

Left side shown in figure 3 above. Please note foil patches are applied to the right side in the same application zones and sequence.

A difference in the expansion rate between the plastic water channel and steel reinforcement plates may cause stress cracks to occur at the edges of the reinforcement plates.

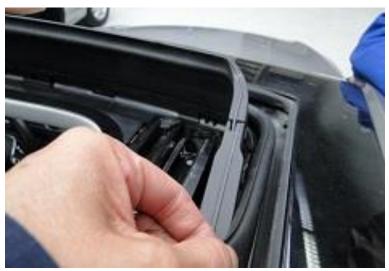
Figure 5 (Inner Sunroof Seal)

Figure 6 (Inner sunroof seal draped over sunroof glass)

2. Remove the inner sunroof seal from around the front of the sunroof opening and lay it back over the sunroof glass (See figures 5 and 6).

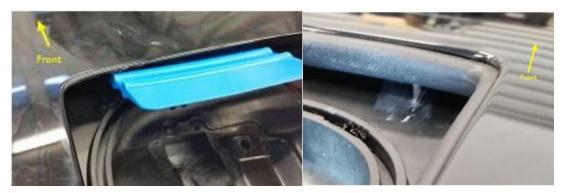
Figures 12 and 13 (Spread sealant working from sunroof opening to underneath the trim panel. Sealant should fill crack and there should be no excess sealant on the water channel.)

- 8. Using the squeegee supplied with the repair kit, spread the sealant pushing it underneath the trim panel from the inside edge of the roof opening to completely cover the crack.
- 9. Remove all excess sealant from the water channel. There must not be any excess sealant that may prevent the foils from being applied completely flat to the water channel. The crack should be filled with sealant with no excess sealant around the crack (See figures 12 and 13).

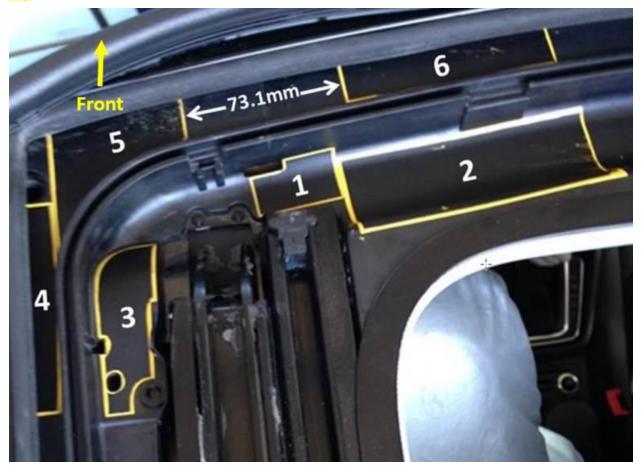
Figure 14 Foil application sequence (Both sides of water channel).

12. Apply the foil tapes one at a time according to the sequence shown in Figure 14.

Foil tapes must be applied in all 12 positions regardless if there is a crack or not.

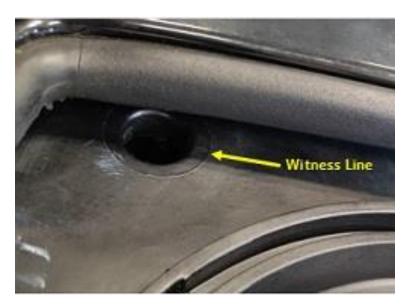
Figure 15 Drain hole and witness line.

For foil positions 4 and 6, it is more important to apply the foil as far underneath the trim panel as possible then attempting to align the foil with the seal channel. Foil positions 4 and 5 should not overlap each other. DO NOT cover the water drain hole or the witness line around the water drain with the foil in positions 4 or 5 (See Figure 15).

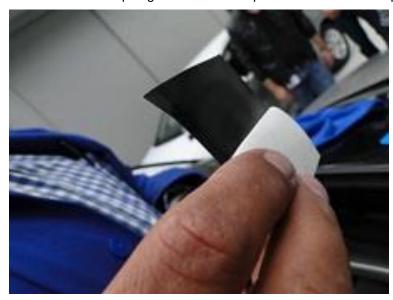
Figure 16 Peel half of backing tape off foil and fold in half to use to hold the foil as it is applied.

13. Peel half of the backing tape off the foil and fold it over to use to hold the foil during application. Align the foil with the edge of the water channel and apply the foil, working it forward using the included squeegee to ensure there are no air bubbles, wrinkles and that there are no gaps under the foil. Peel backing tape off as you work forward. Use the squeegee to work the tape down as smooth as possible.

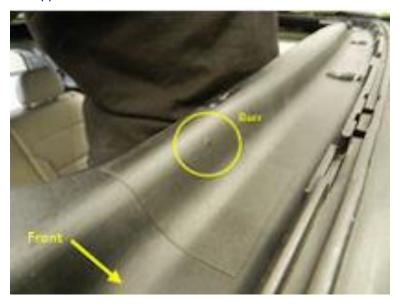
There may be a burr on the water channel in this location that appears to be an air bubble. This is normal and an acceptable condition after applying the foil (Figure 17).

Figure 17 Burr under foil position 1.

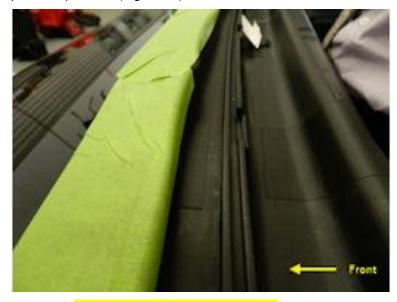
Figure 18 Foil positions 2 and 6 fully applied.

14. In position 6, peel half of the backing tape off the section of foil to be placed underneath the trim panel and fold it over to use to hold the foil during application. Ensure the tape is as far underneath the trim panel as possible before beginning to adhere it to the water channel. Apply the foil working it toward the rear using the included squeegee to ensure there are no air bubbles or wrinkles and that there are no gaps under the foil. Peel backing tape off as you work. Use the squeegee to work the tape down smooth and as far underneath the trim panel as possible (Figure 18).

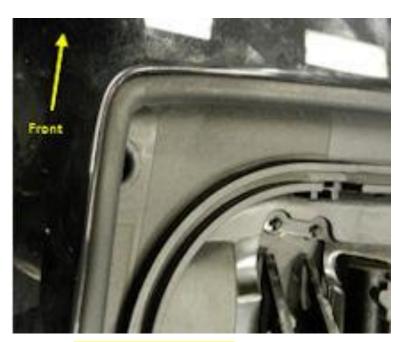
Figure 19 Foil position 5 fully applied.

15. In position 5, peel half of the backing tape off starting at the pointed edge in the radius and fold it over to use to hold the foil during application. Carefully align the radius of the foil to the radius of the seal channel and ensure the drain hole and witness mark around the drain will not be covered. Apply the foil working it forward using the included squeegee to ensure there are no air bubbles or wrinkles and that there are no gaps under the foil. Peel backing tape off as you work. Use the squeegee to work the tape down smooth and as far underneath the trim panel as possible (Figure 19).

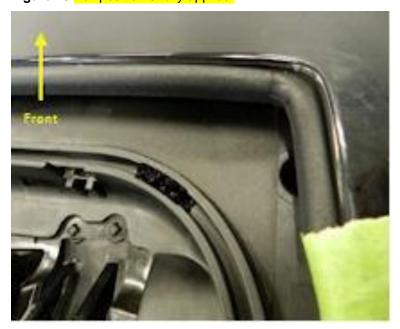
Figure 20 Foil position 5 incorrectly applied covering witness line around drain.

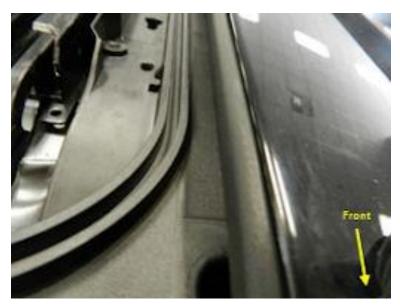
Figure 22 Foil position 4 fully applied.

16. In position 4, peel half of the backing tape off the section of foil to be placed underneath the trim panel and fold it over to use to hold the foil during application. Use a pivoting motion to swing the foil underneath the trim. Ensure the tape is as far underneath the trim panel as possible before beginning to adhere it to the water channel. Apply the foil working it from underneath the trim toward the sunroof opening. Use the included squeegee to ensure there are no air bubbles or wrinkles and that there are no gaps under the foil. Peel backing tape off as you work. Use the squeegee to work the tape down smooth and as far underneath the trim panel as possible (Figures 21 and 22).

It is more important that the foil in position 4 be applied as far underneath the trim panel as possible versus attempting to align it to the edge of the seal channel.

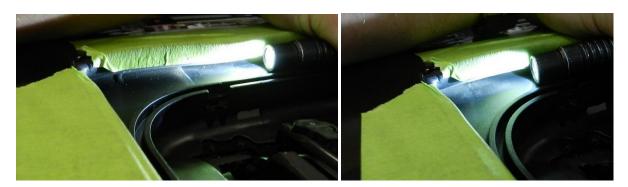
Figure 25 and 26 use a flashlight to help identify any air bubbles in the foils and use the squeegee to work out any defects.

Use a flashlight at different angles to help identify any air bubbles. If any foil needs to be removed and reinstalled, discard the foil and use a new piece (Figures 25 and 26).

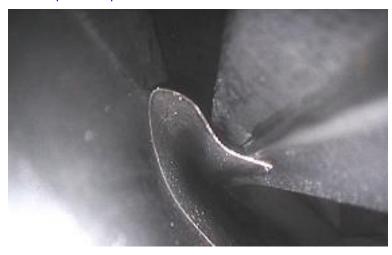
Figure 27 Foil folded and not adhered underneath trim panel

The foil must be fully applied underneath the trim panel. If the foil is folded over, it should be removed and a new piece applied (see figure 27). Use the squeegee to work the foil down on to the water channel as far underneath the trim panel as possible.
