# Technical Bulletin

**24 17 02** February 15, 2017 **2045138** This bulletin revision supersedes V241701 dated January 4, 2017 and allows archiving of, technical bulletin 2031075 (V241208) dated December 17, 2012 and 2038161 (V241506) dated October 1, 2015.

**MIL ON DTCs P2004, P2014 and or P2015 Stored in ECM Fault Memory**

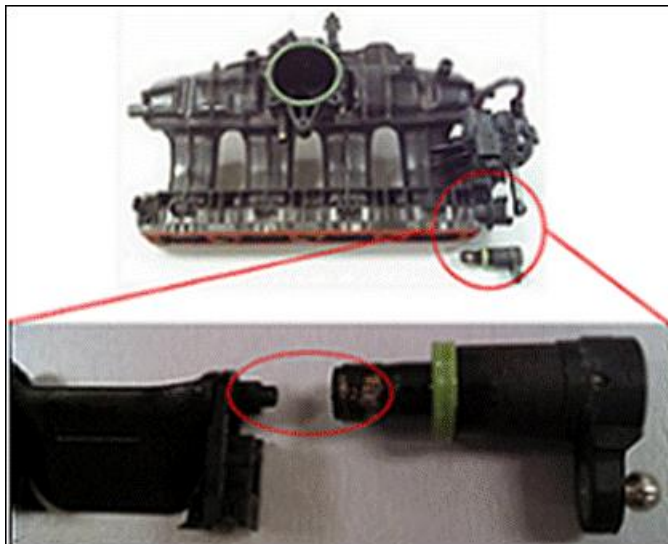
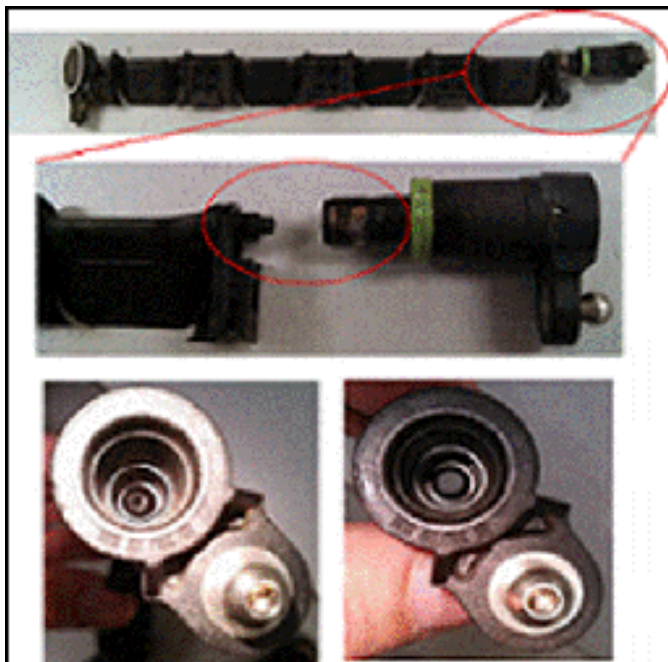
The intake manifold flap can separate internally and will not operate correctly with the regulator valve. See Figure 1. and 2. for an example of a damaged flap disassembled.

Check intake manifold flaps and if necessary replace intake manifold.

If the carrier plate can be pulled out, the flap has separated and the intake manifold must be replaced. See Repair Group 24 Multiport Fuel Injection in Elsa.

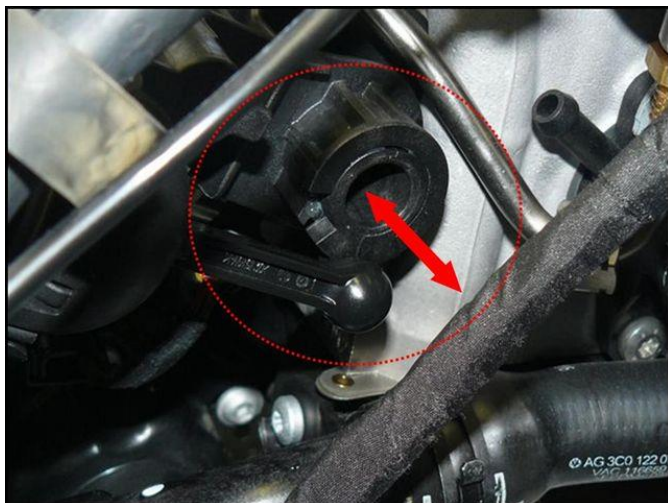
Figure 3.

- Remove the engine cover. See Repair Group 10 Engine Assembly in Elsa.
- Move the carrier plate by hand in an axial direction (Figure 3, red arrow) to check if the carrier plate can be pulled out.
