TITLE:
BLIS fault tracing

REF NO: TJ 25788.1.3	ISSUING DEPARTMENT: Technical Service	CAR MARKET: United States and Canada	
PARTNER: 3 US 7510 Volvo Car USA		ISSUE DATE: 2017-10-16	STATUS DATE: 2017-10-23
FUNC GROUP: 8462	FUNC DESC: Electrical outside mirrors, compl	Page 1 of 27

Volvo Car Customer Service		
	TJ Instruction	
	No25788	
		Date January 2012 Issue 01
Title	BLIS fault tracing.

Volvo Car Customer Service		
		RTJ Instruction
		No.24108
		March 2011 Issue 01
Title	Message in DIM "BLIS Service Required".

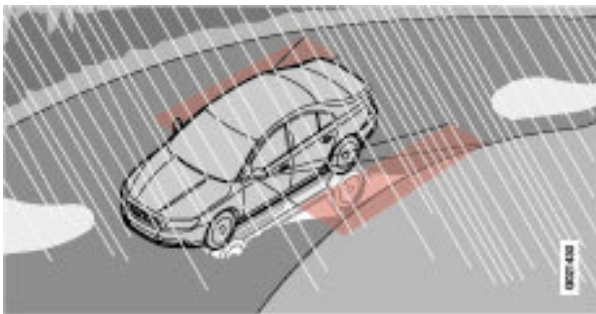
Reflections from shiny wet road surface or puddle.

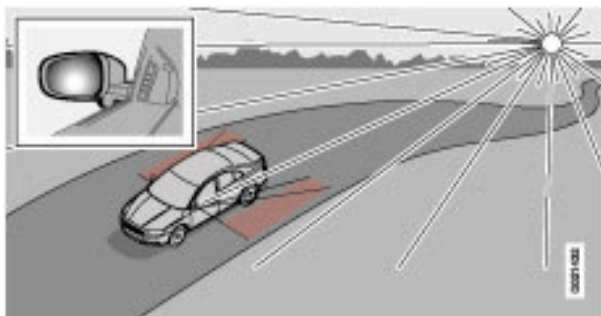
Low sun shining into the camera.

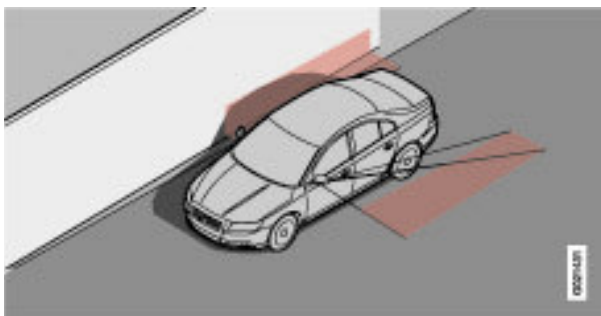
Own shadow on large light smooth surface, e.g. noise barrier or concrete road surface.
