Technical Service Bulletin

19 Coolant pipe seepage on turbocharger

19 17 82 2036167/6 March 21, 2017. Supersedes Technical Service Bulletin Group 19 number 16-76 dated December 6, 2016 for reasons listed below.

Model(s)	Year	VIN Range	Vehicle-Specific Equipment
A8, S6, S7, S8, RS 7	2013 - 2017	All	4.0 T

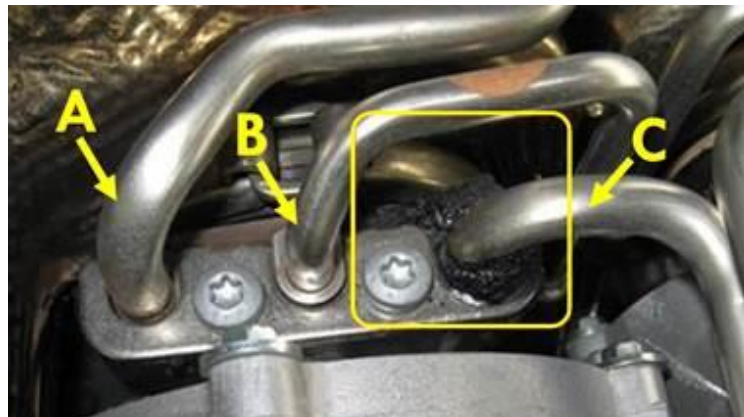
There may be slow coolant loss from the connections at the coolant feed pipe and the coolant return pipe. High temperatures cause the coolant to become encrusted on the connection flange of the turbocharger (Figure 1).

Figure 1. Black, encrusted coolant residue (outlined area), coolant feed pipe (A), oil feed pipe (B), and coolant return pipe (C).

The resulting heat after switching off the engine can, under special operating conditions, lead to very high temperatures on the coolant seals of the turbocharger. This can damage the O-ring.

Optimized temperature-resistant O-rings on the coolant connection of the turbocharger together with an extended operating period of the auxiliary cooling pump after switching off the engine.

Replace the respective O-rings on the coolant supply and return pipes according to the table listed below:
