Technical Service Bulletin

74 Front seat side trim loose or broken

74 17 23 2042470/2 March 30, 2017. Supersedes Technical Service Bulletin Group 74 number 15-22 dated December 1, 2015 for reasons listed below.

Model(s)	Year	VIN Range	Vehicle-Specific Equipment
TT	2016 - 2017	All	Not Applicable
TT Roadster	2016	All	Not Applicable

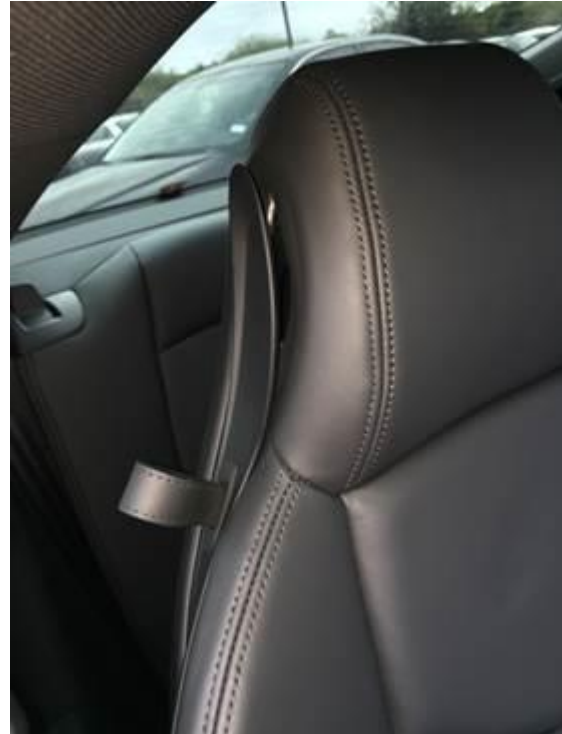
If the customer comes in with concern of seat trim loose and trim is just slightly loose (As shown in Figure 1, Figure 2, and Figure 3), please try to postpone the repair. If the trim is completely loose or falling off, you may move forward with the replacement. You will have to replace the side airbag and airbag guide plate repair kit as well. There is the possibility of a significant delay on those parts at this time.

Figure 1. Outer front seat side trim loose.

The material used in the construction of the trim pieces is of insufficient strength and can break under normal use.

If the trim is completely separated from the seat or the customer is unwilling to postpone the repair, please proceed with repairing with the available trim pieces and replacing the airbag shield.

1. Replace both side trim pieces of the affected seat only. On vehicles produced after 6/15/2016, only the affected seat trim needs to be replaced.
2. Replace loose or broken trim strips with replacement parts along with the side airbag and airbag guide plate repair kit, following the instructions in Elsa. As noted above, TT roadsters are not eligible to receive the updated ABS outer pieces so no airbag replacement is necessary on the roadster.

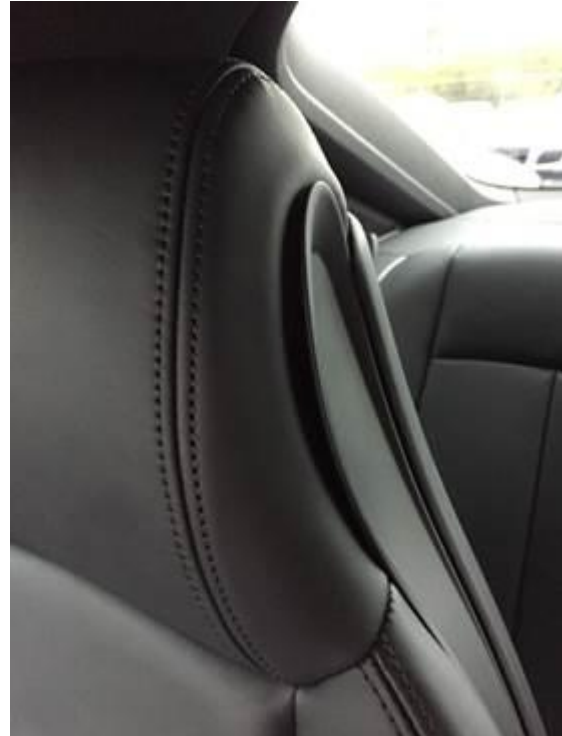
Figure 2. Inner front seat side trim loose.

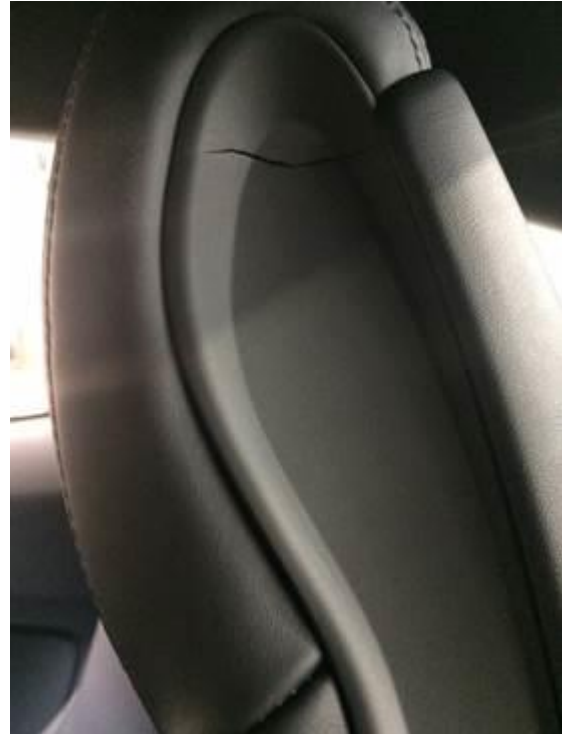
Figure 3. Front seat side trim cracked.

If a piece of trim has broken off, locate and remove the broken piece before reassembly. If the broken piece is not removed, it may cause a rattle noise.
