Technical Service Bulletin

PSS 91 SIRIUSXM intermittently no volume and message "Currently Unavailable" when adjusting volume

91 17 18 2047295/1 March 23, 2017.

Model(s)	Year	VIN Range	Vehicle-Specific Equipment
A3	2017	All	MMI Radio plus

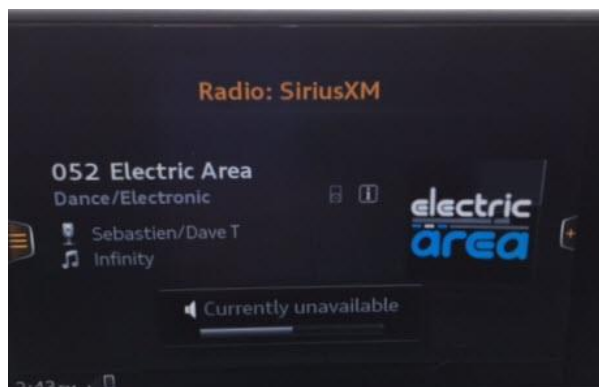
The customer owns a 2017 A3 with MMI Radio plus (PR code "7UH") and complains that when listening to SIRIUSXM the sound intermittently drops out with no volume. When this happens a message of "Currently Unavailable" is seen in the MMI when the customer tries to adjust the volume level.

Figure 1. Message "Currently Unavailable"

The MMI software can incorrectly diagnose a short circuit for the satellite radio antenna. This incorrect diagnosis causes the audio to drop out only when listening to SIRIUSXM. The only way to resolve the concern is to perform a three-finger reset of the MMI or stop the car and turn the ignition off and back on. After a soft reset or an ignition cycle, the issue is resolved.

1. Explain to the customer that a solution is forthcoming and that no repairs are necessary at this point.
Do not replace any vehicle components for this condition since this will not resolve the customer's concern.
2. Explain to the customer how to perform a soft reset of the MMI. Please make sure the customer does this with the vehicle at a stop to prevent driver distraction while driving.

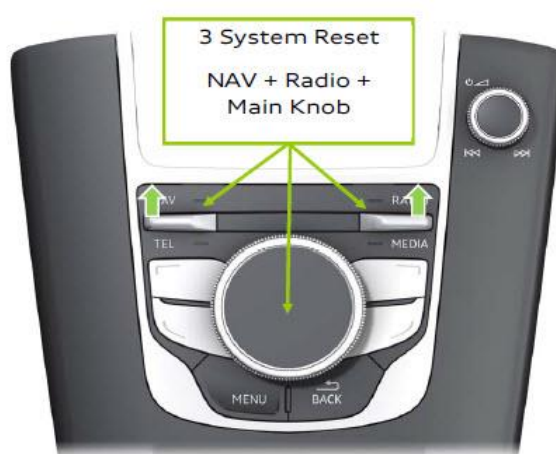
Figure 2. Three-finger system reset

3. The three-finger system reset of the MMI can be performed by pressing up on the Navigation toggle switch and the Radio toggle switch at the same time and then press down on the main MMI knob all at the same time. Once these three switches and knob are released the MMI will perform a soft reset. Please inform the customer that any changes made to the MMI settings during the current ignition cycle will be lost, including but not limited to, navigation destinations, navigation route guidance, radio presets, and Bluetooth pairing.
