# Technical Service Bulletin

## 93 Electric Drive Warning "System error" displayed on instrument cluster

93 17 05 2047162/1 March 29, 2017.

Model(s)	Year	VIN Range	Vehicle-Specific Equipment
A3	2015 - 2016	All	e-tron
A3	2017	000001 - 107339	e-tron

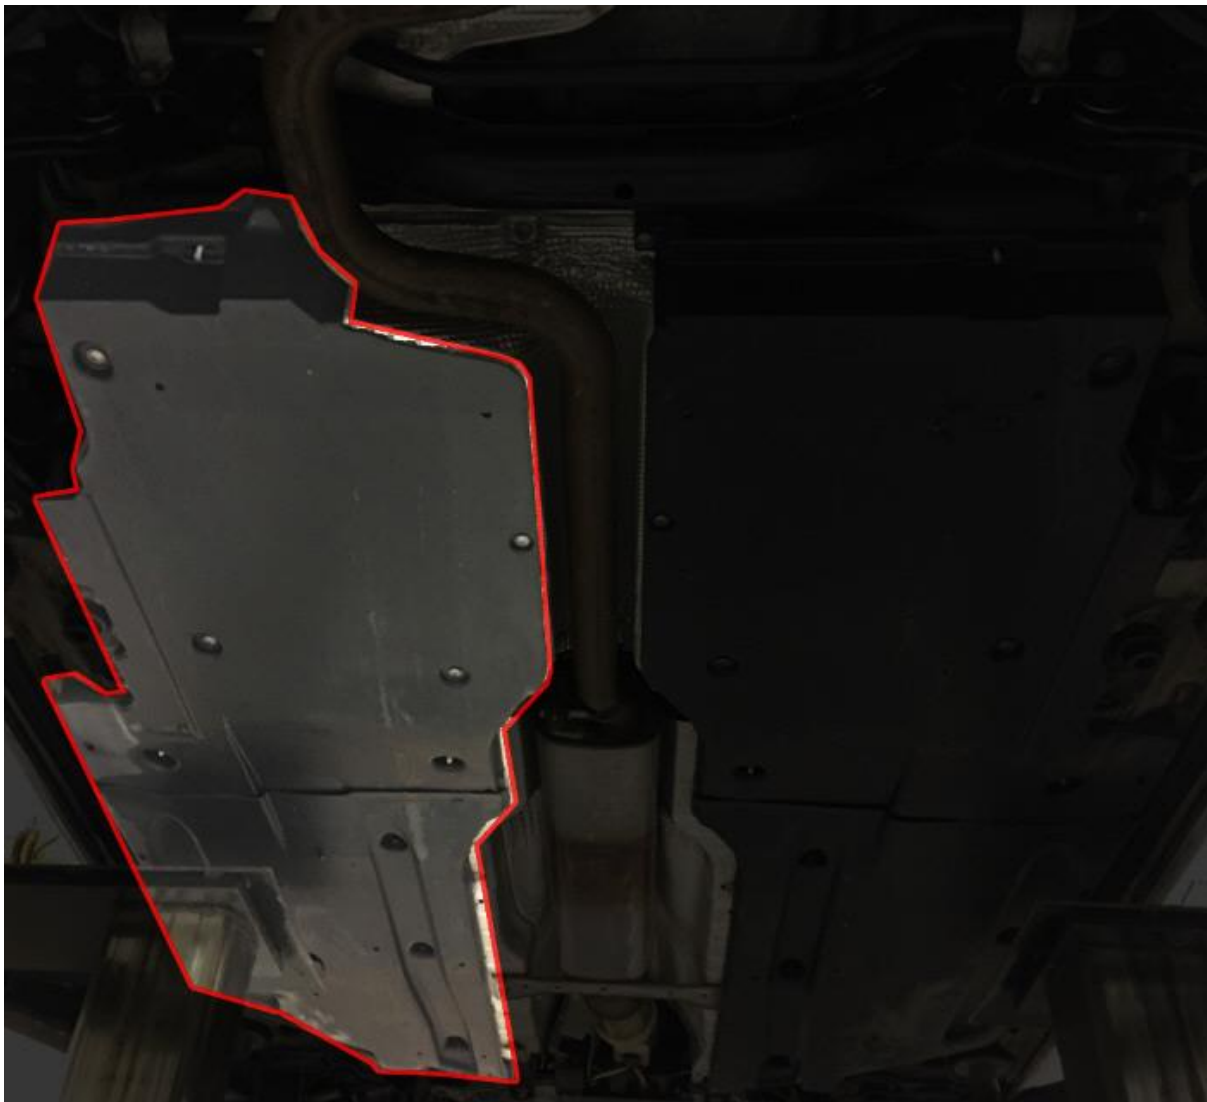
*Figure 1. Left underbody trim panel.*

3. De-energize the high-voltage system. See repair manual for instruction and required qualifications.
4. Remove the underbody trim panel from the left side of the vehicle (Figure 1).

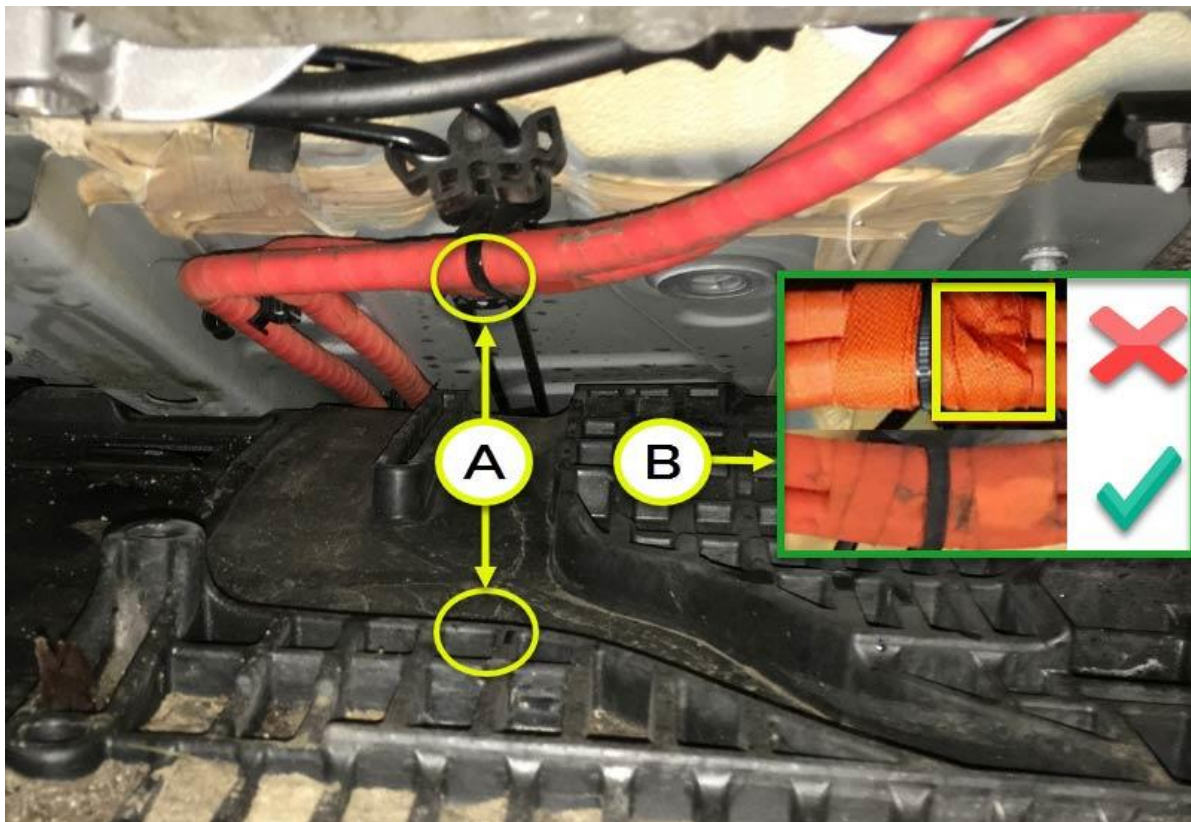
5. Inspect the high-voltage cable in the area (Figure 2-A).

- If the cable was not routed inside the underbody trim panel high-voltage cable channel, then damage can be caused to the cable by the underbody trim panel.
- If there is an indent on the high-voltage cable, proceed with the TSB, otherwise perform diagnostics of the DTC outside of this TSB.

**Figure 2.** Inspect high-voltage cable, in location A, for pinch damage as shown by B.

6. If pinch damage is present, replace the high-voltage cable from the high-voltage battery to the power-electronics.
7. When replacing the high-voltage cable in step 6, install additional retainer bracket (part number 1K0-611-853):
  - Ensure the spacer tabs of the additional retainer bracket (Figure 3-A) point towards the rear of the vehicle and the spacer tab presses up to the original retainer bracket.
  - Secure the high-voltage cable to the additional retainer bracket, not the original bracket.

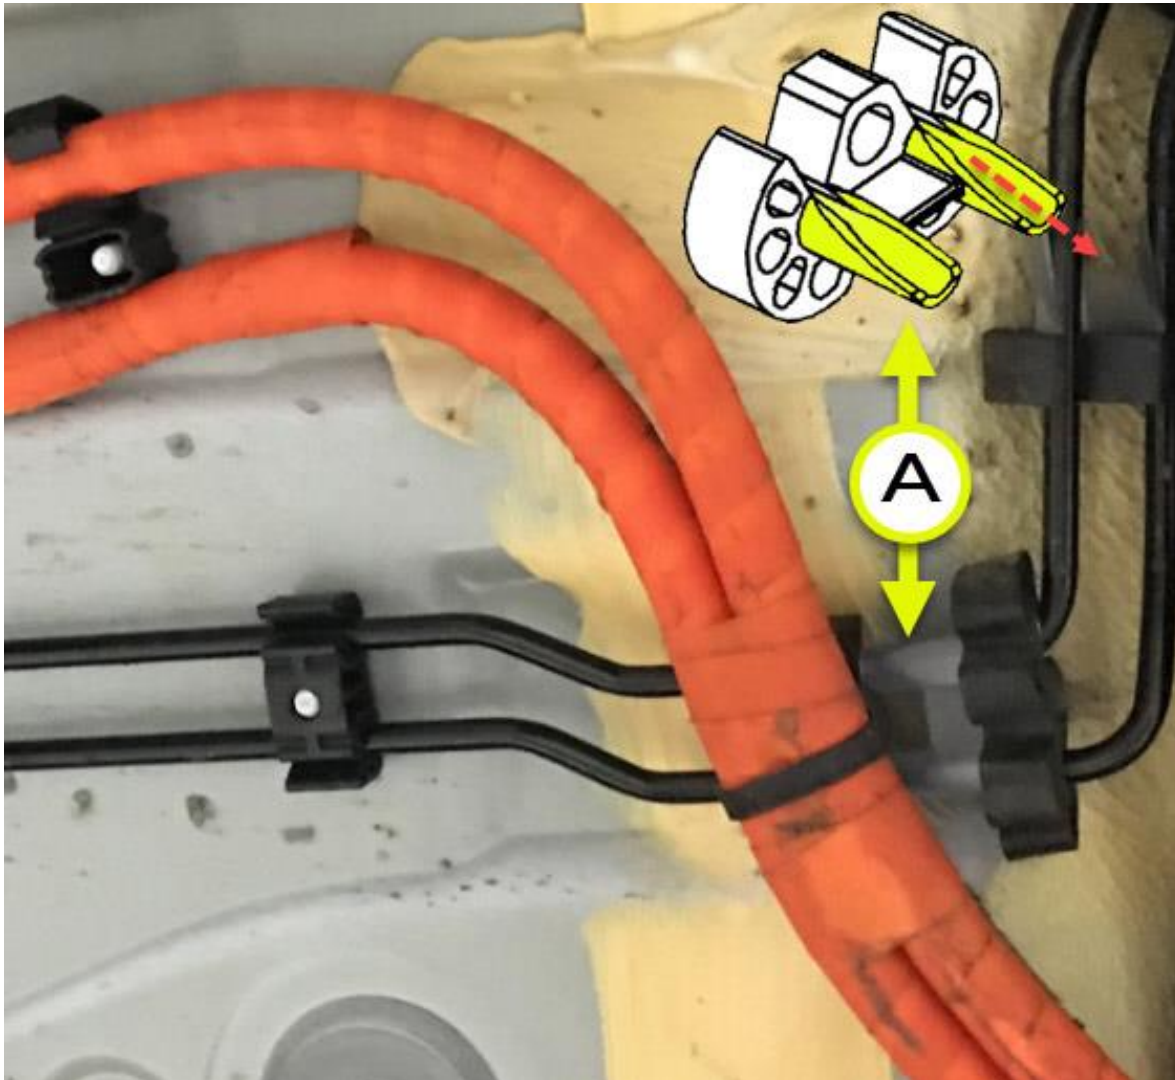
**Figure 3.** Additional retainer bracket (Part Number 1K0-611-853) installed. Retainer bracket tabs (A) must point towards rear of the vehicle, and press up to the original retainer bracket.

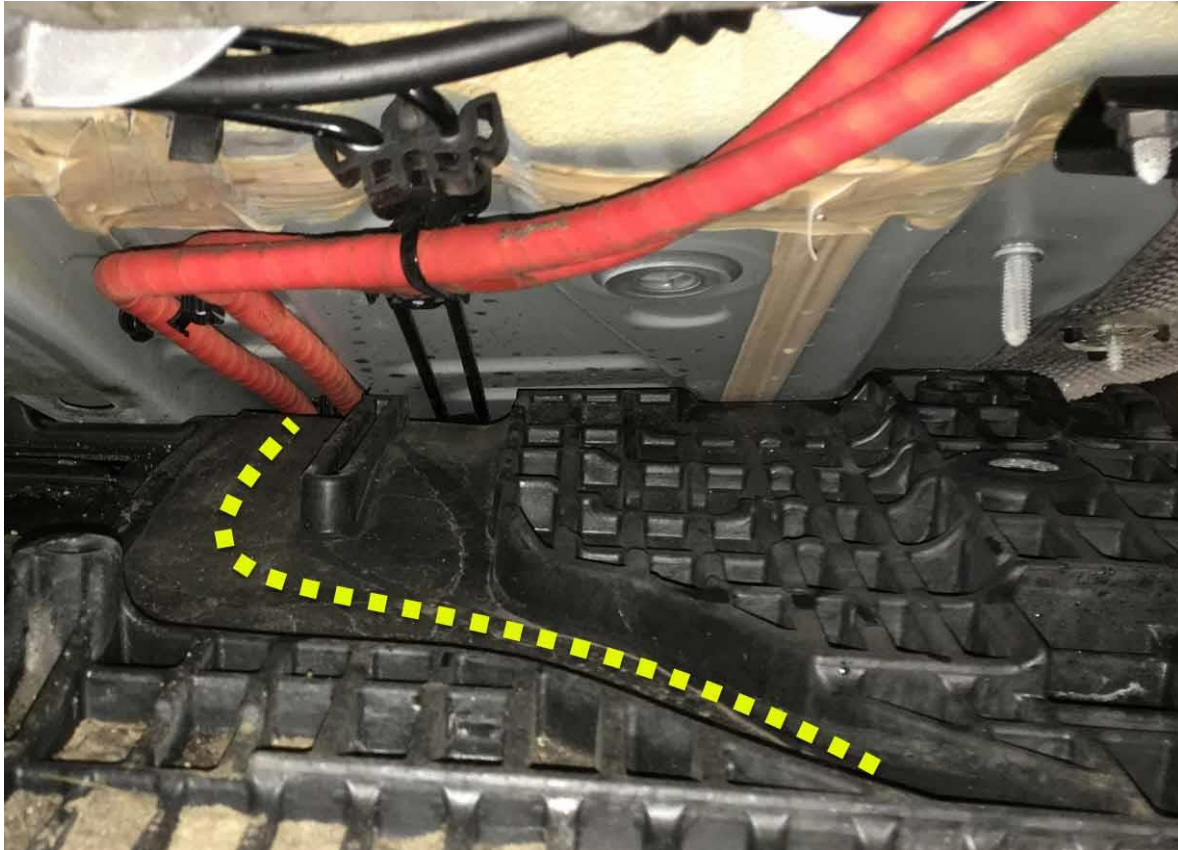
**Figure 4.** Underbody trim panel high-voltage cable channel. Routing path shown by dashed line. Pinch damage will occur if the high-voltage cable is not properly placed inside of the underbody trim panel.

8. When installing the underbody trim panel, ensure that the high-voltage cable fits inside the routing channel (see dashed line in Figure 4). Pinch damage will occur if the high-voltage cable is not properly placed inside of the underbody trim panel.
