Technical Service Bulletin

91 Bluetooth call distorted audio or black screen for Apple CarPlay after using backup camera

91 17 11 2046294/2 March 2, 2017. Supersedes Technical Service Bulletin Group 91 number 17-09 dated February 24, 2017 for reasons listed below.

Model(s)	Year	VIN Range	Vehicle-Specific Equipment
A4	2017	All	MIB2 High Scale

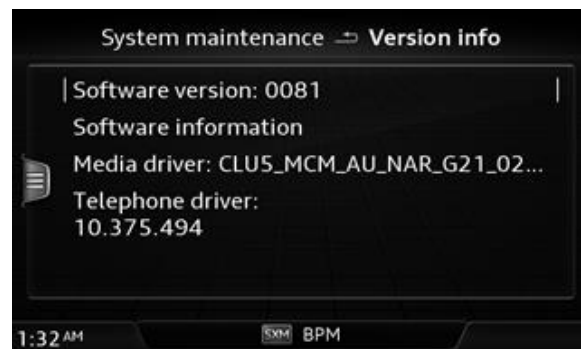
Figure 1. MMI Version Information

1. Verify the customer's MMI requires the software update by going to the *Main Menu >> Settings >> Left drawer option >> Version Information* (Figure 1).

Software versions 0061 & 0081 are only the versions which can be updated. If the MMI is at level 0110, 0116, or 0118, then this TSB does not apply. Cars built after CW22/16 have SW0110 and these vehicles are NOT compatible with this software. Updating a car with SW0110 can damage the MMI.
