Technical Service Bulletin

93 Electric Drive Warning "System error" displayed on instrument cluster

93 17 06 2047162/2 March 31, 2017. Supersedes Technical Service Bulletin Group 93 number 17-05 dated March 29, 2017 for reasons listed below.

Model(s)	Year	VIN Range	Vehicle-Specific Equipment
A3	2015 - 2016	All	e-tron
A3	2017	000001 - 107339	e-tron

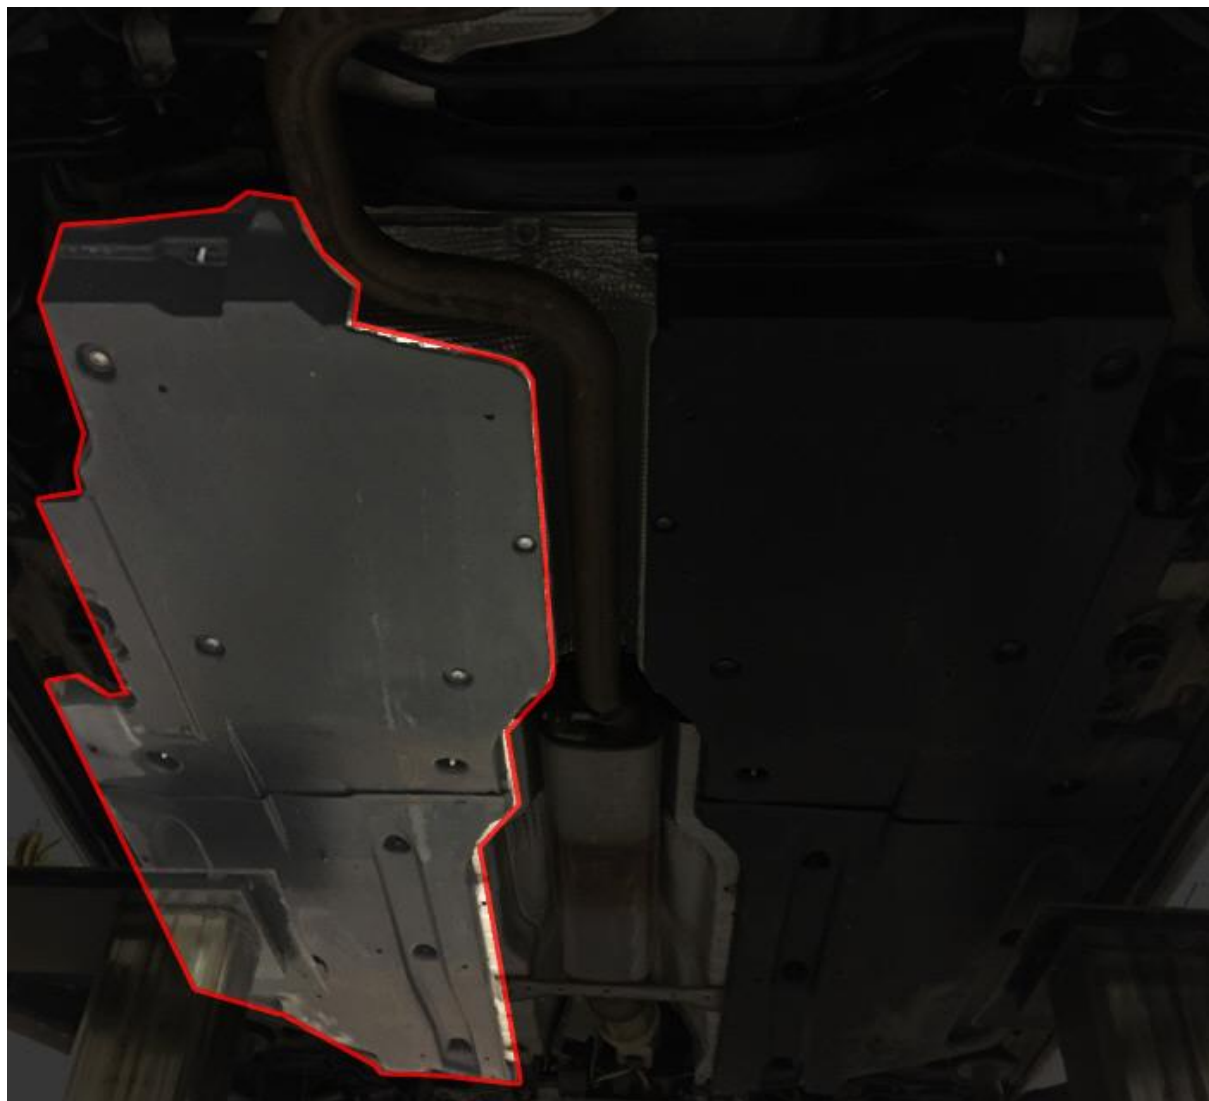
Figure 1. Left underbody trim panel.

1. If DTC P0AA600 Hybrid/EV Battery Voltage System Isolation Fault is not found in the Battery regulation control module, J840 (address word 008C), this TSB does not apply. Perform diagnosis outside of this TSB.
2. Inspect the vehicle for any signs of damage that may affect the high-voltage system. If physical damage is found to the exterior of the vehicle, or to the under body of the vehicle, check to ensure the high-voltage system is not affected by outside influence. This TSB does not apply if the DTC or customer complaint was caused by outside influence.
3. De-energize the high-voltage system. See repair manual for instruction and required qualifications.
4. Remove the underbody trim panel from the left side of the vehicle (Figure 1).

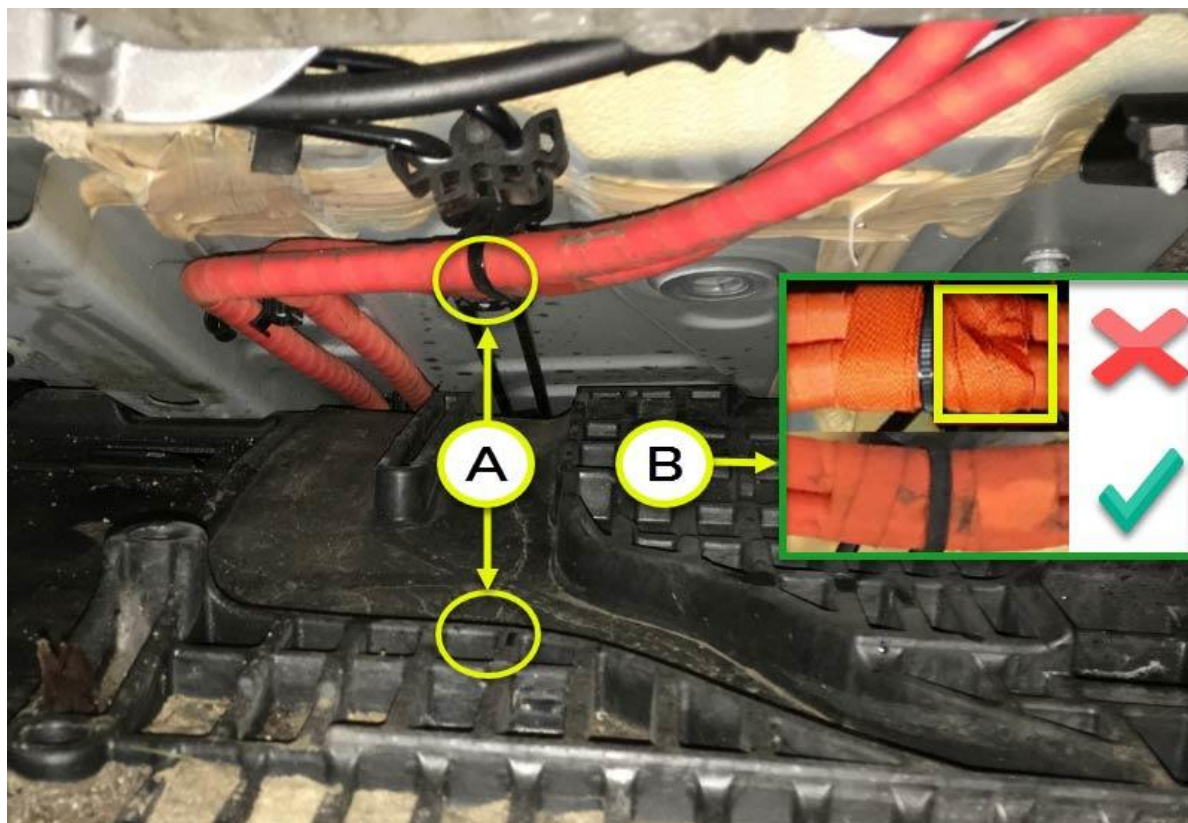
The wire harness for the high-voltage battery maybe pinched by the left underbody trim panel.

5. Inspect the high-voltage cable in the area (Figure 2-A).
 - If the cable was not routed inside the underbody trim panel high-voltage cable channel, then damage can be caused to the cable by the underbody trim panel.

- If there is an indent on the high-voltage cable, proceed with the TSB, otherwise perform diagnostics of the DTC outside of this TSB.

Figure 2. Inspect high-voltage cable, in location A, for pinch damage as shown by B.

6. If pinch damage is present, replace the high-voltage cable from the high-voltage battery to the power-electronics.
7. When replacing the high-voltage cable in step 6, install additional retainer bracket (part number 1K0-611-853):
 - Ensure the spacer tabs of the additional retainer bracket (Figure 3-A) point towards the rear of the vehicle and the spacer tab presses up to the original retainer bracket.
 - Secure the high-voltage cable to the additional retainer bracket, not the original bracket.

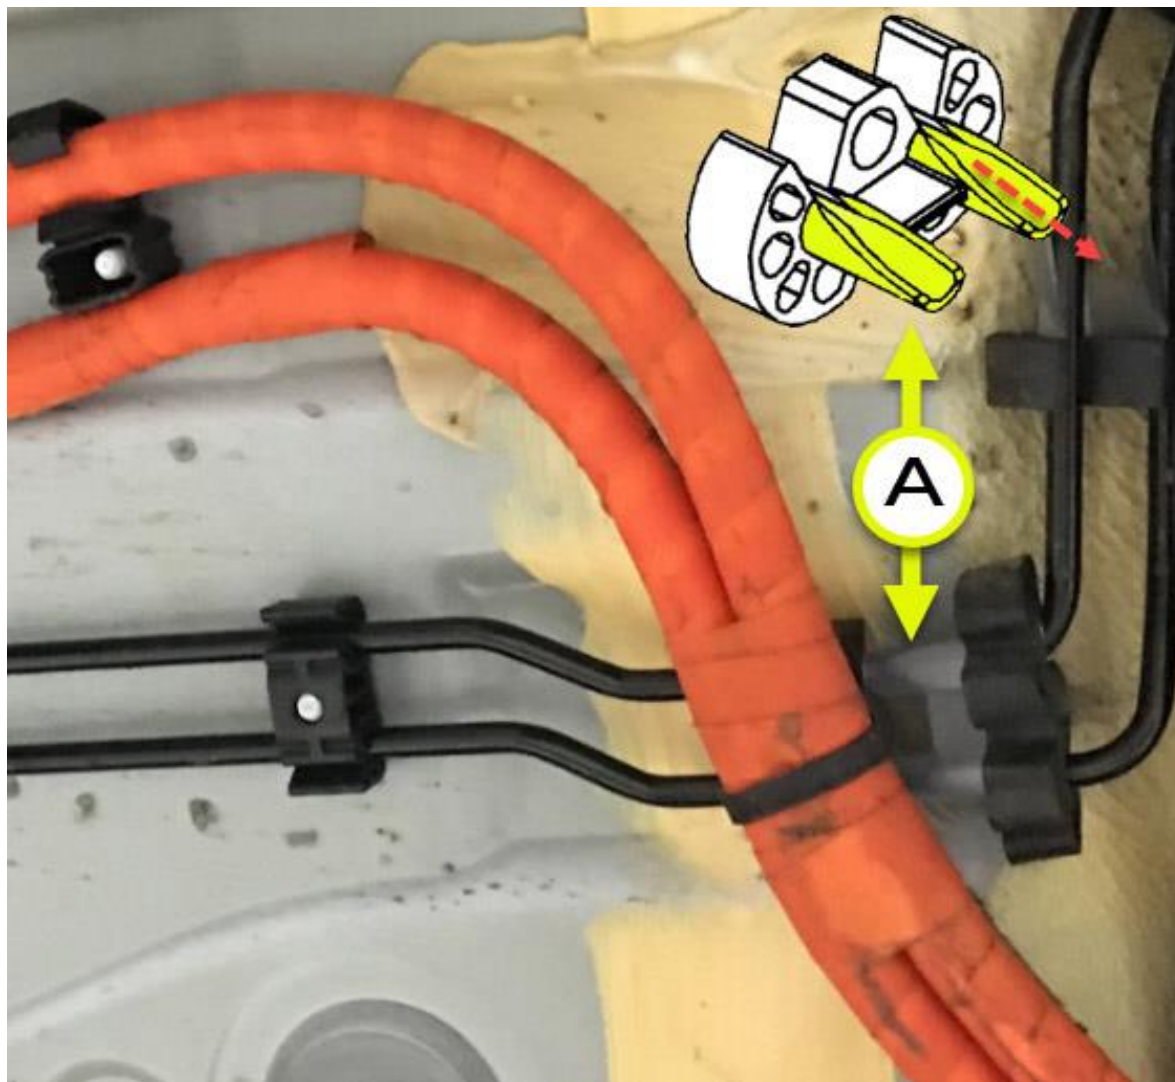
Figure 3. Additional retainer bracket (Part Number 1K0-611-853) installed. Retainer bracket tabs (A) must point towards rear of the vehicle, and press up to the original retainer bracket.

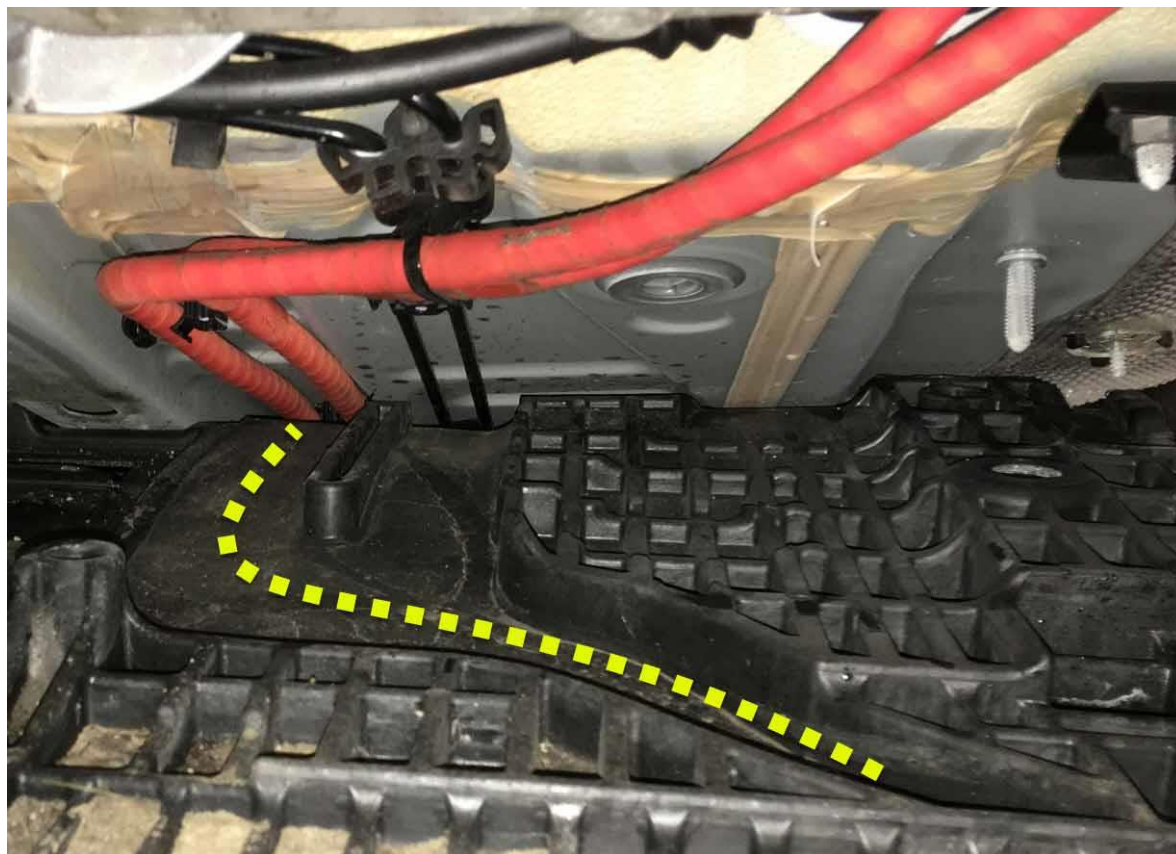
Figure 4. Underbody trim panel high-voltage cable channel. Routing path shown by dashed line. Pinch damage will occur if the high-voltage cable is not properly placed inside of the underbody trim panel.

8. When installing the underbody trim panel, ensure that the high-voltage cable fits inside the routing channel (see dashed line in Figure 4). Pinch damage will occur if the high-voltage cable is not properly placed inside of the underbody trim panel.
