Technical Service Bulletin

01 MIL on (DTC P0011 and/or P0021 - camshaft position)

01 17 08 2041097/3 April 3, 2017. Supersedes Technical Service Bulletin Group 01 number 16-71 dated July 27, 2016 for reasons listed below.

Model(s)	Year	VIN Range	Vehicle-Specific Equipment
S6, S7, RS 7, A8, S8	2013 - 2014	All	4.0 TFSI

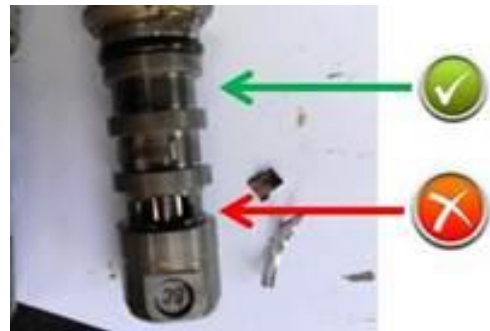
- On the camshaft adjustment valve, the filter element can loosen (Figure 1).
- There is no consequential damage from loosened particles in the oil circuit. They are gathered by the oil filter.

Figure 1. Two top filters are okay, bottom filter is missing.

1. The camshaft adjustment valve is fitted in four different positions. Check the affected camshaft adjustment control valve (see DTC entry). The following list shows which component is affected, based on event entry:
 - N205 – cylinder bank 1, inlet side
 - N318 – cylinder bank 1, exhaust side
 - N208 – cylinder bank 2, inlet side
 - N319 – cylinder bank 2, exhaust side
2. Remove connector (Figure 2) from control valve with DTC.
3. Remove bolt (Figure 2) from control valve with DTC, then remove valve.

4. Install O-ring on new control valve.
 Replace hex collard bolt and tighten new bolt to 5 Nm.

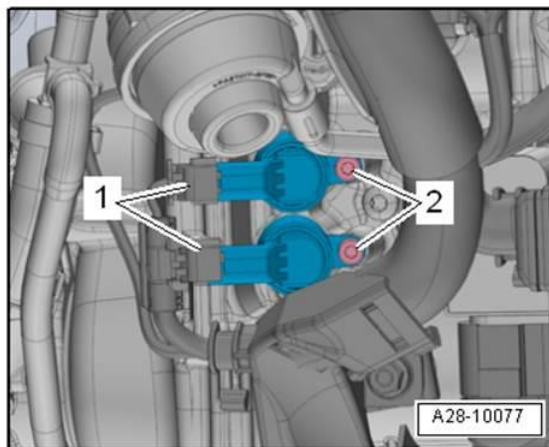
Figure 2. Connector (1) and bolt (2) to be removed from affected control valve.
