Technical Service Bulletin

91 SOS Warning Displayed On Instrument Cluster

91 17 20 2046155/3 April 4, 2017. Supersedes Technical Service Bulletin Group 91 number 17-99 dated January 4, 2017 for reasons listed below.

Model(s)	Year	VIN Range	Vehicle-Specific Equipment
A4	2016 - 2017	All	With connected gateway

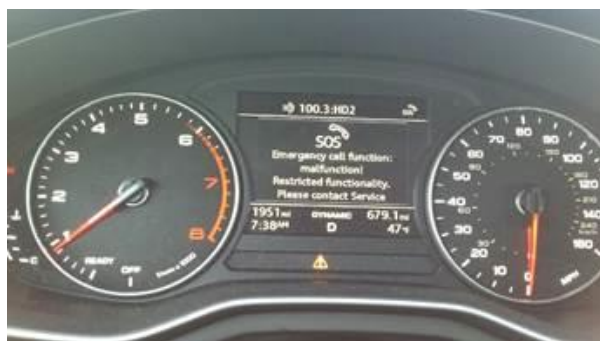
- Customer may report a SOS warning message is displayed on the instrument cluster (Figure 1)
- DTC B105313** GSM antenna Open Circuit stored in connected Gateway Module (databus onboard diagnostic interface), J533 (address word 0019)

Figure 1. SOS warning in instrument cluster.

Poor connection in the coaxial wiring from the Gateway Module J533 to the external R263 antenna.

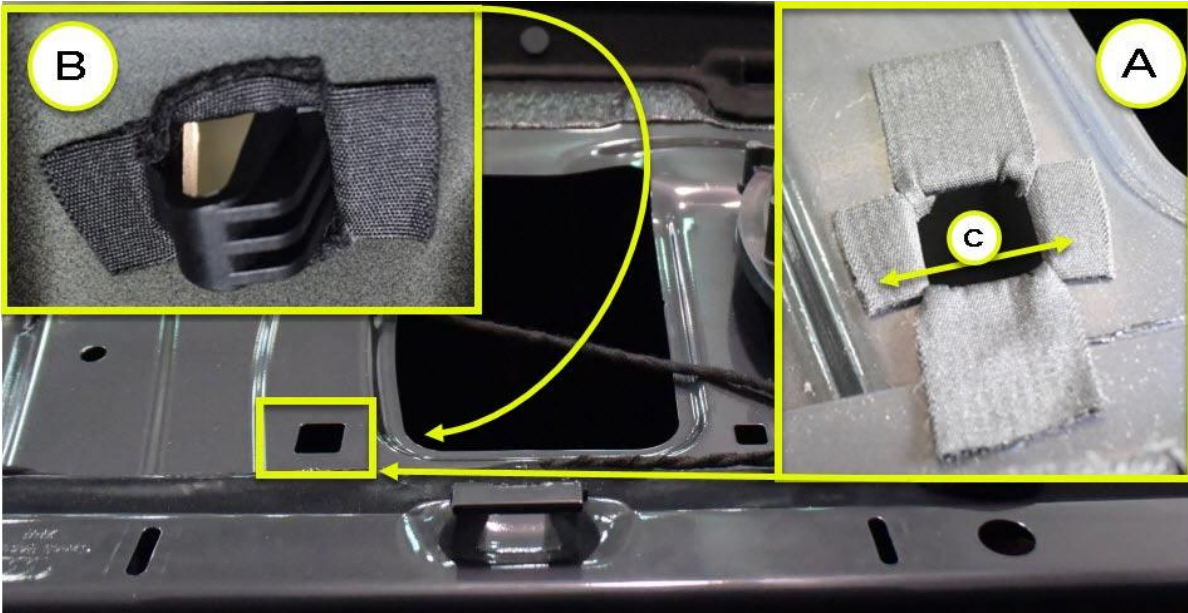
Figure 2. Add adhesive tape to insulate right mounting points for the new antenna bracket.

Tip: Make sure the adhesive tape (D373125A2) wraps around the mounting hole and secures to the rear of the panel (Figure 2B and Figure 3B).

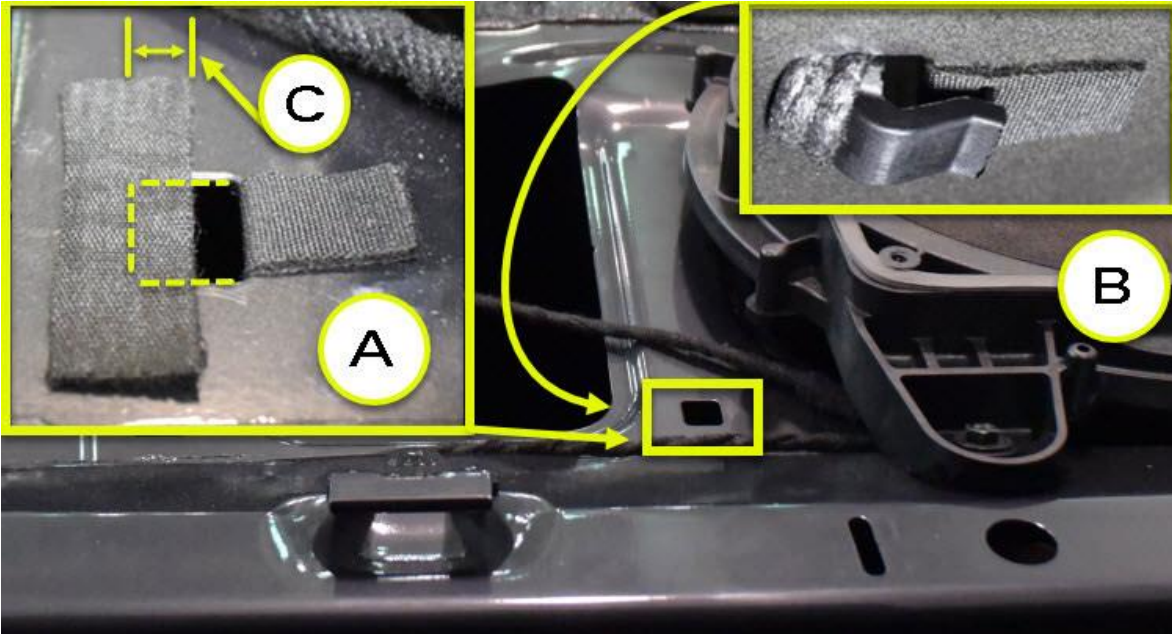
Figure 3. Add adhesive tape to insulate left mounting points for the new antenna bracket.

Left mounting hole (Figure 3):

- Cut one, 1 inch long strip of adhesive tape (D373125A2)
- Cut this strip in half, creating two 1 inch strips
- On the left side of the mounting hole, wrap one of the strips around the opening (Figure 3A)

On the right side of the mounting hole lay the other strip down. Strip should face front to back. 50% of the strip's width should overlap the mounting hole (Figure 3C).

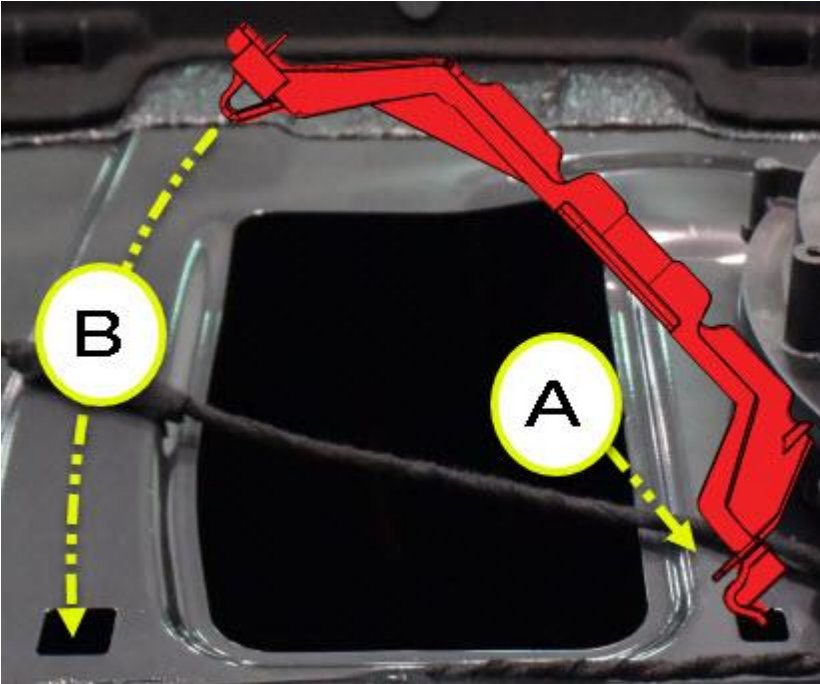
Figure 4. Install the new mounting bracket by inserting the retaining tab (A) into the left mounting hole. Rotate the bracket down into the right mounting hole (B).

5. Install the new antenna (4M0035504):
 - Clip the new antenna (4M0035504) into the new antenna bracket (8W0035596)Secure the new assembly into the mounting holes (Figure 4):
 - Insert new antenna bracket (8W0035596) into the left mounting hole (Figure 4A)
 - Rotate the new antenna bracket down into the right mounting hole (Figure 4B)
 - Ensure the locking tab is fully pressed forward (Figure 5B)

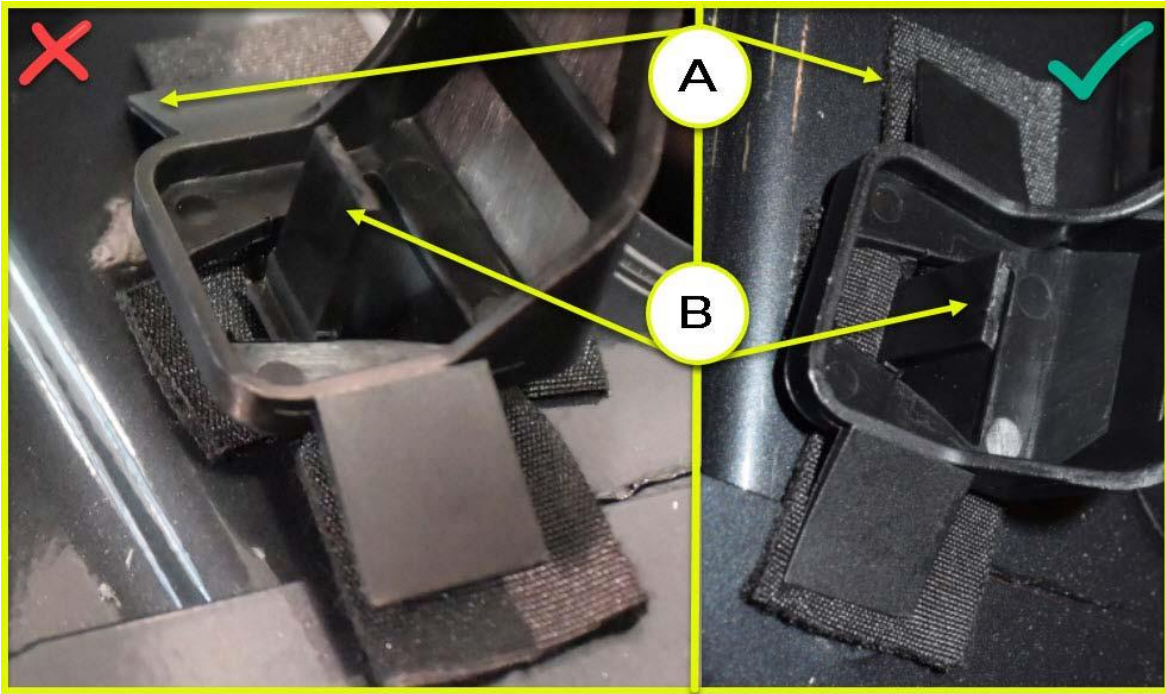
Figure 5. Ensure the locking tab of the mounting bracket is fully locked by pushing it forward (B). Make sure all mounting surfaces are covered with the adhesive tape (A).

Make sure all areas of the rear shelf that come in contact with the mounting bracket are covered with the adhesive tape. If not, remove the antenna bracket and adjust the tape applied in step 3 so that all areas of the antenna bracket that come into contact with the rear self are insulated (Figure 5).

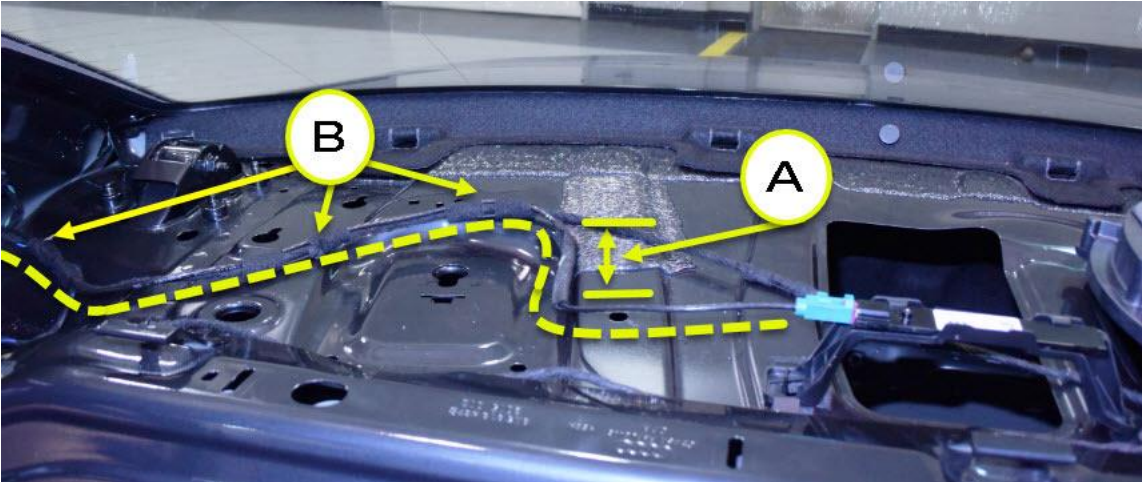
Figure 6. Routing path of the new coaxial wire (000098655) is shown by the dashed line. Wrap a strip of adhesive tape (D373125A2) around the coaxial wire where it comes into contact with the sheet metal (A). Secure the new coaxial wire to the existing harness body clips wrapping a piece of cloth tape (N10729301) on each side of the body clip.

6. Prep the new pre-made coaxial wire (000098655) by unrolling it. Ensure that there are no kinks or bends during this process.
7. Install new coaxial wire (000098655) on the rear deck lid:
 - Plug the Fakra connector onto the new antenna
 - Route coaxial cable along the path indicated by the dashed line in (Figure 6)
 - The coaxial line will run along the sheet metal stamp indent, as shown by the dashed line (Figure 7)
 - To avoid possible noises, wrap a strip of adhesive tape (D373125A2) around the coaxial wire where it comes into contact with the sheet metal (Figure 6A)
 - Secure the new coaxial wire (000098655) to the existing harness body clips (Figure 6B) by wrapping a piece of cloth tape (N10729301) on each side of the body clip

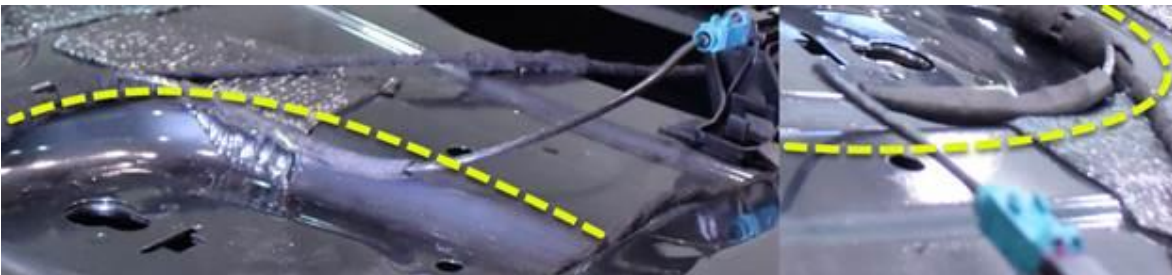
Figure 7. The coaxial line will run along the sheet metal stamp indent, as shown by the dashed line.

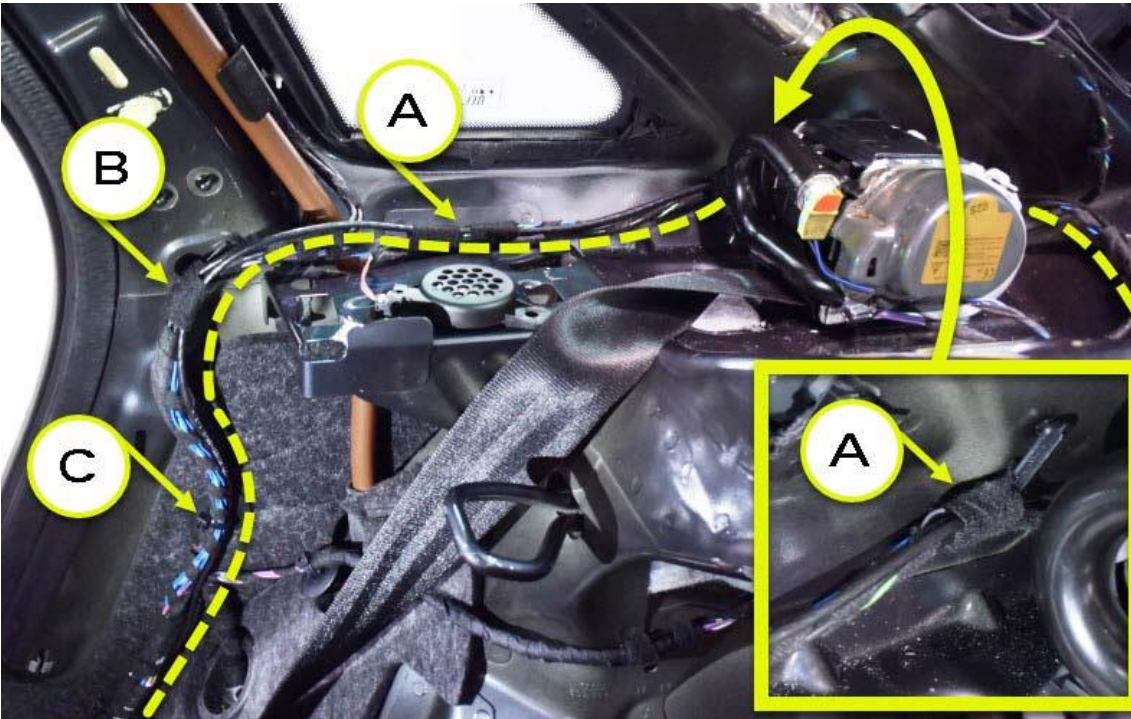
Figure 8. Route the new coaxial wire (000098655) along the path shown by the dashed line. Secure the new coaxial wire to the existing harness body clips and wrap with cloth tape.

8. Attach the new coaxial wire (000098655) along the right rear of the vehicle:
 - Route the new coaxial wire (000098655) along the path shown by the dashed line (Figure 8)Secure the new coaxial wire (000098655) to the existing harness body clips:
 - Wrap a piece of cloth tape (N10729301) on each side of the body clips (Figure 8A)
 - Wrap a piece of cloth tape (N10729301) on the lower side of the body clip (Figure 8B)
 - Replace the existing plastic zip tie (Figure 8C)

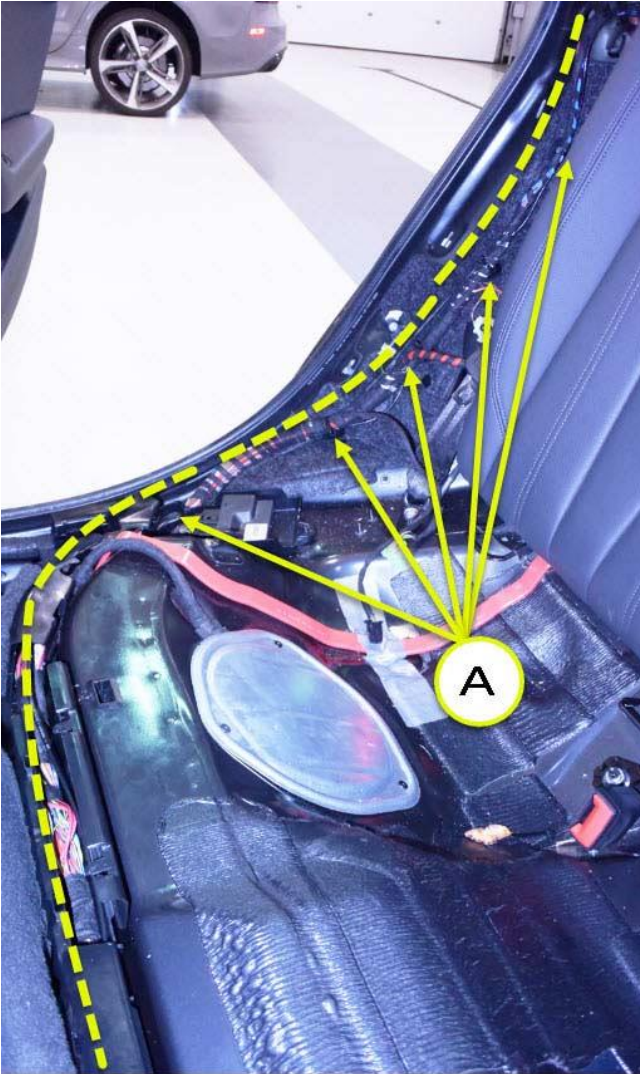
Figure 9. Route the new coaxial wire (000098655) along the path shown by the dashed line. Secure the new coaxial wire to the existing harness body clips by replacing the exiting plastic zip ties (A).

9. Route the new coaxial wire (000098655) along the right of the vehicle:
 - Route the new coaxial wire (000098655) along the path shown by the dashed line (Figure 9)
 - Secure the new coaxial wire (000098655) to the existing harness body clips by replacing the existing plastic zip tie (Figure 9A)

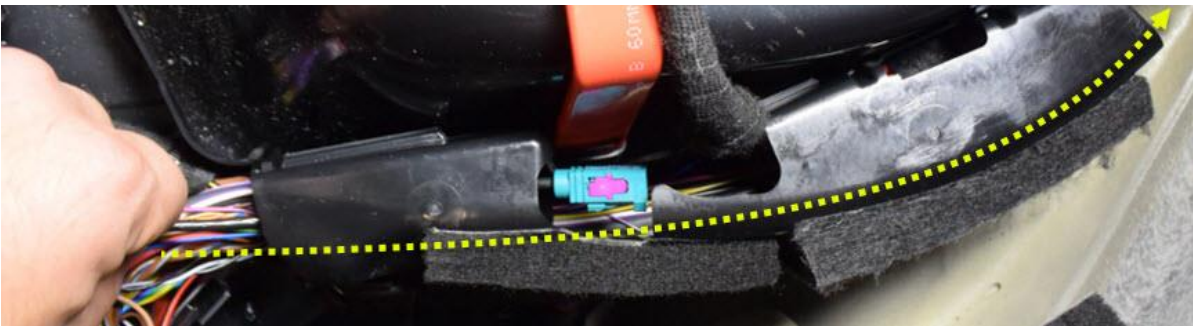
Figure 10. There is enough room inside the plastic conduit to feed the wire without opening it.

Tip: There is enough room inside the plastic conduit to feed the wire up without opening the conduit (Figure 10).

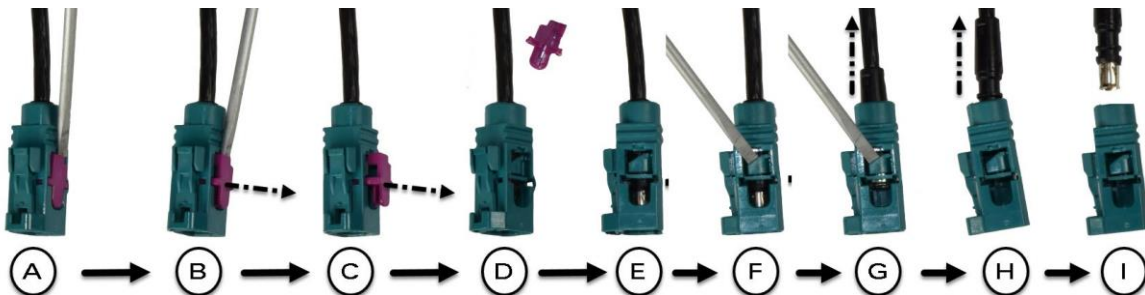
Figure 11. Remove coaxial wire from single Fakra connector. Lift locking pin (A, B, and C). Locking pin removed (D and E). Lift primary locking tab (F). With primary locking tab lifted, pull coaxial wiring from Fakra housing (G). Remove coaxial wiring from Fakra housing (H and I).

11. Install the connector housing for antenna (6Q0035608K) onto the new coaxial wire (000098655) and connect to Gateway:
 - Remove the locking tab from the single Fakra connector on the new coaxial wire (000098655) (Figure 11)

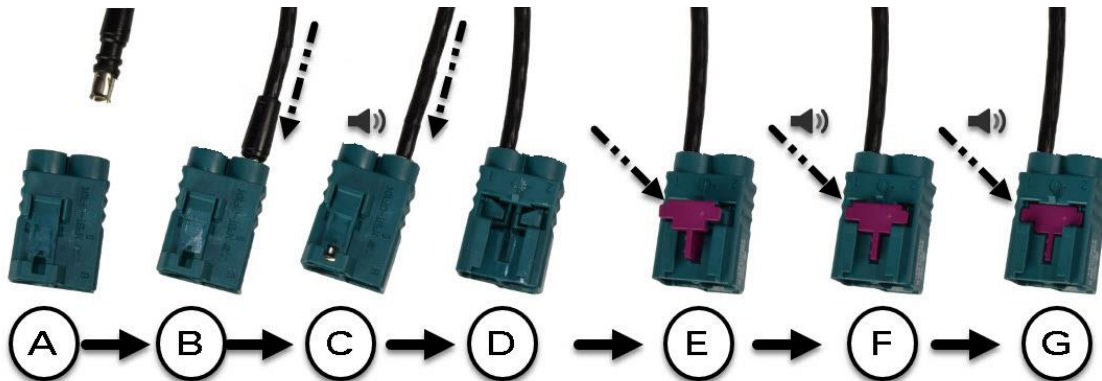
Figure 12. Insert coaxial wire into Fakra connector on Pin1 (A and B). When coaxial wire is fully seated, there will be an audible “click” noise as the primary locking tab engages (C). Install the locking pin into the Fakra connector (E). There will be one audible “click” noise at the first detent (F). There will be a second audible “click” noise at the second detent (G).

- Install the new connector housing for antenna (6Q0035608K) onto the new coaxial wire (000098655) (Figure 12)
- Make sure the coaxial wire is fully seated in pin 1 of the connector
- You will hear an audible “click” (Figure 12C) when the coax wire is fully seated
- When installing the locking tab of the new connector housing for antenna (6Q0035608K), you will hear two clicks as it seats. First “click” (Figure 12F). Second “click” (Figure 12G)

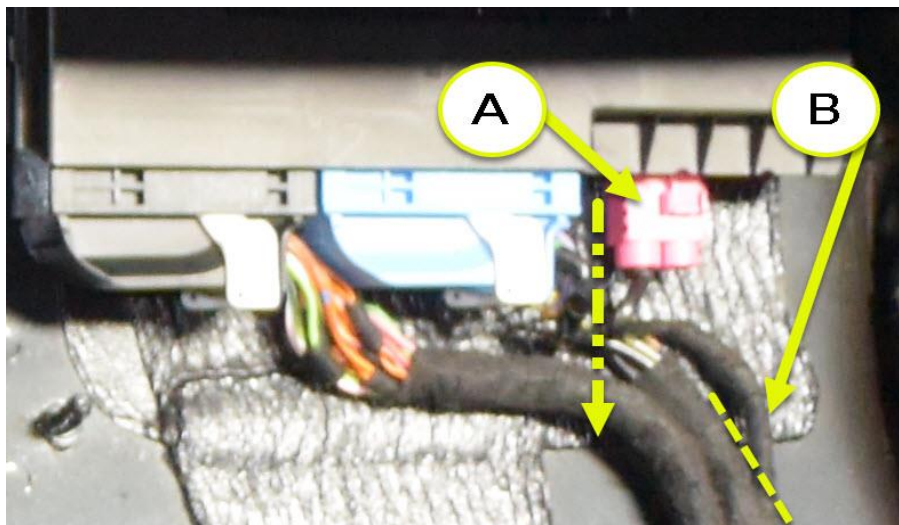
Figure 13. Unplug the original pink coaxial connection from the Gateway Module (A). Follow the coaxial wiring back to where it enters the harness and cut it off at the cut line shown by the dashed line (B).

12. Remove the original coaxial line from vehicle harness:

- Unplug the original pink connector from the gateway (Figure 13A)
- Where the coaxial wire enters the main harness, cut it off (Figure 13B)

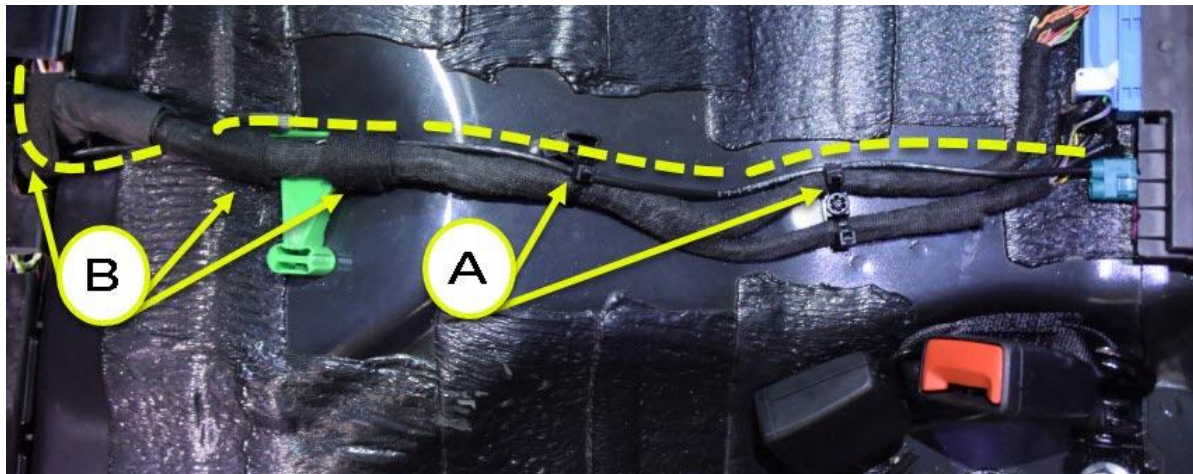
Figure 14. Cut the fabric tape at B. Route the new coaxial wire along the path shown by the dashed line and re-tape the harness.

13. Complete routing of the new coaxial wire (000098655) to the Gateway Module J533:

- Open the three tape points (Figure 14B)
- Open the two plastic zip tie points (Figure 14A)
- Route the coaxial wire along the path shown (Figure 14)
- Plug the new connector into the Gateway Module J533

Secure the new coaxial wire to the existing harness by:

- Installing new plastic zip ties (Figure 14A)
- Re-tape the harness at points shown with cloth tape (N10729301) (Figure 14B)
