# Technical Service Bulletin

## 91 Audi connect myAudi pin not saved for stored online destinations

91 17 23 2047433/1 April 11, 2017.

Model(s)	Year	VIN Range	Vehicle-Specific Equipment
A6, A7	2016 – 2017	All	MIB2 High Navigation

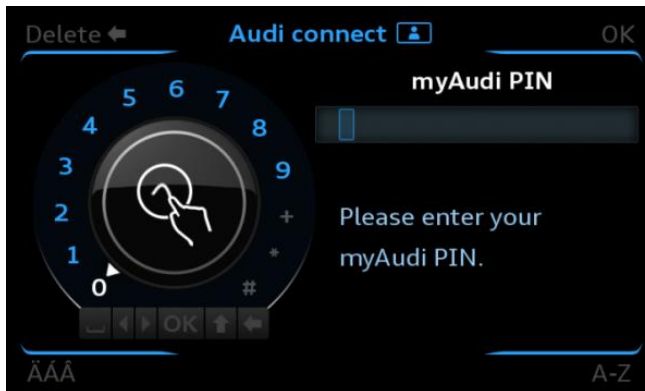
The vehicle is a MY2016 or MY2017 A6, A7, S6, S7, or RS 7 and the customer states that when retrieving the stored myAudi online destinations, the myAudi PIN (Figure 1) is not saved and must be entered each time after the vehicle has been switched off for a long period of time. Additionally, the customer's vehicle is equipped with MMI Navigation plus (MIB2 High Nav; PR code "7UG").

Figure 1. myAudi Pin entry screen.

The condition is the result of an MMI software bug and can be fixed by updating the MMI software. The software bug only prevents the myAudi PIN from being stored in the navigation area of the MMI menu. The myAudi pin is saved in the Audi connect menu for accessing custom news feeds.

The service solution is to update the MMI software to SW1062 for MY16 and SW0924 for MY17 to fix the myAudi PIN issue.
