Technical Service Bulletin

91 Volume control knob does not work intermittently

91 17 25 2047139/1 April 20, 2017.

Model(s)	Year	VIN Range	Vehicle-Specific Equipment
Q7	2016	000001 - 019815	MMI Navigation plus

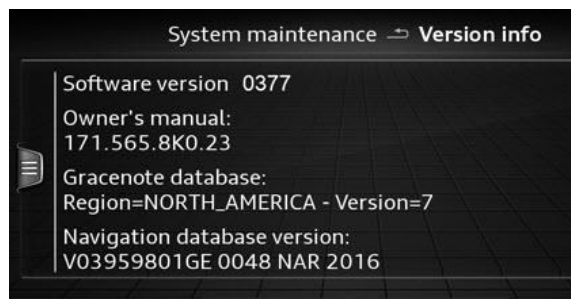
Figure 1. MIB2 Software Version in MMI

1. Verify the customer's MMI requires the software update by going to the *Main Menu>>Settings>>Left drawer option>>Version Information* (Figure 1).

Cars built after CW22/16 have SW 0692 and these vehicles already contain the software fix. If the customer's vehicle has the SW 0692 or higher and vehicle still has the volume concern, then this TSB does not apply.
