Technical Service Bulletin

94 Rear lights do not switch from bumper to hatchgate

94 17 87 2047618/1 April 25, 2017.

Model(s)	Year	VIN Range	Vehicle-Specific Equipment
Q7	2017	010120 - 999999	Not Applicable

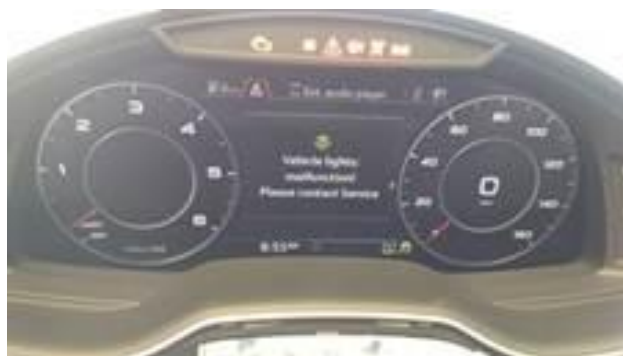
- When the rear lid is closed, the lights in the rear bumper do not switch over to the main lights on the rear lid.
- The error message “Vehicle lights: malfunction! Please contact Service” intermittently appears in the driver information system (Figure 1).
- All of the rear light bulbs are fully functional. None are found to be faulty or incorrect.

Figure 1. Error message.

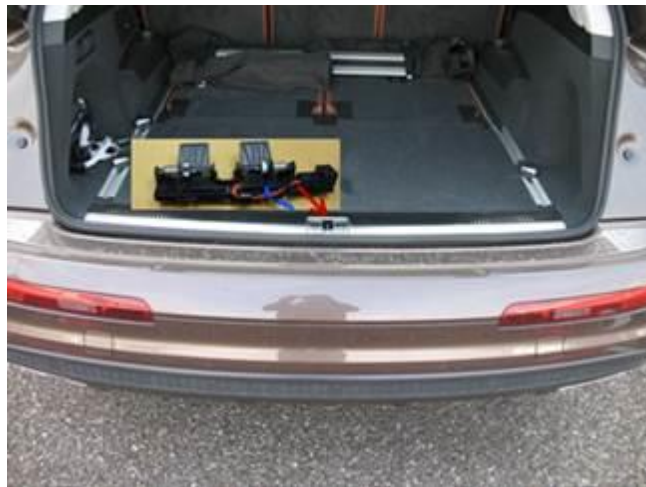
This condition may be caused by incomplete actuation of the Rear Lid Closed Sensor G525/G526 due to debris in the switch mechanism (Figure 2).

Figure 2. Rear Lid Closed Sensor.

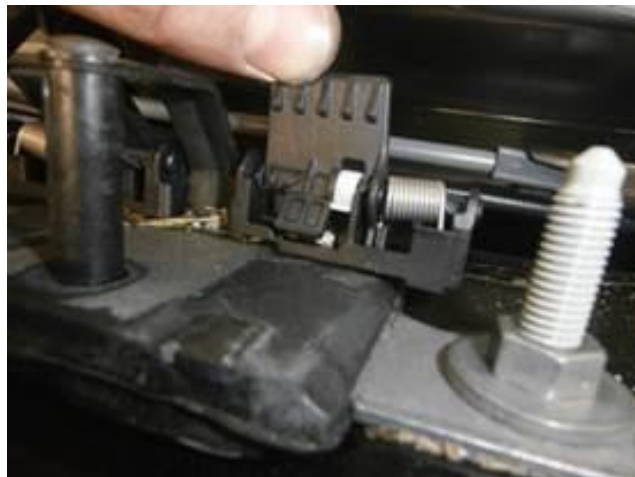
Mounted to the base of the rear lid striker is the G525/G526 Rear Lid Closed Sensor. Due to its position, debris that enters the striker housing can get caught in the switch mechanism and cause incomplete switch actuation (Figure 3).

Figure 3. Debris in the Rear Lid Closed Sensor.

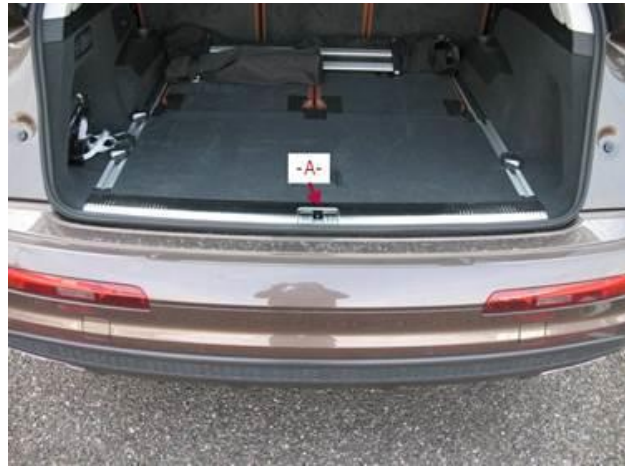
Figure 4. Striker cover opening.

1. Press down the striker cover on the loading sill cover -A- (Figure 4).

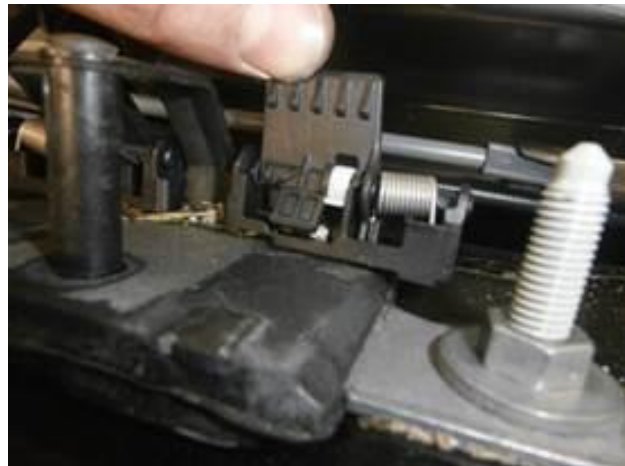
Figure 5. Debris trapped in the Rear Lid Closed Sensor.

2. Blow out any debris that might be causing an obstruction with compressed air (Figure 5).
