# Technical Service Bulletin

## 91 Volume control knob does not work intermittently

91 17 26 2047139/2 May 9, 2017. Supersedes Technical Service Bulletin Group 91 number 17-25 dated April 20, 2017 for reasons listed below.

Model(s)	Year	VIN Range	Vehicle-Specific Equipment
Q7	2016	000001 - 019815	MMI Navigation plus

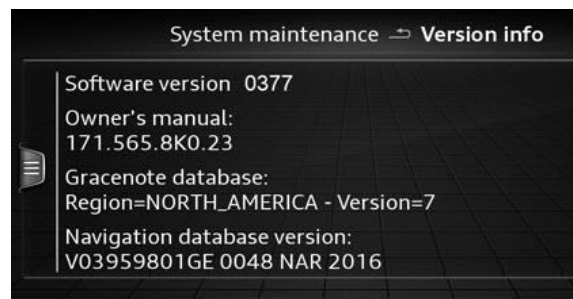
**Figure 1.** MIB2 Software Version in MMI

1. Verify the customer's MMI requires the software update by going to the *Main Menu>>Settings>>Left drawer option>>Version Information* (Figure 1).

Cars built after CW22/16 have SW 0692 and these vehicles already contain the software fix. If the customer's vehicle has the SW 0692 or higher and vehicle still has the volume concern, then this TSB does not apply.
