70 Noises from headliner/sunroof area

70 17 60 2044417/4 May 17, 2017. Supersedes Technical Service Bulletin Group 70 number 17-58 dated March 8, 2017 for reasons listed below.

Model(s)	Model(s) Year VIN Range		Vehicle-Specific Equipment	
Q7	2017	All	Not Applicable

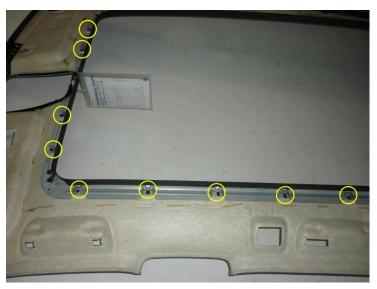
Figure 1. Location of the headliner to sunroof frame clips.

Remove the headliner. The clips shown in the illustration will need fleece adhesive tape (D 373125A2) (Figure 1).

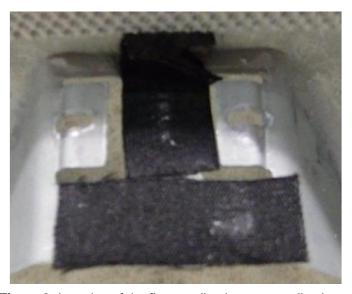
Figure 2. Location of the fleece adhesive tape application.

3. Remove the clips and apply the fleece adhesive tape underneath them, as shown (Figure 2).

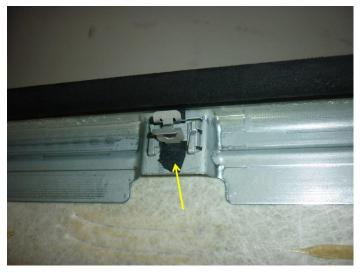
Figure 3. Clips reinstalled.

4. Reinstall the clips (Figure 3).

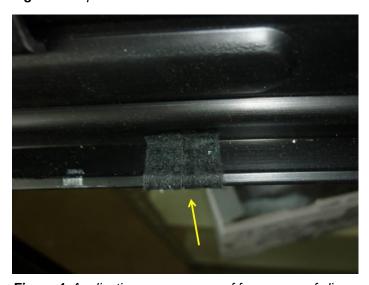
Figure 4. Application area on sunroof frame area of clip engagement.

5. Apply fleece adhesive tape to the sunroof frame lip at each clipping point (Figure 4).
