Technical Service Bulletin

48 Creaking or squeaking noises from steering column (sealing boot)

48 17 74 2034351/8 May 25, 2017. Supersedes Technical Service Bulletin Group 48 number 17-72 dated April 12, 2017 for reasons listed below.

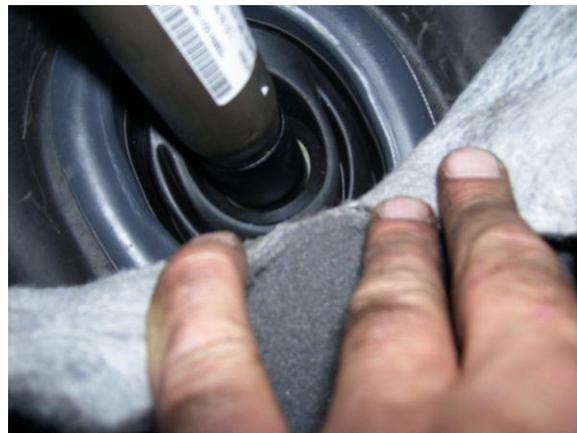
The noise comes from the sealing sleeve/steering column opening on the bulkhead. For an example of the noise, listen to the audio file at <https://audi-external.kzoplatform.com:443/swf/player/304> (Figure 1).

Insufficient lubrication of the intermediate steering shaft in the area of the sealing sleeve.

Figure 1. Sealing sleeve on the bulkhead.

1. Check the sealing sleeve for proper installation and fit (Figure 1).
2. To eliminate the noise, loosen the upper bolted connection of the steering intermediate shaft and the steering column. Pull the intermediate steering shaft out about 4 in (10 cm) and spray the special lubricant spray (**G052172M2**) in the area of the bearing ring and the black plastic sleeve. Push it in and pull it out a few times to distribute the spray on the intermediate steering shaft.

Do not lubricate the u-joints of the steering shaft.

3. Retighten the shaft with a new bolt on the steering column.
4. If the noise persists, replace the intermediate steering shaft.
