# Technical Service Bulletin

## 26 Chirping noise from rear of vehicle

26 17 32 2047565/2 May 16, 2017. Supersedes Technical Service Bulletin Group 26 number 17-31 dated April 18, 2017 for reasons listed below.

Model(s)	Year	VIN Range	Vehicle-Specific Equipment
R8	2016 - 2017	900001 - 904259	Not Applicable

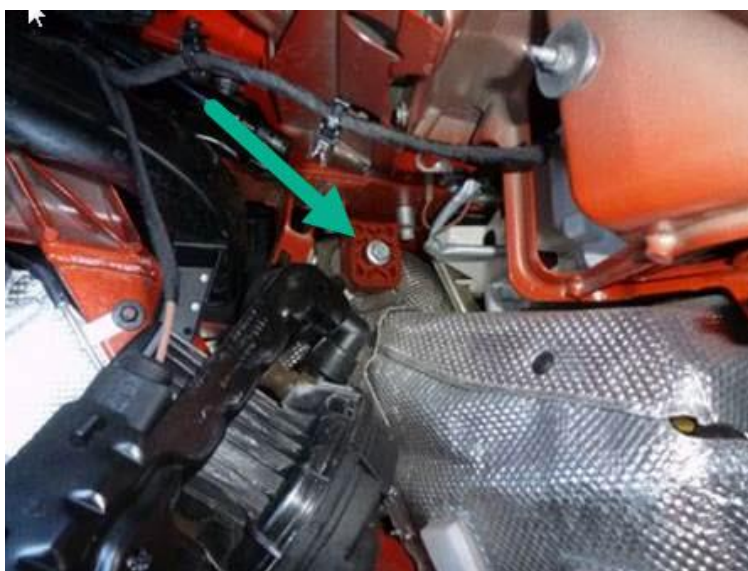
**Figure 2.** Bracket for exhaust system.

- The noises can be located to the mounting assembly of the muffler or more precisely to the washer of the mounting assembly

The noises which are perceived as chirping are due to friction caused by a washer of the exhaust system mounting (Figure 1). For an example of the sound, see the video located at: <https://audi-external.kzoplatform.com:443/swf/player/337>.

If the concern is caused by the washer, replace the washer on both sides of the muffler (Figure 2).

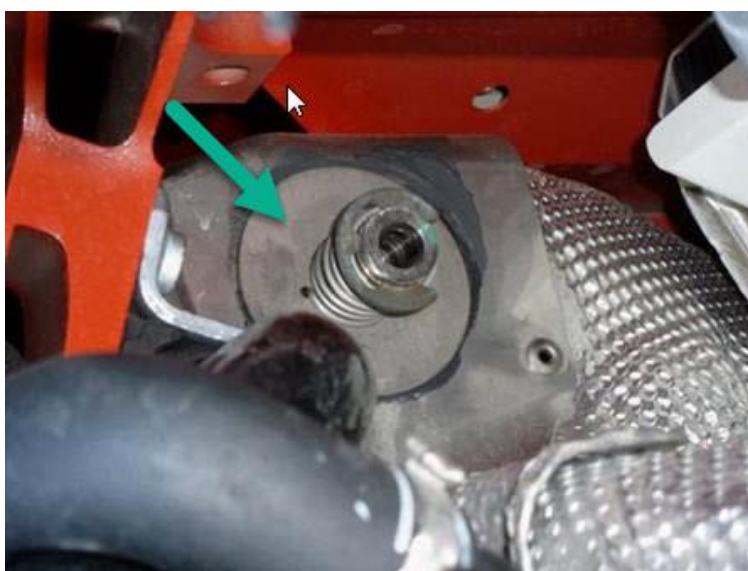
**Figure 3.** Washer.

Modified washer. The new washer is coated on one side with graphite.

The graphite-coated side of the washer must face the heat shield (Figure 3).
