Technical Service Bulletin

19 Coolant pipe seepage on turbocharger

19 17 88 2036167/7 May 26, 2017. Supersedes Technical Service Bulletin Group 19 number 17-82 dated March 21, 2017 for reasons listed below.

Model(s)	Year	VIN Range	Vehicle-Specific Equipment
A8, S6, S7, S8	2013 - 2015	All	4.0 T

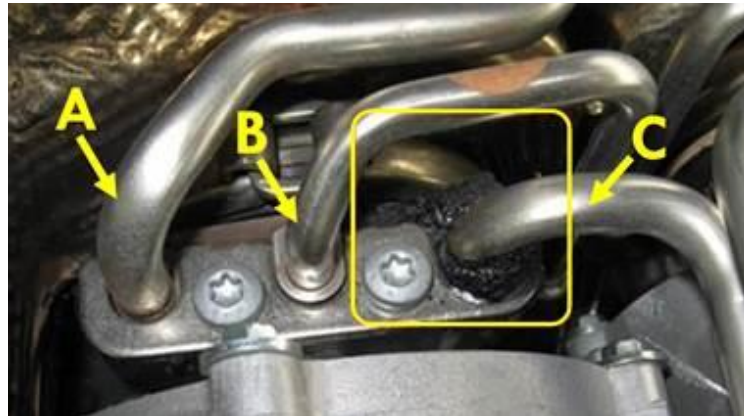
There may be slow coolant loss from the connections at the coolant feed pipe and the coolant return pipe. High temperatures cause the coolant to become encrusted on the connection flange of the turbocharger (Figure 1).

Figure 1. Black, encrusted coolant residue (outlined area), coolant feed pipe (A), oil feed pipe (B), and coolant return pipe (C).

The resulting heat after switching off the engine can, under special operating conditions, lead to very high temperatures on the coolant seals of the turbocharger. This can damage the O-ring.

Optimized temperature-resistant O-rings on the coolant connection of the turbocharger together with an extended operating period of the auxiliary cooling pump after switching off the engine.

Replace the respective O-rings on the coolant supply and return pipes according to the table listed below:

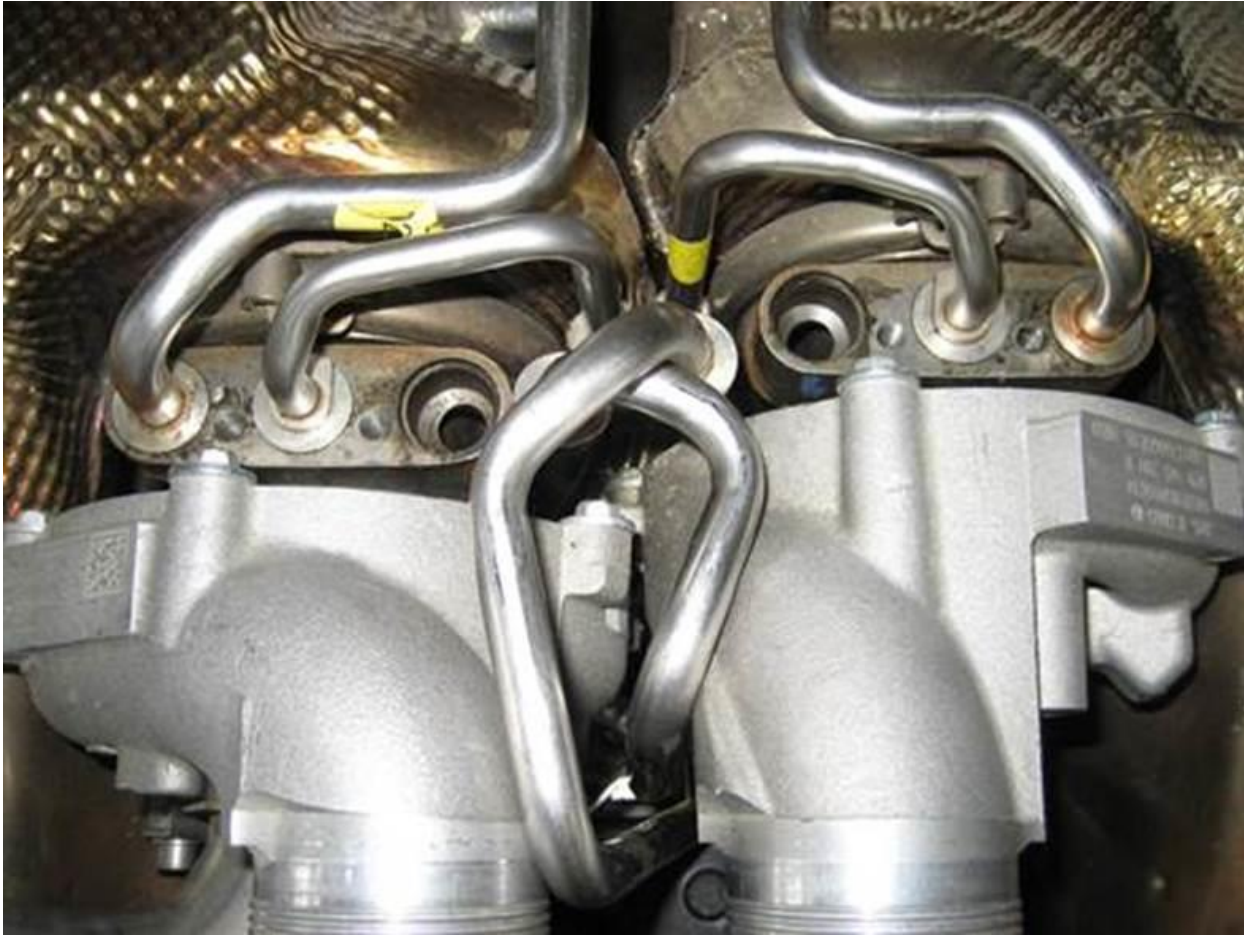
Figure 2. Recommended pipe position.

For the replacement of the two O-rings for the coolant supply pipes we recommend the following pipe position to allow access to remove and replace the O-rings (Figure 2).
