December 2017
SF533A-O
SECOND REVISED NOTICE

Subject: Instrument Cluster Update

Models Affected: Specific Freightliner 108SD, 114SD, and Business Class M2 models; and Freightliner Custom Chassis B2 school bus chassis (Thomas Built Buses Saf-T-Liner C2), and S2/S2C shuttle bus chassis manufactured January 12, 2015, through August 22, 2016, with Cummins ISB and ISL engines.

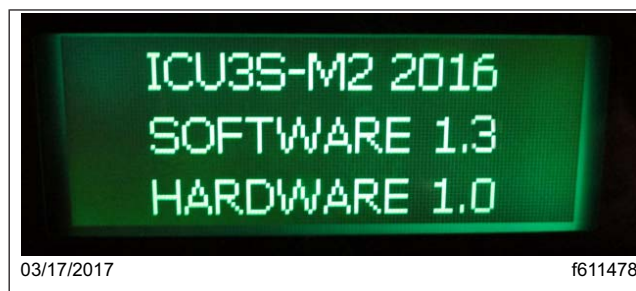
Fig. 1, ICU3S Screen Showing Software Version 1.3 (correct)

If the software level of the ICU3S is 1.3, or higher, no further action is necessary. Continue with step 19.

If the software level is below 1.3, continue with the next step.
