December 2017
FL745AB
NHTSA #17V-521
Transport Canada #17-407
REVISED NOTICE

Subject: Western Star 4900 Front Springs

Models Affected: Specific Western Star 4900 vehicles manufactured November 18, 2016, through July 21, 2017.

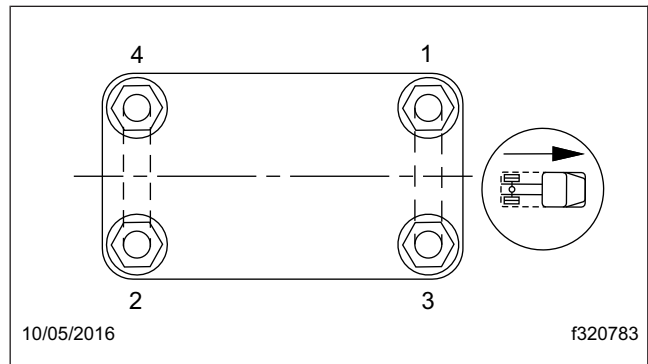
Fig. 5, Tightening Pattern for U-Bolt (or Clamp Bolt) High Nuts

Failure to retighten the U-bolt fasteners as instructed could result in spring breakage or abnormal tire wear.

22. Install the new U-bolts. Tighten the new U-bolt high nuts in stages and in a diagonal pattern as shown in [Table 3](#) and [Fig. 5](#).

U-Bolt Torque Values	
Stage	Torque: lbf·ft (N·m)
1	Hand-tighten
2	60 (81)
3	200 (271)
4	420–500 (571–680)
