## FIELD SERVICE CAMPAIGN – 16138

24 January 2017

Fan Hub Mounting Bolts

DuraStar®, WorkStar®

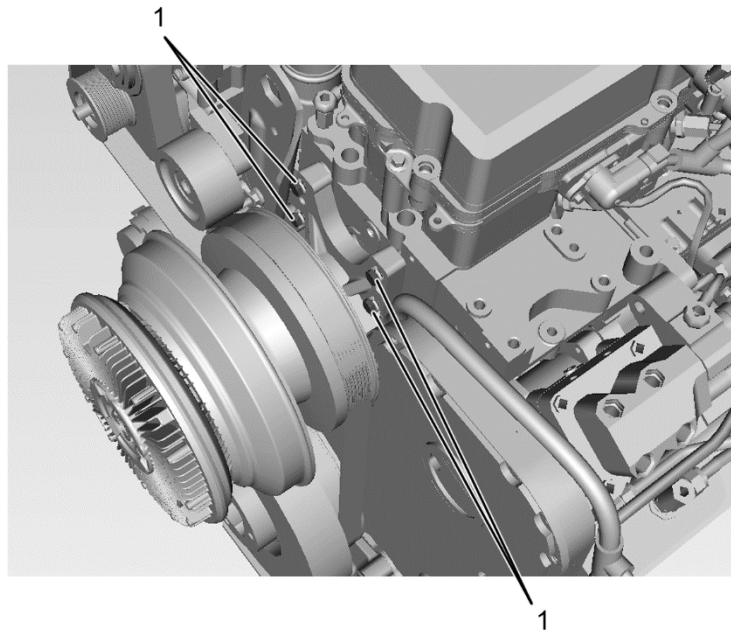
### **Figure 1. Fan Drive**

The fan hub mounting bracket may be loose on certain DuraStar® and WorkStar® vehicles with Cummins® ISL engines due to the mounting bolts being too long.

1. Fan drive mounting bolt (4)
5. Remove one fan drive mounting bolt (Figure 1, Item 1). Discard bolt and washer, if equipped.
6. Install new 35mm long fan drive bolt with no washer. Using a torque wrench, torque to 50 lb-ft (68 N•m).
7. Repeat Steps 5 and 6 on remaining three fan drive mounting bolts.
8. Verify torque on all four fan drive mounting bolts.
9. Close and latch hood.
10. Remove wheel chocks.
