Technical Service Bulletin

Subject: ACCESSORY ROOF RACK DIFFICULT OR CANNOT INSTALL	Bulletin No.: 09-047/17
	Last Issued: 12/18/2017

APPLICABLE MODEL(S)/VINS 2016-2017 CX-3

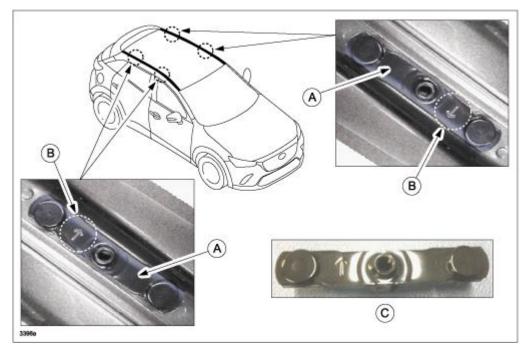
(C) - Bracket Unit

On some vehicles, one or more roof carrier brackets (A) may be installed in reverse (with arrows (B) facing outward). In this case, accessories, such as a roof carrier cannot be installed. Even if the accessory installation was possible, it may cause loose fitting, water leaks or other concerns.

This concern was caused by improper assembly during vehicle production.

2. If anyroof carrier bracket(s) are not installed correctly, remove the affected bracket(s) and install new ones in the correct direction, according to the ROOF CARRIER BRACKET REMOVAL/INSTALLATION instructions.

NOTE: All four (4) roof carrier brackets must be installed so the arrows face inward.
