# Technical Service Bulletin

SCBS / SBS, LAS / LDWS, MASTER AND/OR HBC WARNING LIGHTS ON WITH DTC U3000:98 STORED DURING HOT WEATHER

**Bulletin No.:** 15-006/17

Last Issued: 12/22/2017

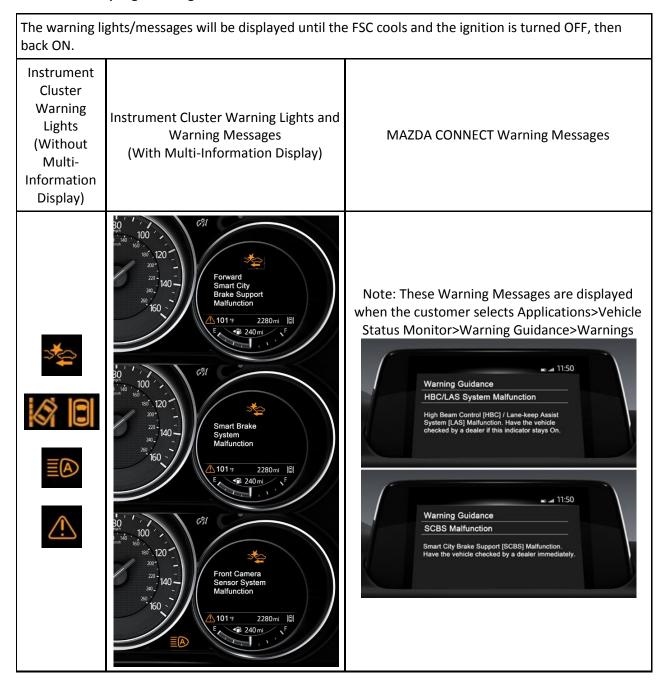
#### **Before FSC Reprogramming:**

This condition may be caused by FSC control logic that is too sensitive. When the FSC detects DTC U3000:98 during high temperature, it stops the internal communication and stores DTC U3000:04. DTC U3000:04 will not clear and SCBS/SBS, LAS/LDWS, and/or HBC functions will not resume until the ignition switch has been turned OFF even if the temperature of the FSC cools.

Customers having this concern should have their vehicle repaired using the following repair procedure.

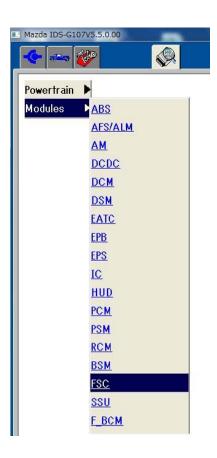
"C\_SCORE" has to be 174 or higher to perform the FSC reprogramming.

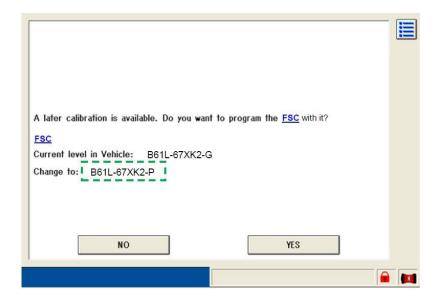
If the message "No later calibration is available on the system for this FSC" is displayed, the FSC is already at the latest calibration. "Current level in Vehicle" will show the new file name. This TSB does not apply.

**NOTE**: The calibration level does not match to the part number level.

Click "YES" and follow the M-MDS instructions to reprogram the FSC.
