## SERVICE ADVISORY # 17-286

### Impact Rear A/C Wiring

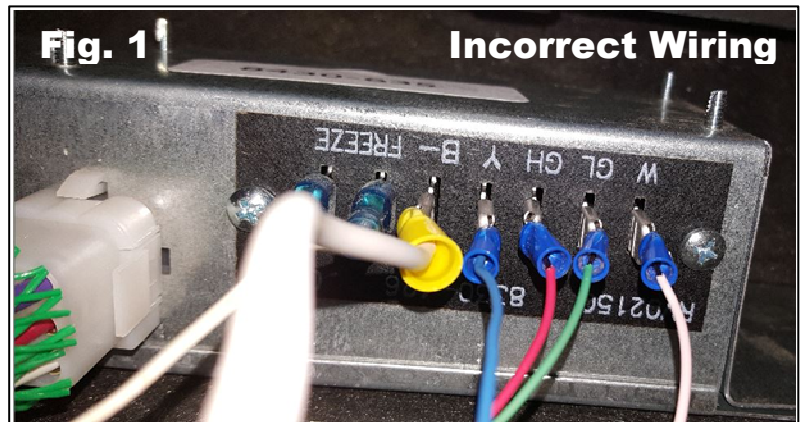
It has been determined that on some 2017-2018 Impact models the air conditioner was wired incorrectly preventing the compressor from running. This advisory explains how to correct the problem if it exists.

Locate the rear A/C control box, Figure 1. The wiring must be corrected as follows.
