# Service Update

## 17445 Engine Mount Bolts Not Tightened

Reference Number: N172121530

Release Date: December 2017  
Revision: 00

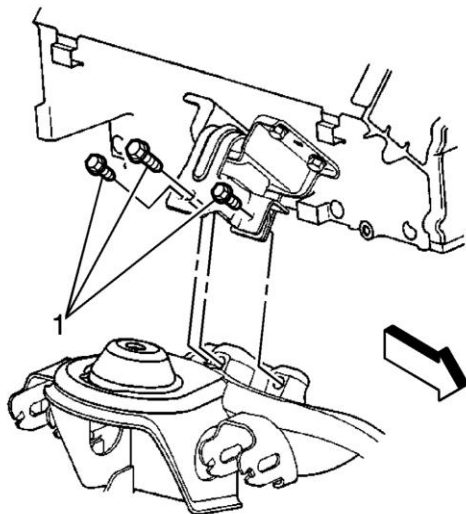
307275

2. Locate the 6, (3 left and 3 right) engine mount-to-engine mount bracket bolts (1).

**TIP: The right-side bolts can be accessed through the passenger side wheelhouse area.**

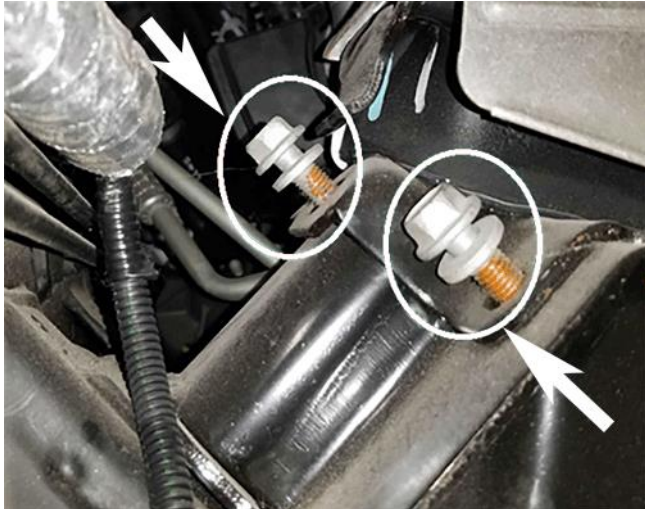
4913543

3. Visually verify that the 3 bolts per side have been tightened. The use of a mirror and flashlight will aid in the inspection process.
  - If the bolts appear tight, no further action is required.

- If the bolts are installed but not tightened, proceed to step 4.
4. Replace the three engine mount bolts on the effected side. If both sides of the vehicle display the condition, replace all six bolts. Tighten to 70 Nm (52 lb ft).
  5. Lower the vehicle.
