Service Update

16179 Missing Welds at Front Right Side Lower Wheelhouse

Reference Number: N162076610

Release Date: January 2017

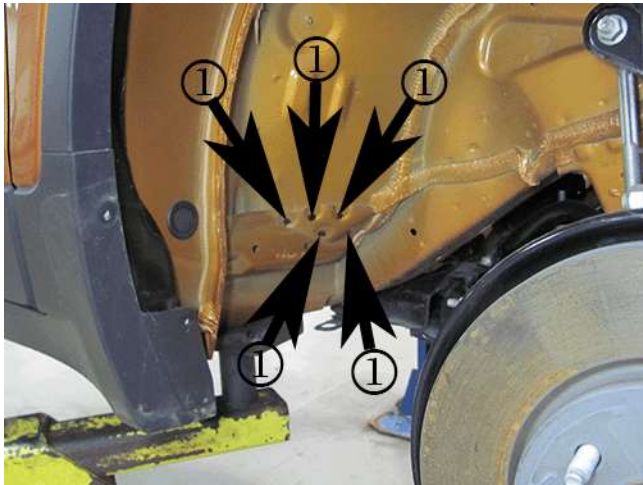
4666515

2. Locate the reinforcement in the rear of the wheelhouse area. There are five spot welds connecting the reinforcement to the front of dash panel (1).

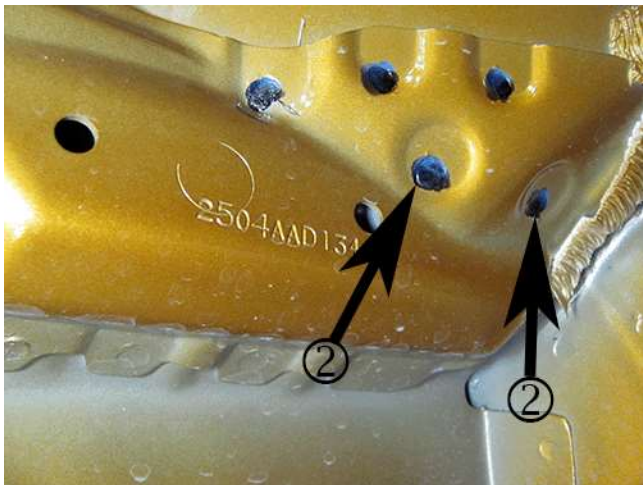
4666517

3. Inspect the brace and verify that the two lower spot welds are present (2).
 - If the **2 lower spot welds are present, no further action is required**. Reinstall the wheelhouse liner. Refer to Front Wheelhouse Liner Replacement (Chevrolet) in SI.
 - If the **2 lower spot welds are not present, proceed to step # 4**.
