Special Coverage Adjustment

15682 Primary Tank Module Flange Fuel and Vapor Leaks

Release Date: January 2017

Revision: 03

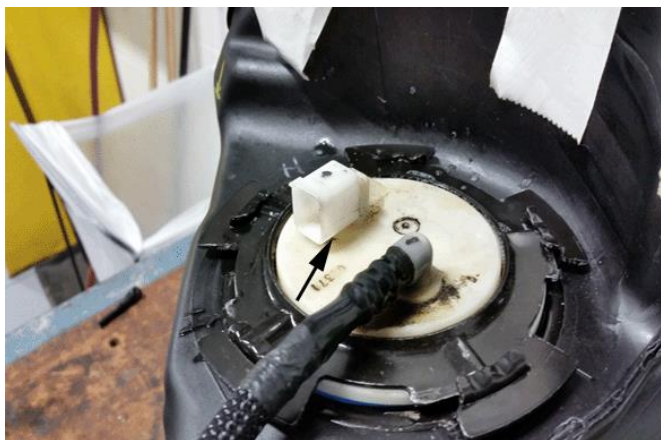
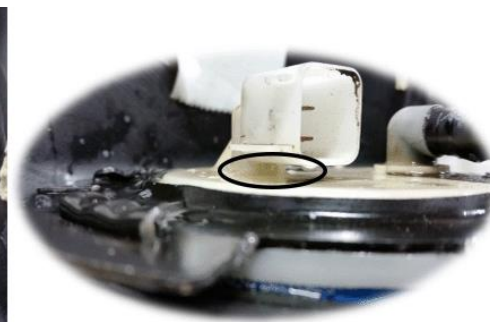
4567575

- Inspect the area below the electrical connector (as shown above) for evidence of fuel leakage.
 - If there is evidence of fuel leakage, replace the fuel tank fuel pump module. Refer to Fuel Tank Fuel Pump Module Replacement - Left Side (LS3, LS7) or Fuel Tank Fuel Pump Module Replacement - Left Side in SI.
