Service Update

31170 Rear Suspension Shackle Bolt Contacts HVAC Line

Reference Number: N16203117 Release Date: January 2017

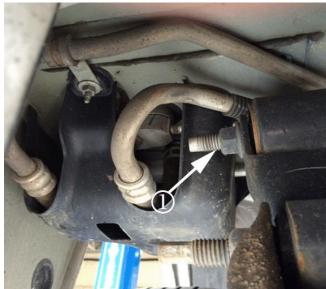
4593753

Condition	Certain 2015 and 2016 model year Chevrolet Express and GMC Savana vehicles, equipped with HVAC system rear - air conditioner (RPO C69) or auxiliary heater (RPO C36), may have contact between the rear leaf spring shackle bolt and rear HVAC coolant lines that may rub through creating a coolant leak.
	This leak may cause the engine to overheat, leading to loss of propulsion or loss of HVAC performance.
Correction	Replace the shackle bolt. Inspect and, if necessary, replace the auxiliary heater hose.

- 4. Remove the spring shackle to leaf spring mounting bolt (1) and DISCARD.
- 5. Install a NEW spring shackle to leaf spring mounting bolt.
- 6. Tighten the spring shackle to leaf spring mounting nut.

6.1. First Pass: 100 Nm (74 lb ft)6.2. Final Pass: (210 degrees)

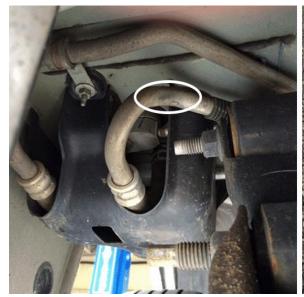
4593757

Note: If there are any signs of damage to the auxiliary heater hose or evidence of the auxiliary heater hose contacting the spring shackle to leaf spring mounting bolt, the auxiliary heater hose MUST be replaced.

- Inspect the auxiliary heater hose for any signs of damage or evidence of the auxiliary heater hose contacting the spring shackle to leaf spring mounting bolt.
 - If there are NOT any signs of damage to the auxiliary heater hose or evidence of the auxiliary heater hose contacting the spring shackle to leaf spring mounting bolt, no further action is required.
 - If there are any signs of damage to the auxiliary heater hose or evidence of the auxiliary heater hose contacting
 the spring shackle to leaf spring mounting bolt, replace the auxiliary air conditioning evaporator hose or auxiliary
 heater inlet and outlet hose depending on vehicle content. Refer to Auxiliary Air Conditioning Evaporator Hose
 Replacement (Rear) in SI.
- 9. Install the left rear tire. Refer to Tire and Wheel Removal and Installation in SI.
- 10. Lower the vehicle. Refer to Lifting and Jacking the Vehicle in SI.
