Customer Satisfaction Program

16038 Transmission Oil Cooler Line in Contact with Body Stud

Reference Number: N162051960

Release Date: January 2017
Revision: 00

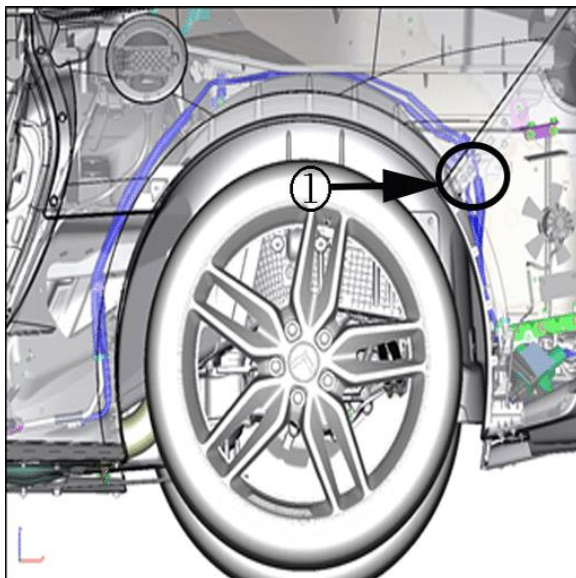
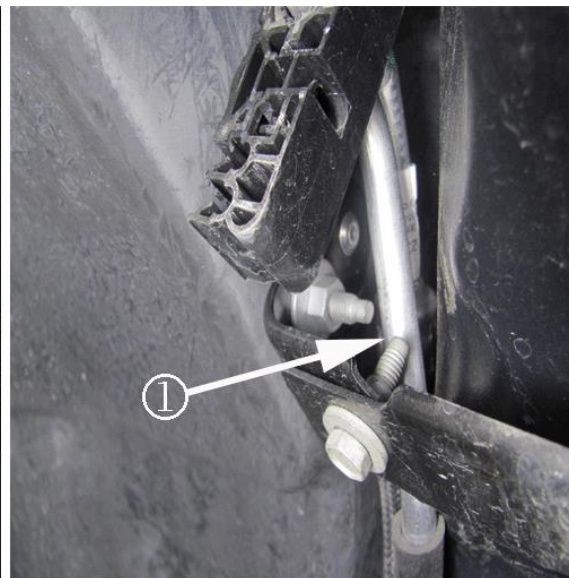
4673806

3. Locate the area of the transmission fluid auxiliary cooler inlet rear intermediate pipe that is being serviced (1).
