# Service Update

## 16135 One Touch Fold Seat Release

**Reference Number:** N16207169

**Release Date:** January 2017  
**Revision:** 01

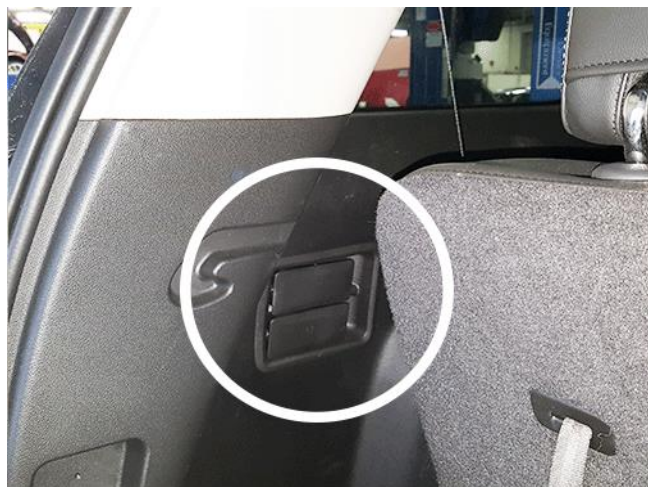
4676095

<b>Condition</b>	Certain 2017 model year GMC Acadia vehicles may have a condition in which the rear cargo area left hand 2nd row seat release handle doesn't release the seat, or requires too much effort to release.
<b>Correction</b>	Dealers are to inspect, and if necessary, adjust the 2nd row seat cable.

- Inspect the operation of the 2nd row seat release using the release levers located in the rear cargo area shown above.
  - If the 2nd row seat releases the seat correctly without extra effort, no further action is required.

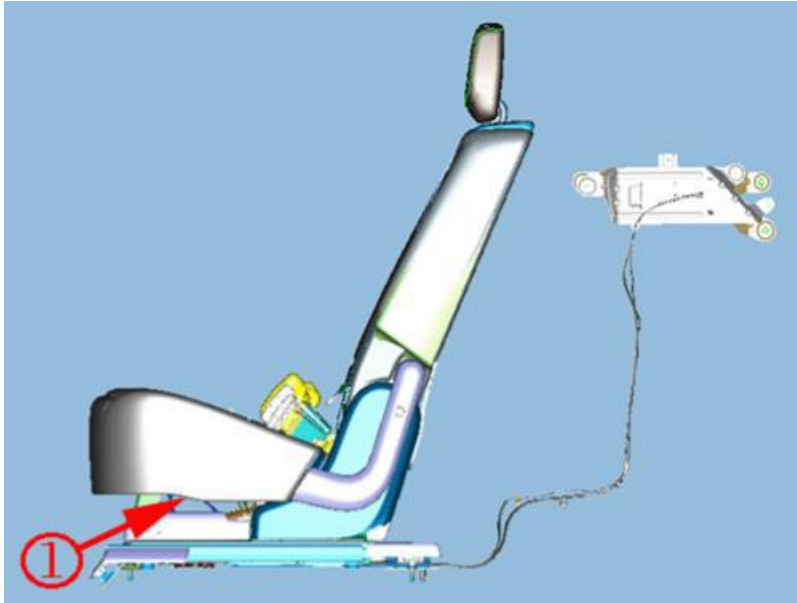
4563488

- If the 2nd row seat release handle does not release the seat or requires too much effort, proceed to step 2 and adjust the 2nd row seat release cable.
2. Ensure that the 2nd row seat is in the upright position and both recliners are fully locked.

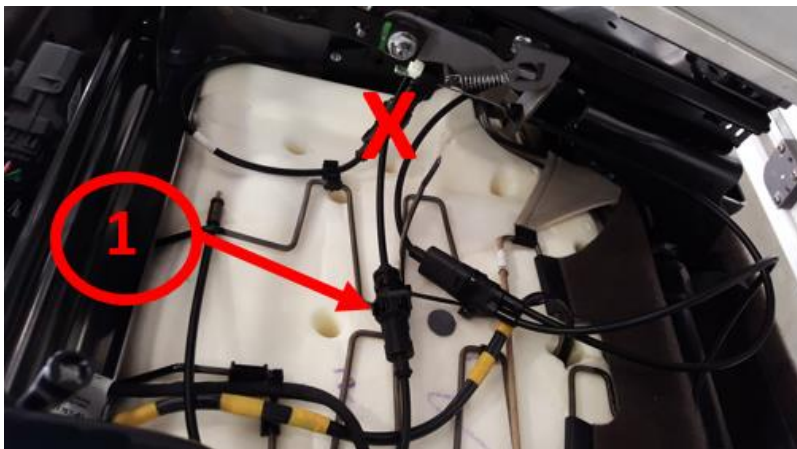
4640426

3. Look under the seat to locate the One Touch Fold (OTF) cable adjuster # 1 (See picture above) and open the slider on the adjuster body.

**Note:** Do not open the other adjuster (marked with an "X" in the picture above), as it will not help resolve this issue.
