Service Update

16195 Brake Lamps Remain Activated

Reference Number: N162068110

Release Date: January 2017

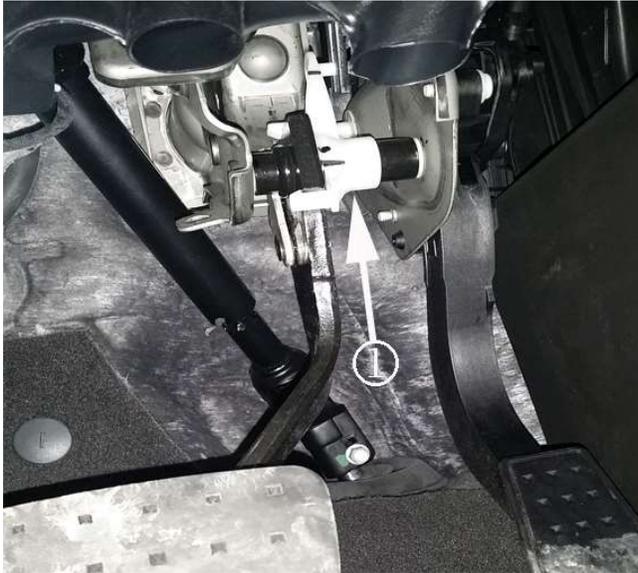
4671098

1. Position the front driver seat in the rear most position to gain access to the brake pedal position sensor (BPPS) switch activation bracket (1).

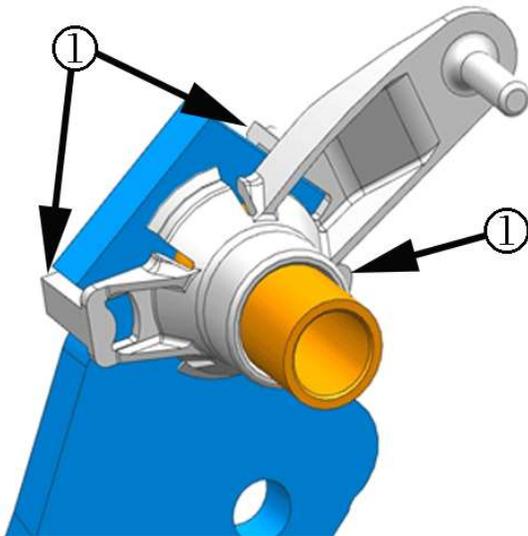
4671106

2. Ensure all three BPPS switch activation bracket plastic tabs (1) are secured over the pedal arm.
 - If all three BPPS switch activation bracket plastic tabs are secured over the pedal arm, proceed to the next step.
 - If any of the BPPS switch activation bracket plastic tabs are NOT secured over the pedal arm, secure the BPPS switch activation bracket tabs over the pedal arm and proceed to the next step.

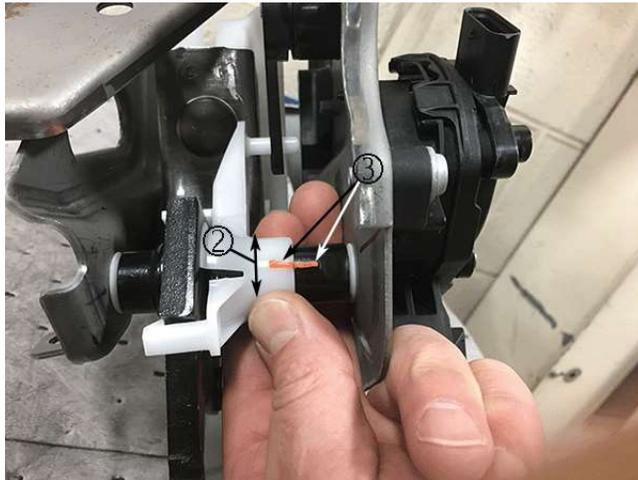
4690695

Brake and accelerator pedal assembly shown out of vehicle for illustration purposes. Paint pen scribe mark (3) shows relationship between the base of the BPPS switch bracket and bracket shaft. Two-sided arrow (2) indicates rotation path of the BPPS switch bracket.

- Using your fingers, rotate the BPPS switch activation bracket back and forth (2) to determine if there is any movement at the base of the bracket and bracket shaft (3).

- If there is 1 mm (3/64 in) or less of movement in any direction or less than 2 mm (5/64 in) of movement total in both directions and the brake lights do NOT remain on after attempting to rotate the BPPS switch activation bracket, no further action is required.
- If there is more than 1 mm (3/64 in) of movement in any direction or over 2 mm (5/64 in) movement total in both directions and the brake lights remain on after attempting to rotate the BPPS switch activation bracket, replace the brake and accelerator pedal assembly. Refer to *Brake and Accelerator Pedal Assembly Replacement* in SI.

Note: If the brake lights remain on after the BPPS inspection, replace the brake and accelerator pedal bracket. Refer to *Brake and Accelerator Pedal Assembly Replacement* in SI.
